Aids to Navigation Foundation Survey Report

**FY26 MCON Project P-1200 Yap Port and Channel
Improvements**

Yap Island
Federated States of Micronesia

15 January 2025

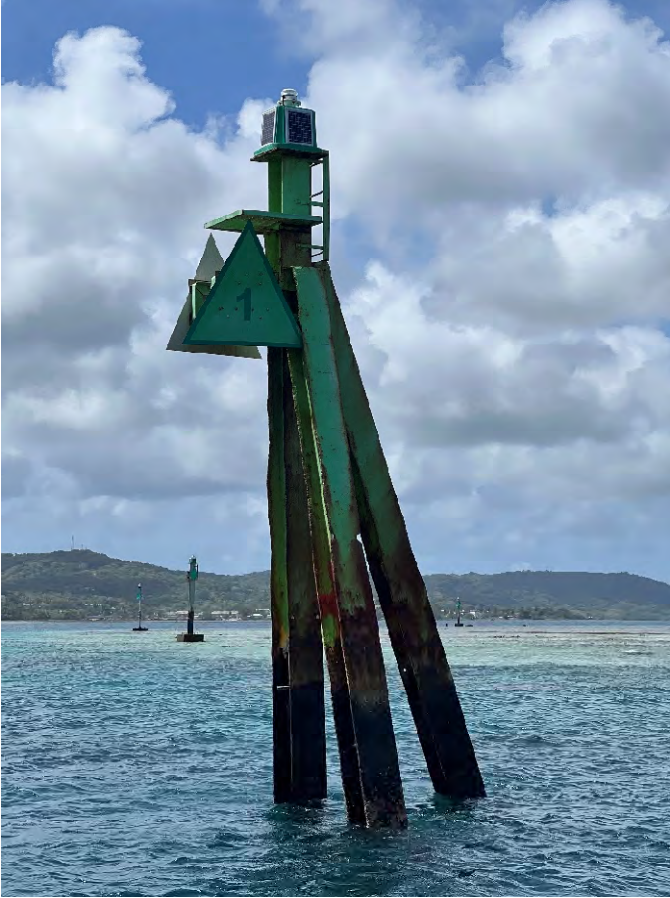
Channel Marker #	Existing ATON Photo	Foundation Photos	Foundation Photos	Foundation Dimensions	Water Depth (FT, MWH)	Notes
G1

N/A	22.1	<p>Fixed aid #1 is a three pile structure with driven piles. Large coral heads are present around the three legs. The World Bank project replaced the light and dayboards but left the piles in place. Cathodic protection is installed on one of the three legs. Surface rust is present at and above the splash zone, however steel pile cross sections appear to be intact.</p>

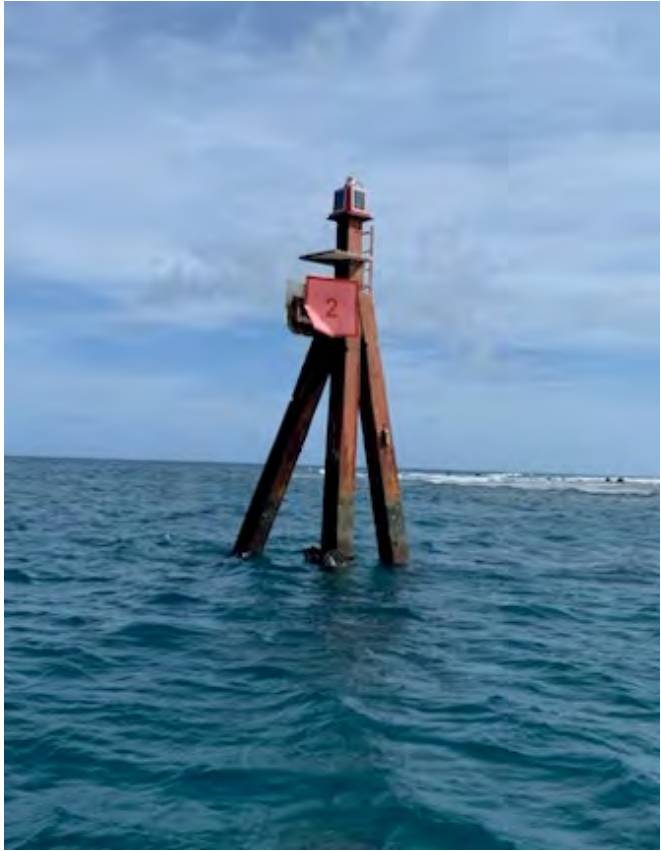
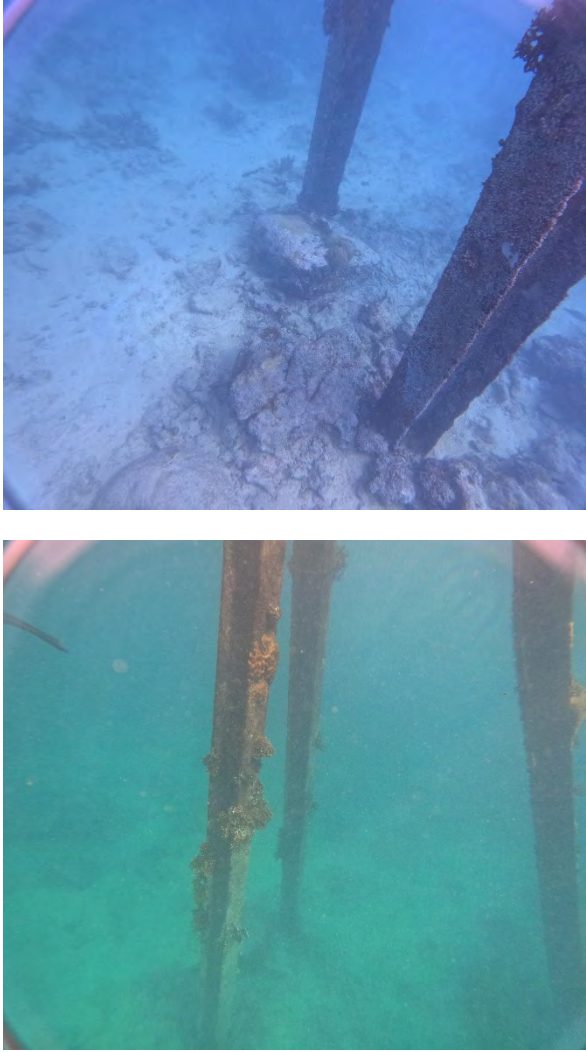
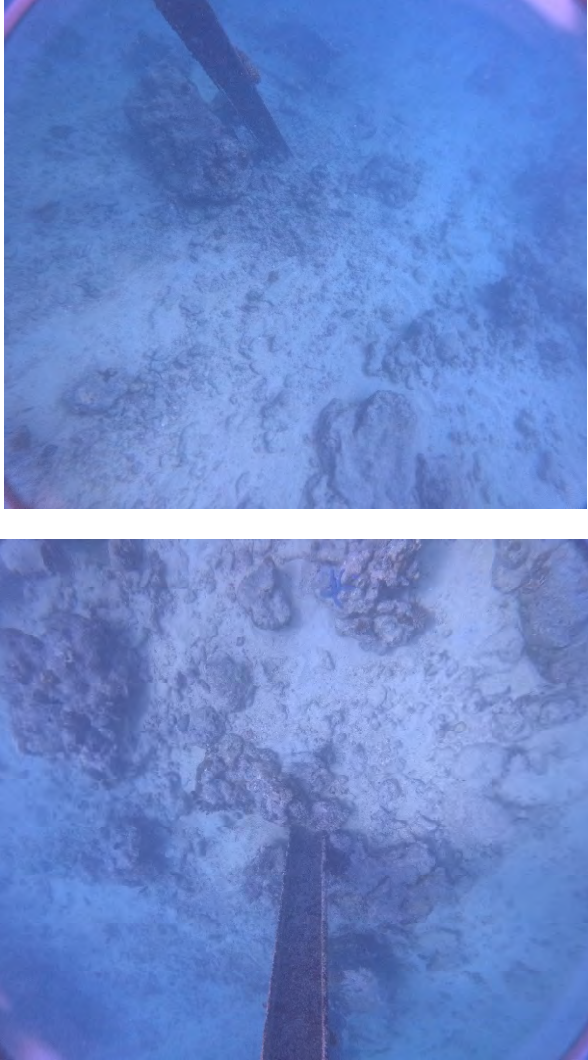
R2

N/A	23.9	<p>Fixed aid #2 is a three pile structure with driven piles. The bottom is mainly a sandy bottom at this location with much less coral growth on this side of the channel. The World Bank project replaced the light and dayboards but left the piles in place. Cathodic protection is installed on one of the three legs. Surface rust is present at and above the splash zone, however steel pile cross sections appear to be intact.</p>
----	---	--	--	-----	------	---

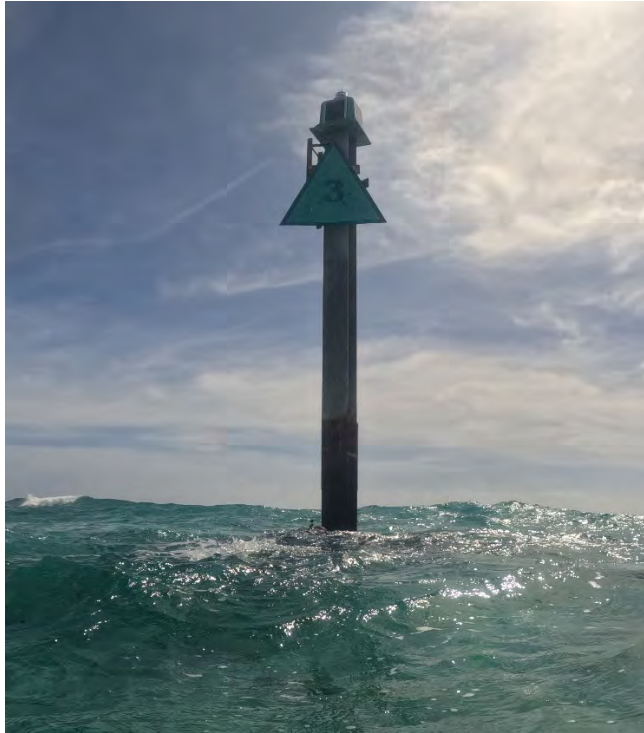
G3

60" X 60" X 44"	5.8	<p>Little to no coral present at this location. This is a newer aid that was installed via a World Bank project within the past 5 years. Although there is corrosion protection installed on the pile, there is visible signs of surface rust at and above the splash zone Dayboard is broken on one side.</p>
----	---	---	---	-----------------	-----	--

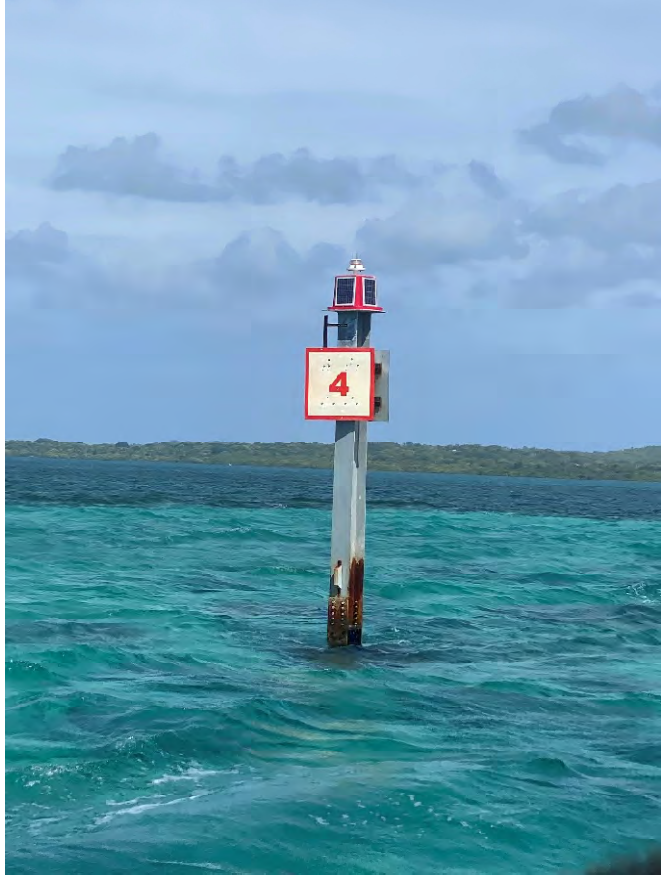
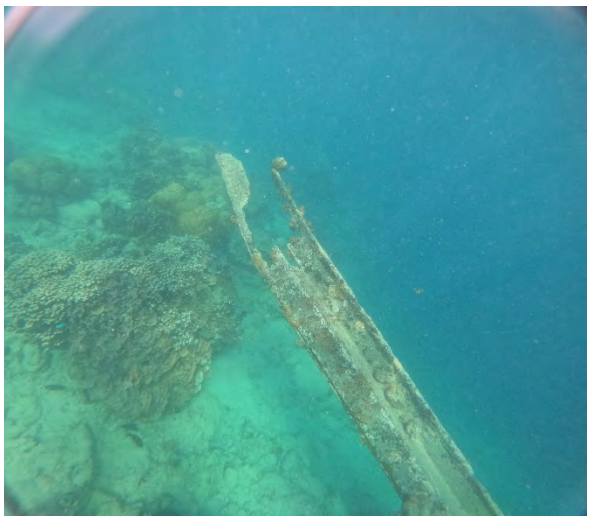
<p>R4</p>

<p>60" X 60" X 44"</p>	<p>6.9</p>	<p>Little to no coral present at this location. This is a newer aid that was installed via a World Bank project within the past 5 years. Although there is corrosion protection installed on the pile, there is visible signs of surface rust at and above the splash zone. Old concrete bases and driven pile remnants remain on the bottom along with other debris.</p>
-----------	---	---	---	------------------------	------------	---

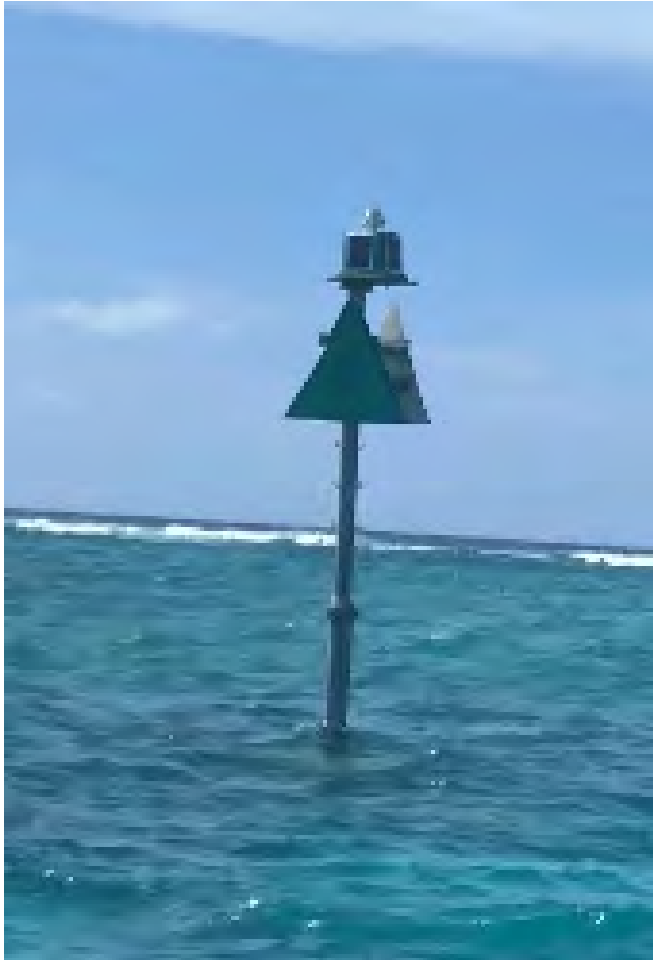
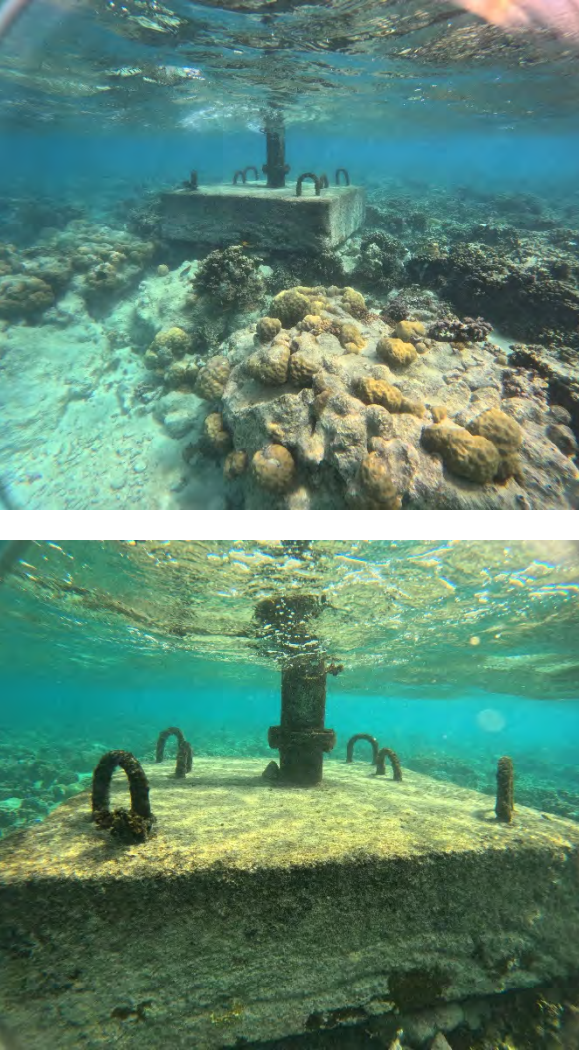
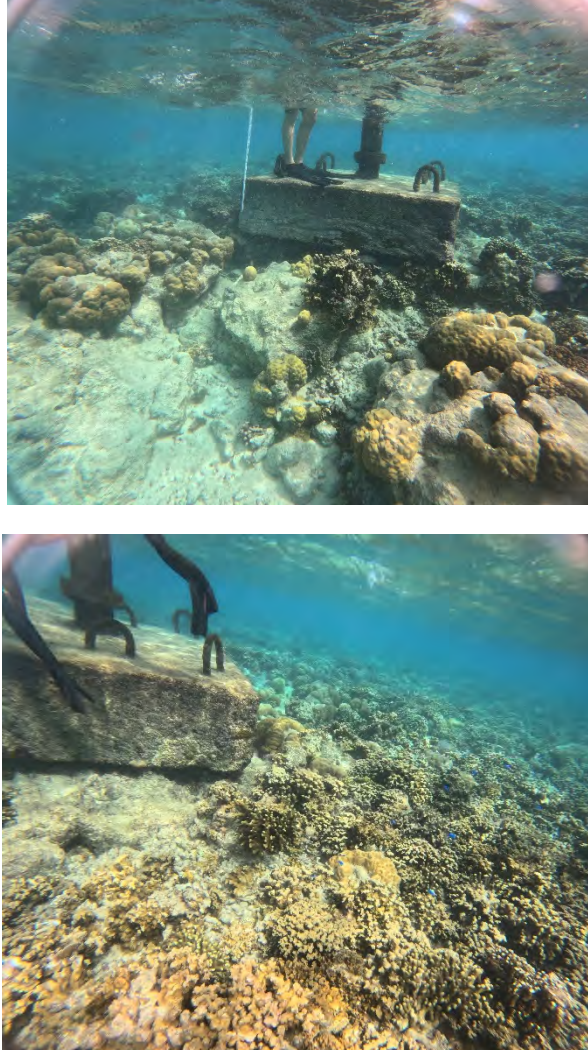
<p>G5</p>

Two underwater photographs showing the foundation of aid G5. The top image shows a concrete base with several metal rings, surrounded by coral and other marine life. The bottom image shows a similar view from a different angle, highlighting the concrete structure and the surrounding seabed.	<p>76" x 76" x 21"</p>	<p>5.8</p>	<p>Older single pile Aid with replacement light. No visible reason for this aid no being replaced other than its location further from the edge of the channel. Foundation is sitting on top of a bed of coral and does not appear the coral has attached to it.</p>

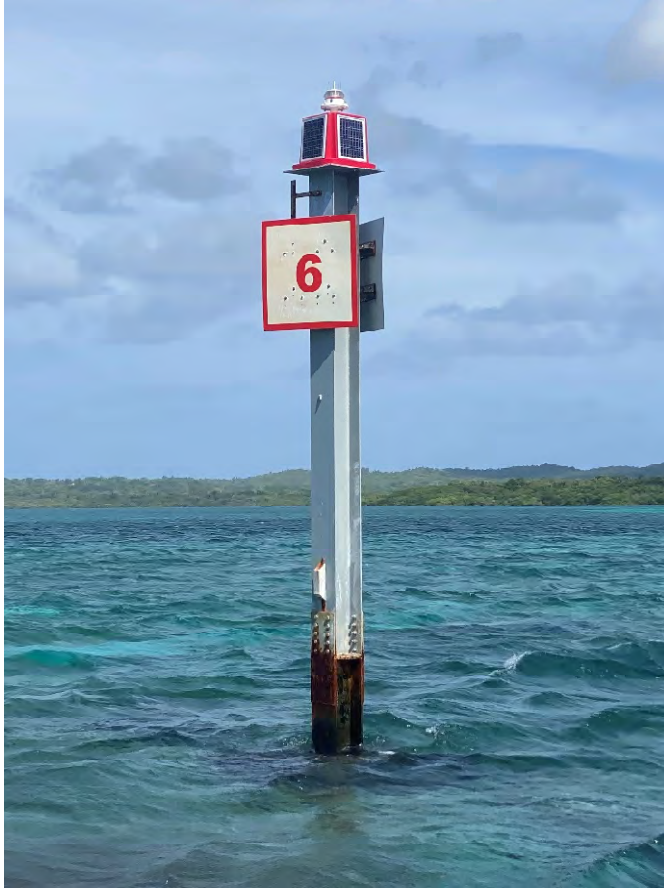
<p>R6</p>

<p>60" X 60" X 44"</p>	<p>6.2</p>	<p>This aid was initially planned to be the site of the new front range, however due to a shift in the channel centerline the location will no longer work for the front range. It is recommended to replace this aid with a standard single pile aid. Visible day boards front and back. This is a newer aid that was installed via a World Bank project within the past 5 years. Although there is corrosion protection installed on the pile, there is visible signs of surface rust at and above the splash zone.</p>
-----------	---	---	---	------------------------	------------	---

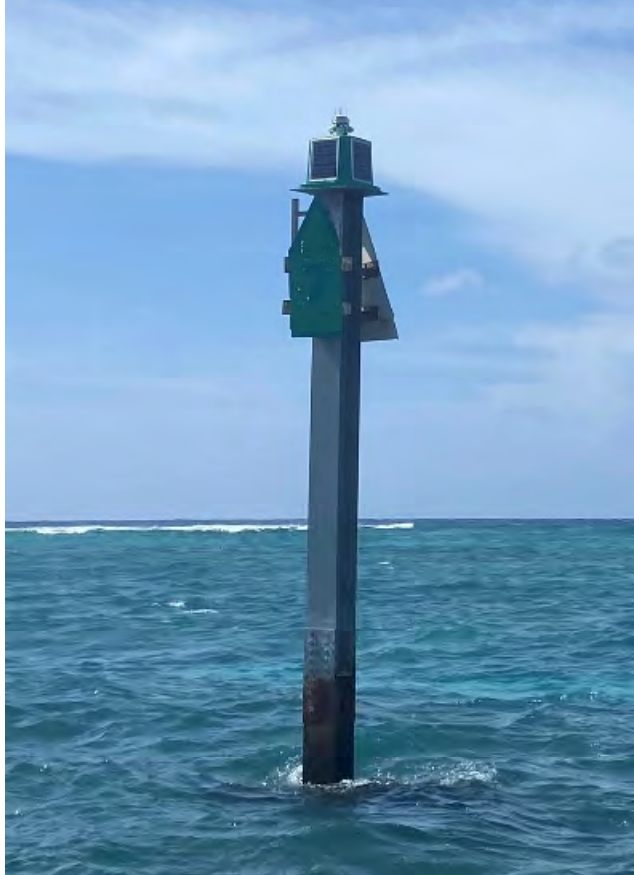
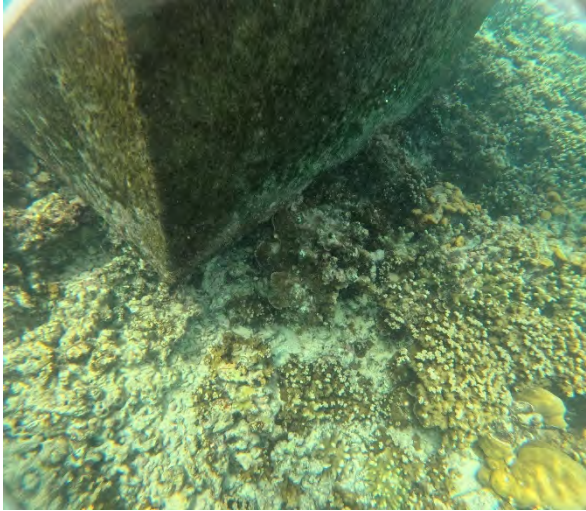
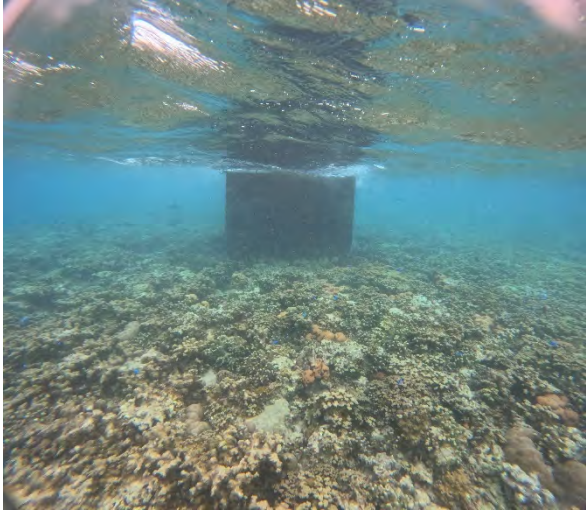
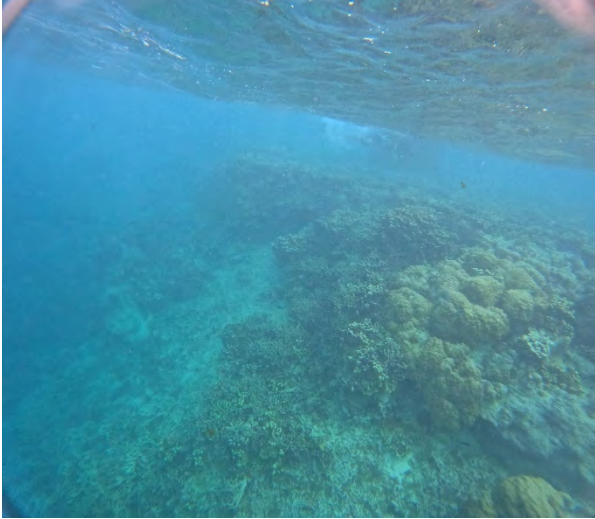
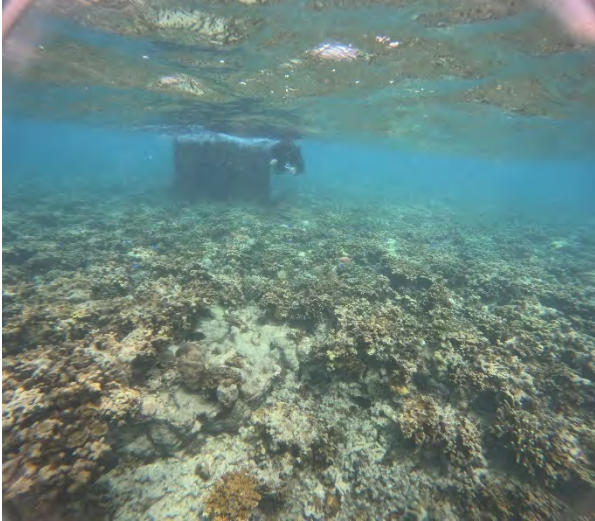
<p>G7</p>

<p>60" X 60" X 44"</p>	<p>5.4</p>	<p>Visible day boards front and back. This is a newer aid that was installed via a World Bank project within the past 5 years. Although there is corrosion protection installed on the pile, there is visible signs of surface rust at and above the splash zone. Foundation rests on top of the reef with coral under and around the concrete block.</p>
-----------	---	--	--	------------------------	------------	---

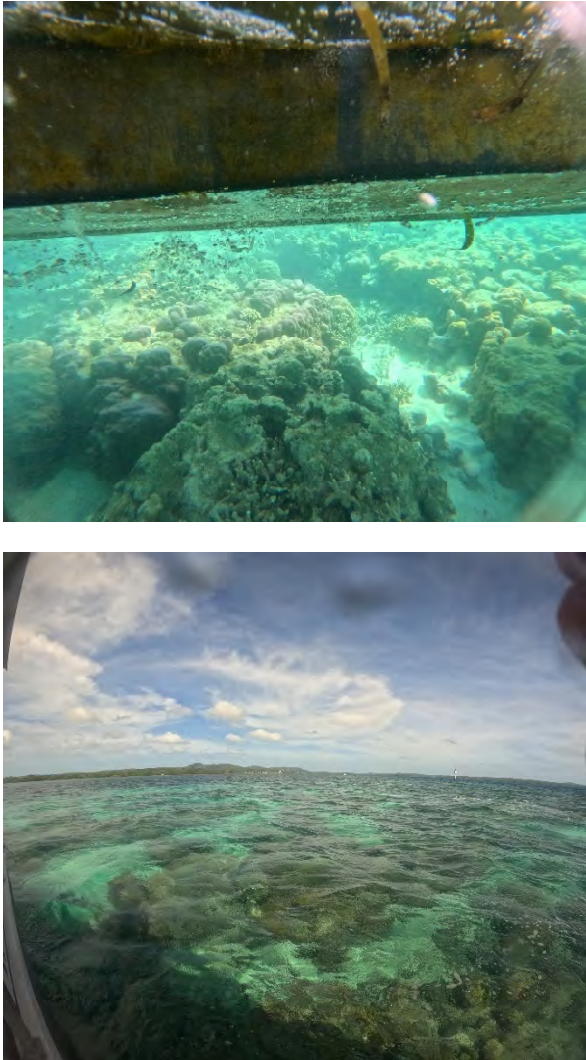
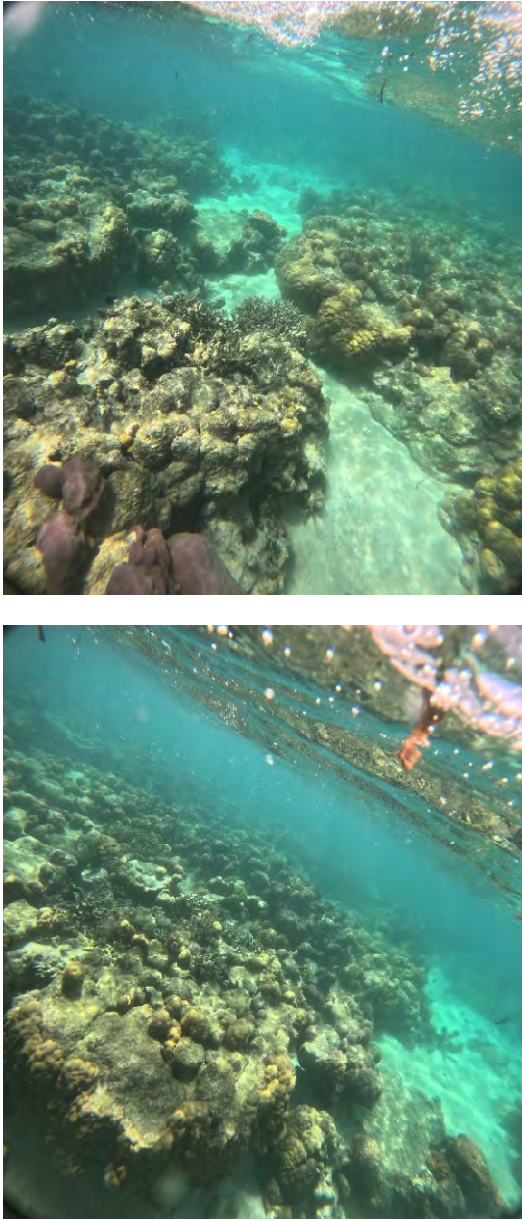
<p>FR</p>	<p>N/A</p>

<p>Proposed 4 pile 10' X 10' platform with foundation blocks on each leg that measure approximately 6 ft square in this location</p>	<p>~4.5</p>	<p>This is the location for the proposed four pile front range tower. The design calls for the four (4) piles to be mounted to 6ft X 5ft concrete gravity blocks which will support a 10' X 10' platform with a 20 f tall tower mounted on top. The tower will have dayboards and lights for daytime and nighttime navigation.</p> <p>This area is shallow and there are lots of coral in the area. To erect the range tower it will likely be necessary to remove coral in order to place the concrete foundations on a flat supportive surface using bedding stone.</p>
-----------	------------	--	--	---	-------------	---

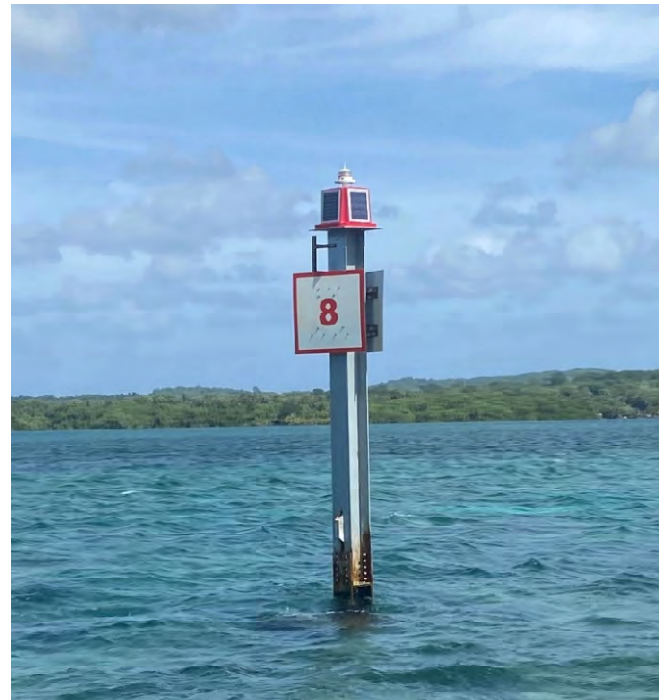
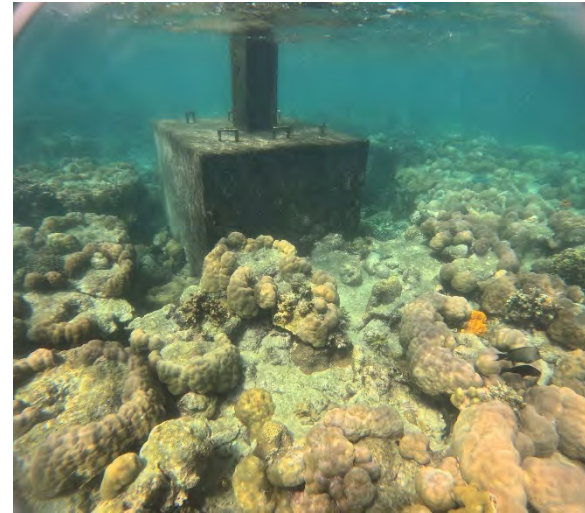
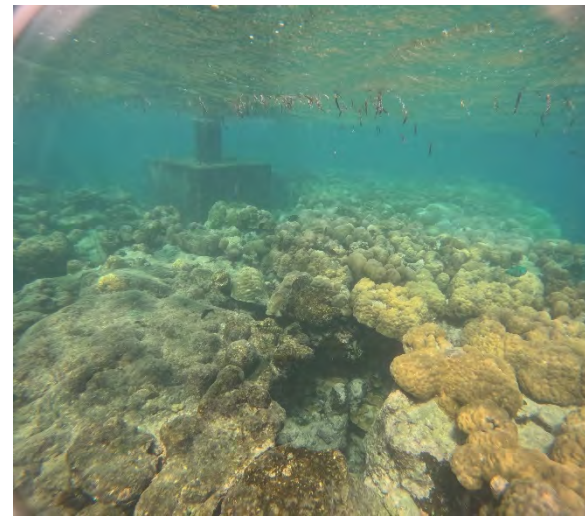
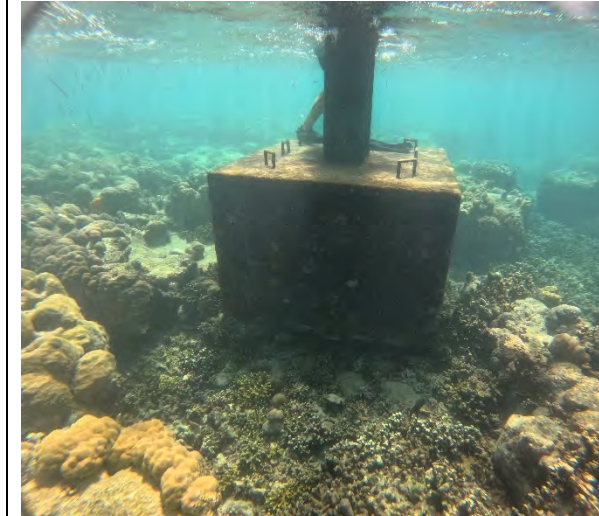
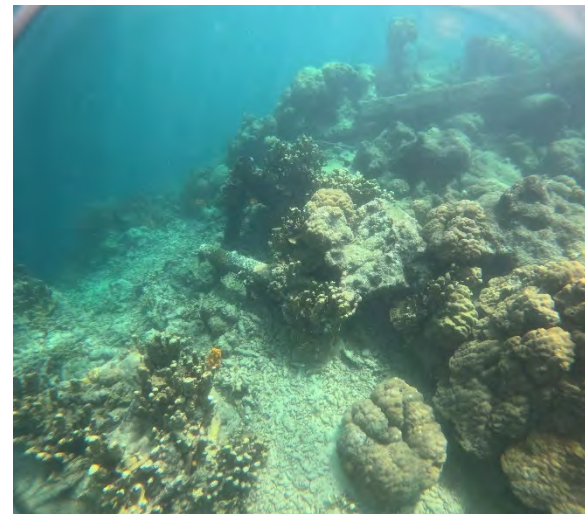
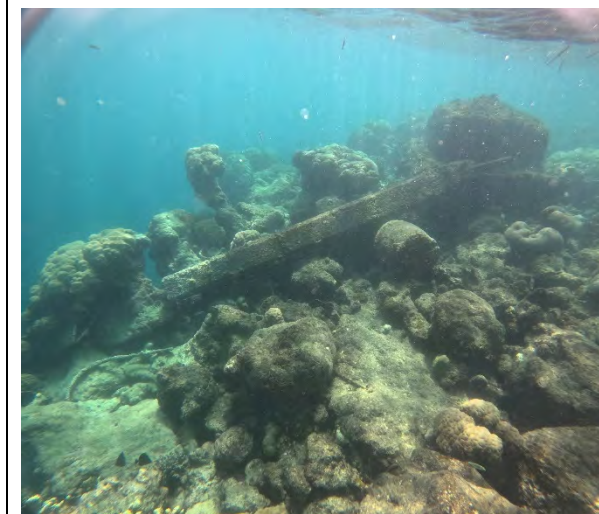
R8

Visible day boards front and back. This is a newer aid that was installed via a World Bank project within the past 5 years. Although there is corrosion protection installed on the pile, there is visible signs of surface rust at and above the splash zone. There is a lot of coral around this foundation. It appears that either a hole in the coral was found or created when this aid was placed as it sits below the surrounding coral heads. Evidence of older aids are present, but not hazardous to navigation.

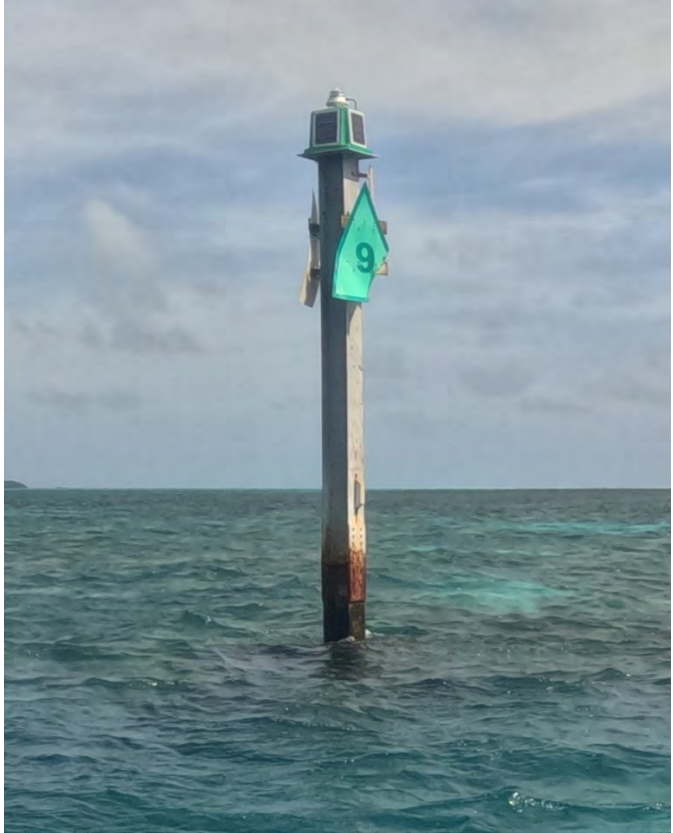
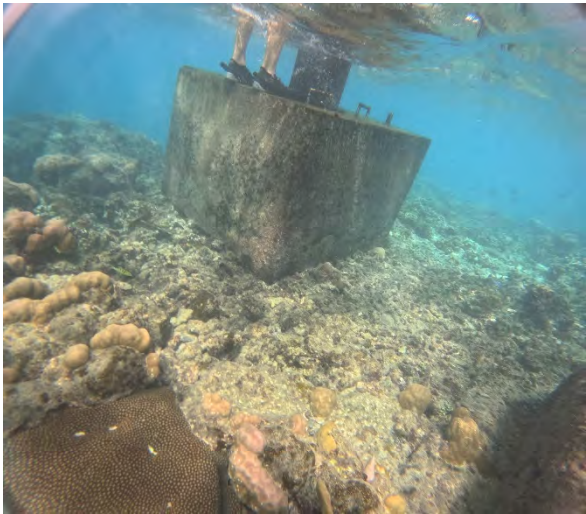
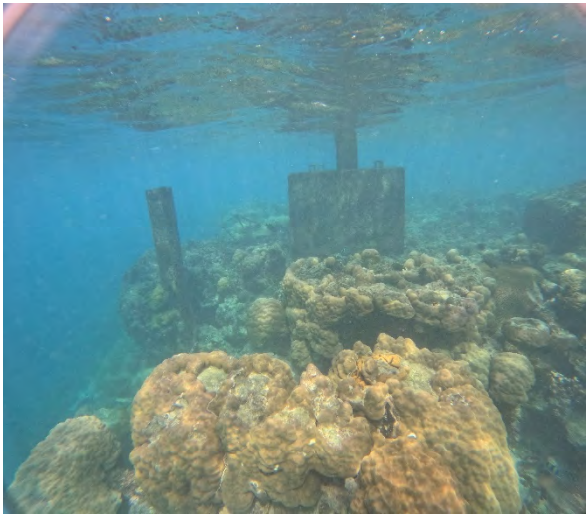
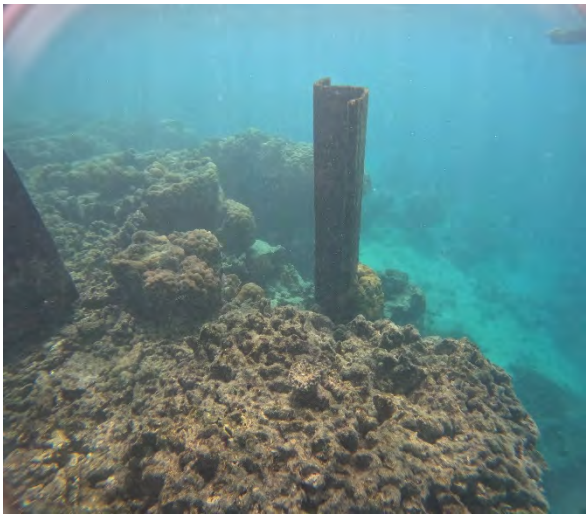
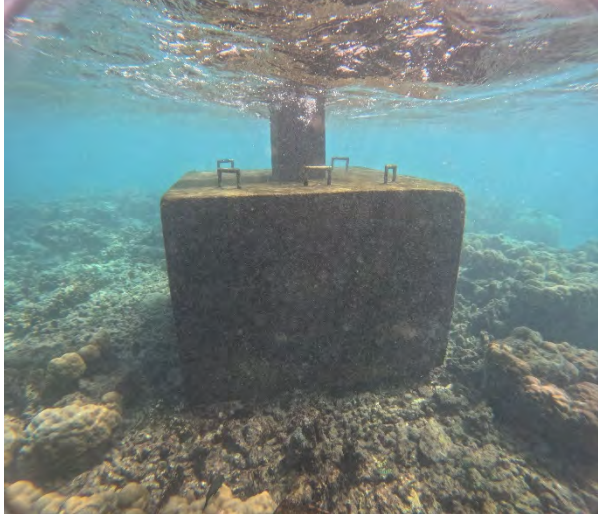
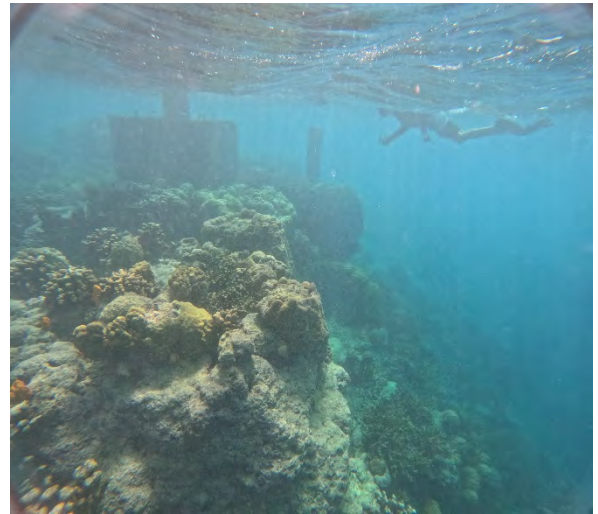
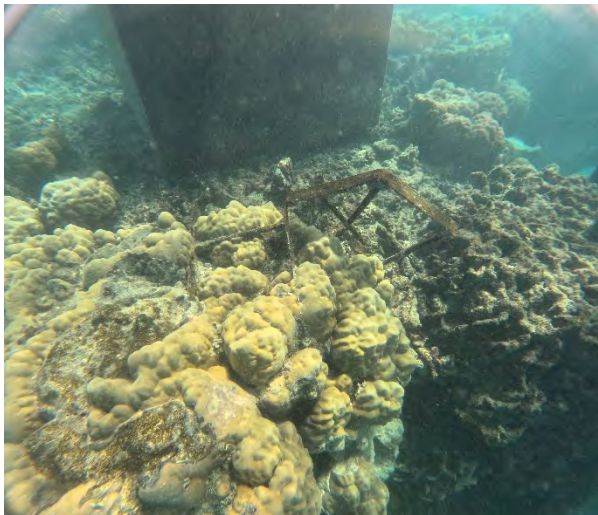
<p>G9</p>

<p>60" X 6000" X 44"</p>	<p>5.6</p>	<p>Damaged day boards front and back. This is a newer aid that was installed via a World Bank project within the past 5 years. Although there is corrosion protection installed on the pile, there is visible signs of surface rust at and above the splash zone. Evidence of older aids are present. The old driven pile appears to have been cut off below the waterline. It is recommended that it be either removed or cutoff at the mudline to eliminate the navigational hazard present.</p>
-----------	---	--	--	--------------------------	------------	--

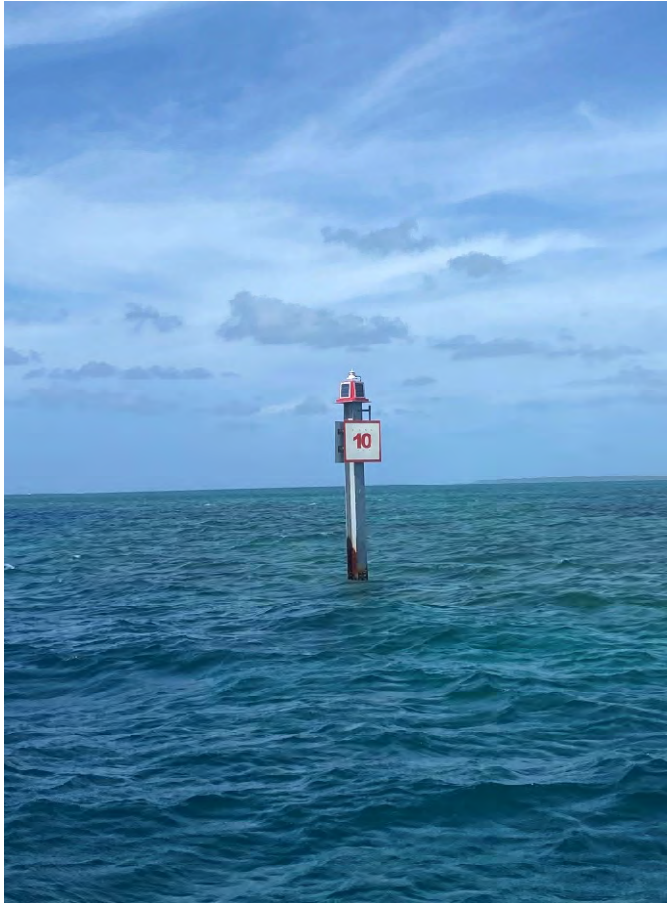
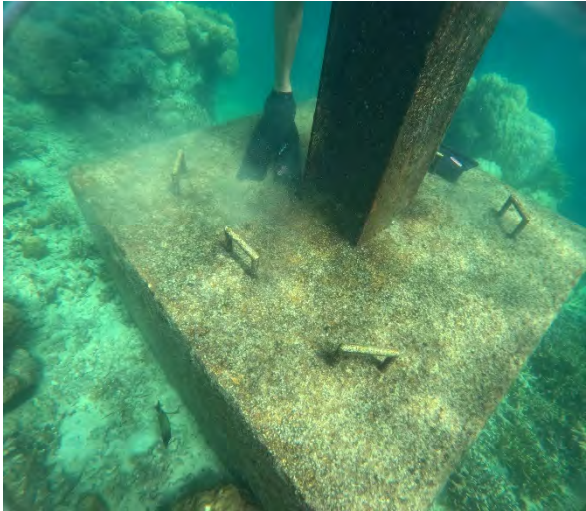
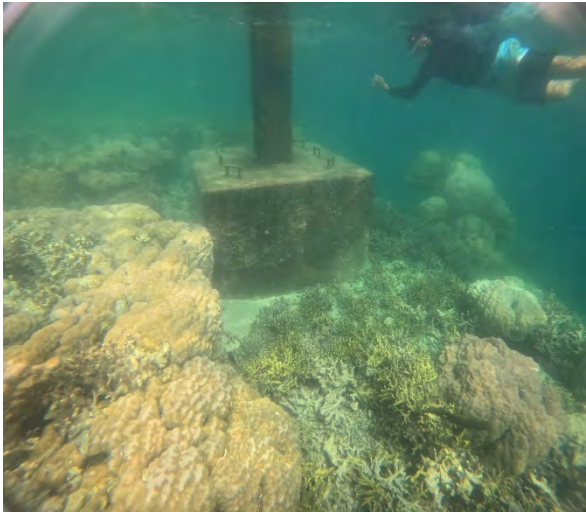
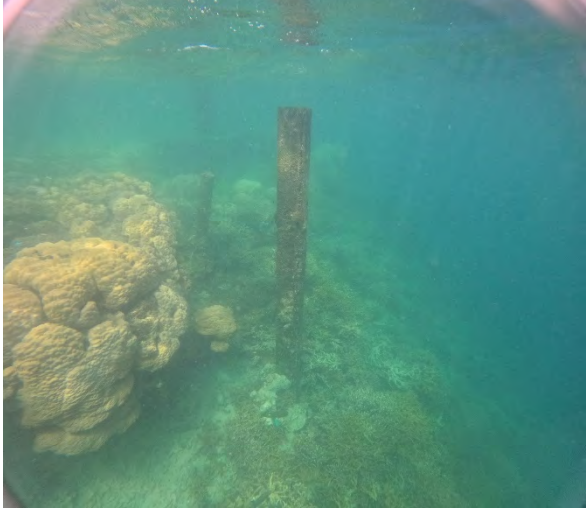
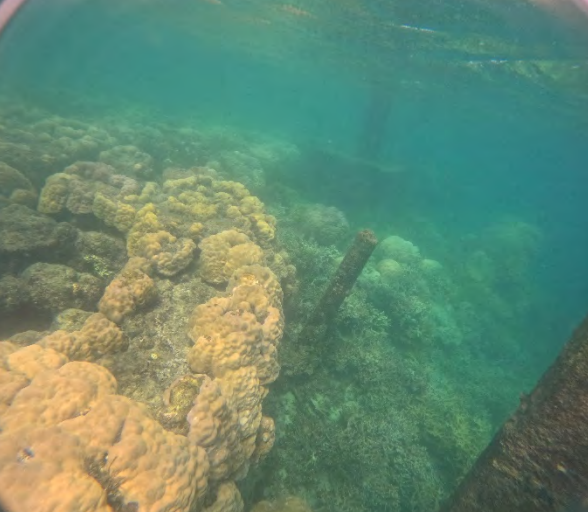
<p>R10</p>

<p>Two underwater photographs showing an older, rusted metal pile. The pile is surrounded by coral and other marine life. The water is clear and blue.</p>	<p>60" X 60" X 44"</p>	<p>8.2</p>	<p>Visible day boards front and back. This is a newer aid that was installed via a World Bank project within the past 5 years. Although there is corrosion protection installed on the pile, there is visible signs of surface rust at and above the splash zone.. Evidence of older aids are present. The old driven pile appears to have been cut off below the waterline. It is recommended that it be either removed or cutoff at the mudline to eliminate the navigational hazard present.</p>

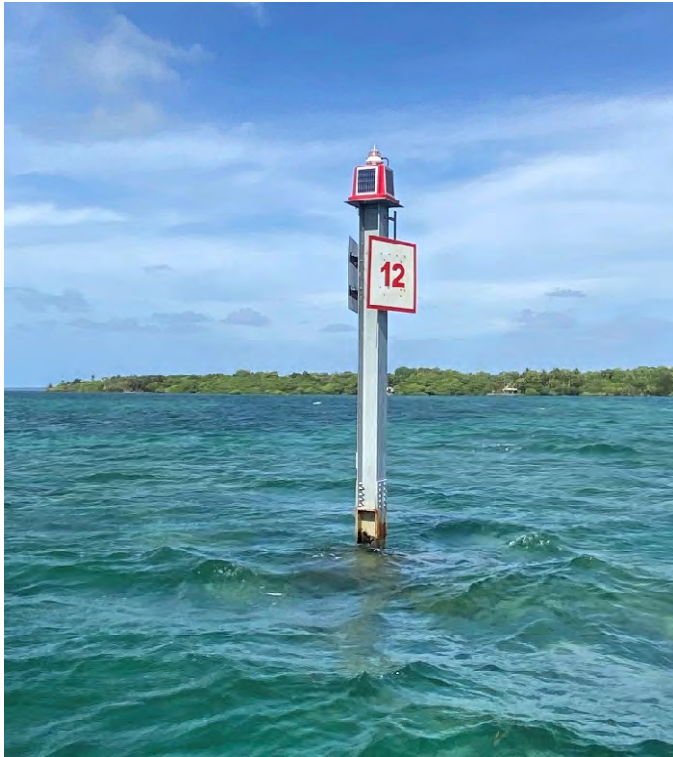
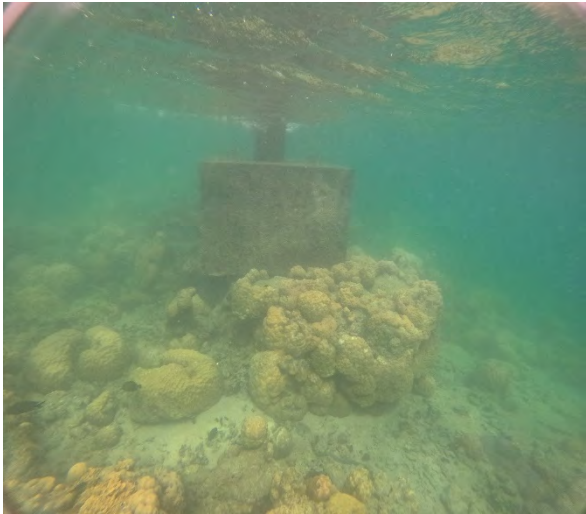
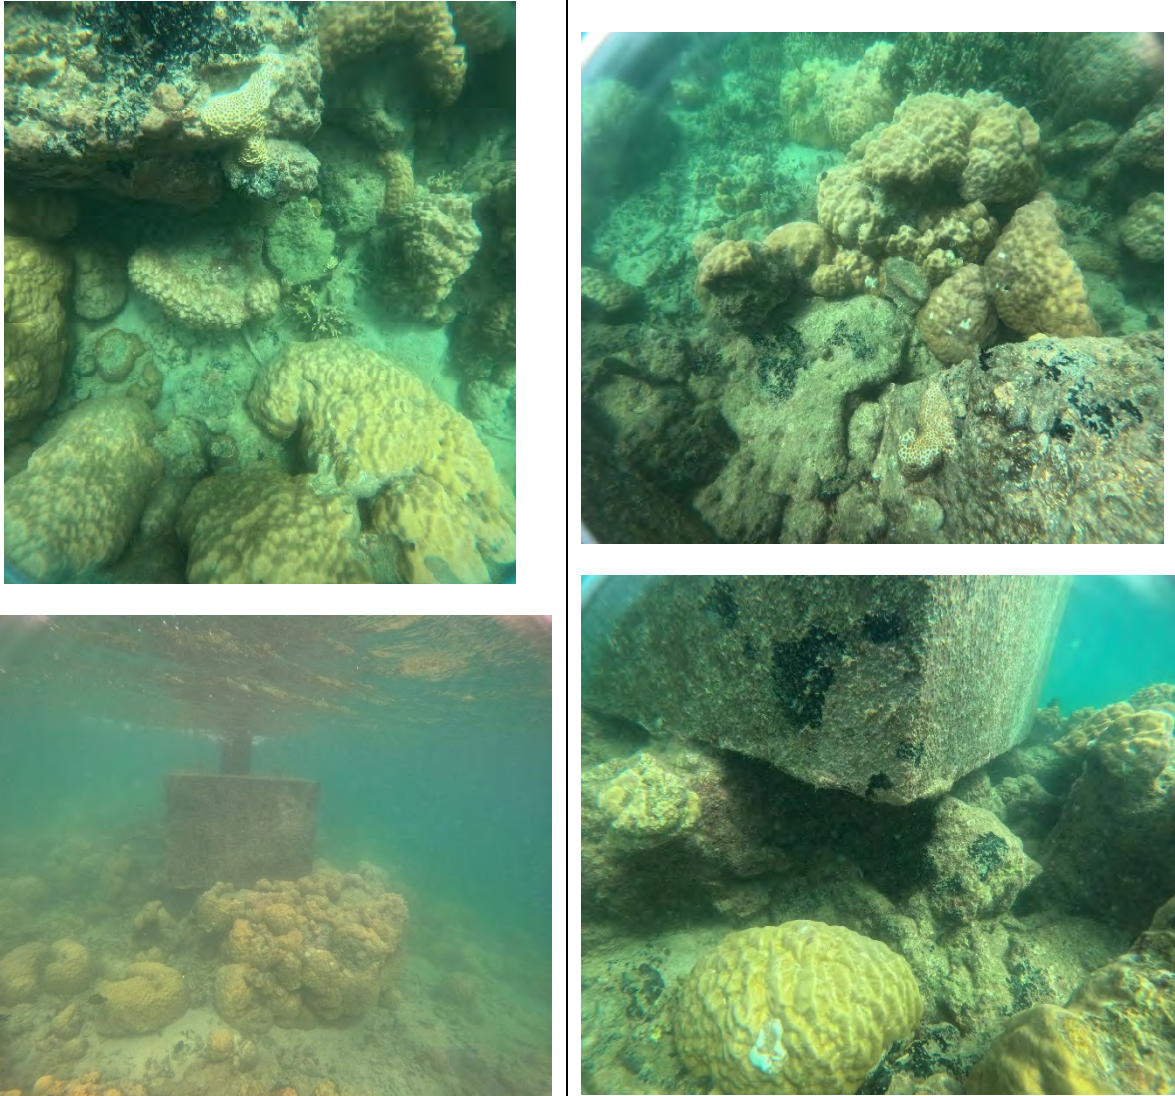
<p>R12</p>

<p>60" X 60" X 44"</p>	<p>8.1</p>	<p>Visible day boards front and back. This is a newer aid that was installed via a World Bank project within the past 5 years. Signs of surface rust at Although there is corrosion protection installed on the pile, there is visible signs of surface rust at and above the splash zone. Foundation appears to be sitting on top of some larger coral but there is little coral attached to the foundation itself.</p>
------------	---	---	--	------------------------	------------	--

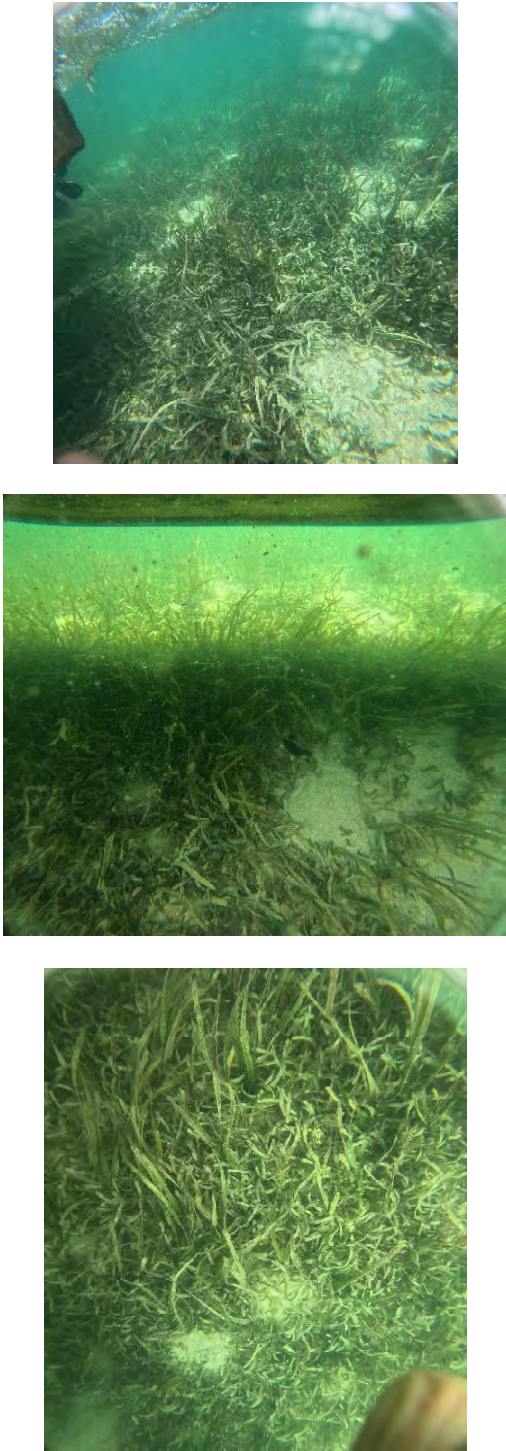
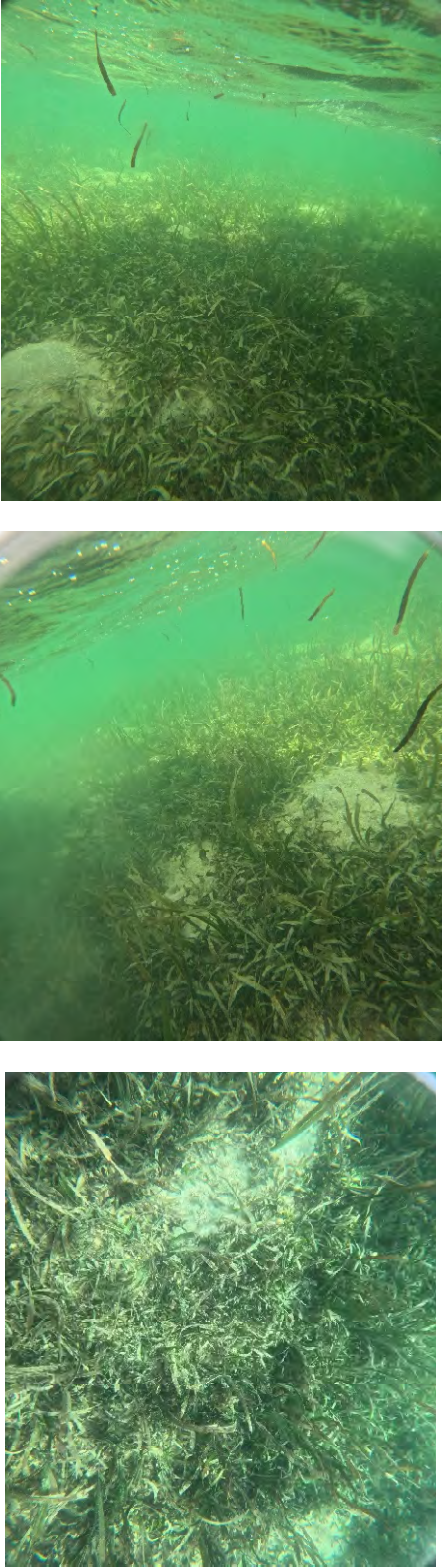
<p>RR</p>	<p>N/A</p>

<p>Proposed 4 pile 10' X 10' platform with foundation blocks on each leg that measure approximately 6 ft square in this location</p>	<p>4.1</p>	<p>This is the location for the proposed four pile rear range tower. The design calls for the four (4) piles to be mounted to 6ft X 5ft concrete gravity blocks which will support a 10' X 10' platform with a 20 f tall tower mounted on top. The tower will have dayboards and lights for daytime and nighttime navigation.</p> <p>This area is shallow and there is a lot of sandy areas with seagrass, but not much coral. Placing the concrete foundations would be relatively easy in this location.</p>
-----------	------------	--	--	--	------------	--

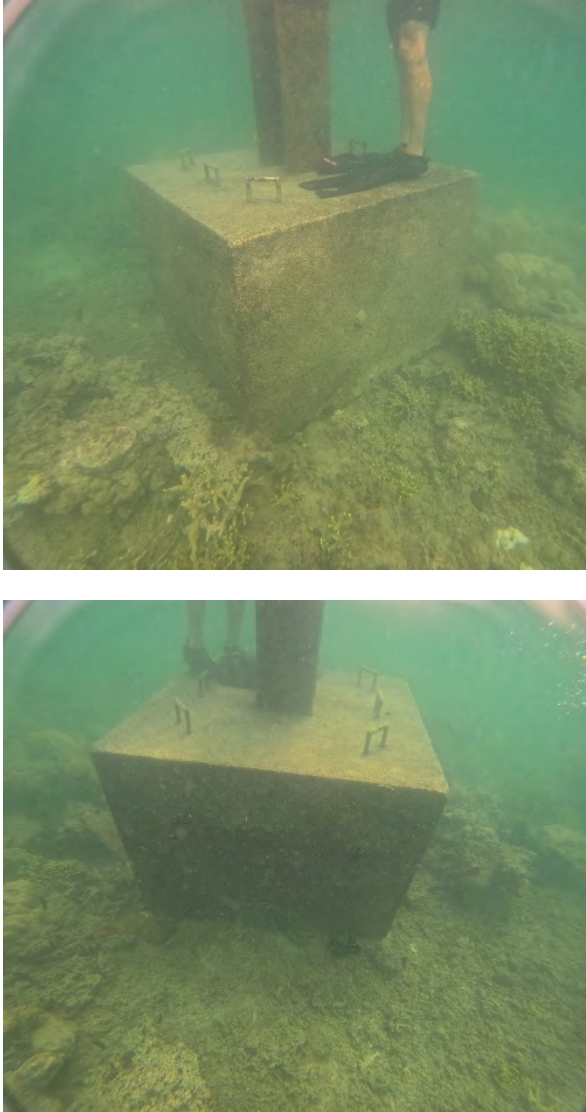
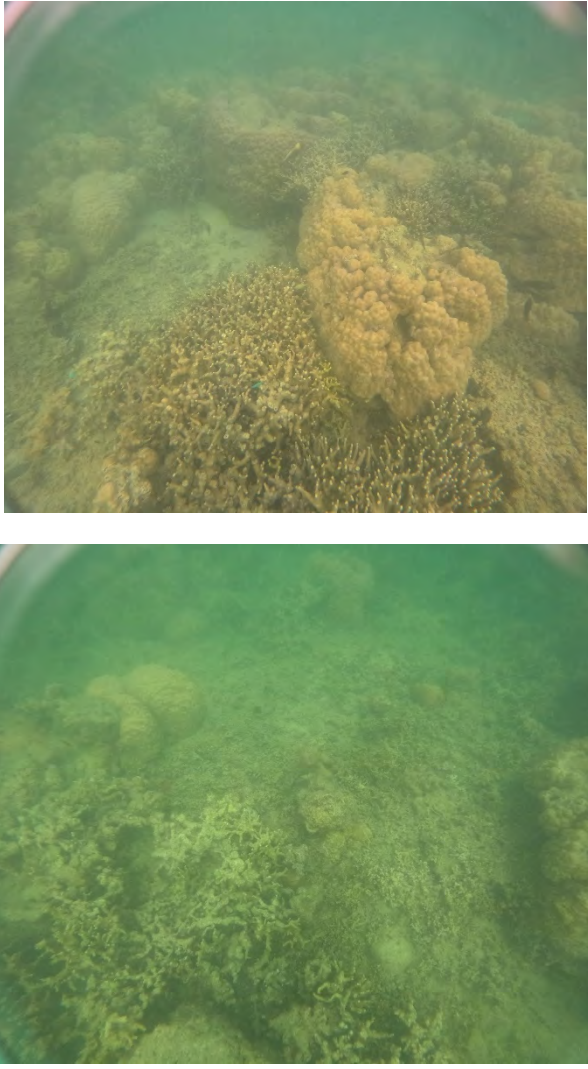
<p>R14</p>

<p>60" X 60" X 44"</p>	<p>6.7</p>	<p>Visible day boards front and back. This is a newer aid that was installed via a World Bank project within the past 5 years. Although there is corrosion protection installed on the pile, there is visible signs of surface rust at and above the splash zone. There are some corals around the foundation, but it is mostly rubble in the immediate area around the foundation. Visibility is poor in this area. Approximately 15-20 ft from the channel's edge.</p>
------------	---	--	--	------------------------	------------	--
