Aids to Navigation Foundation Survey Report

**FY26 MCON Project P-1200 Yap Port and Channel
Improvements**

Yap Island
Federated States of Micronesia

15 January 2025

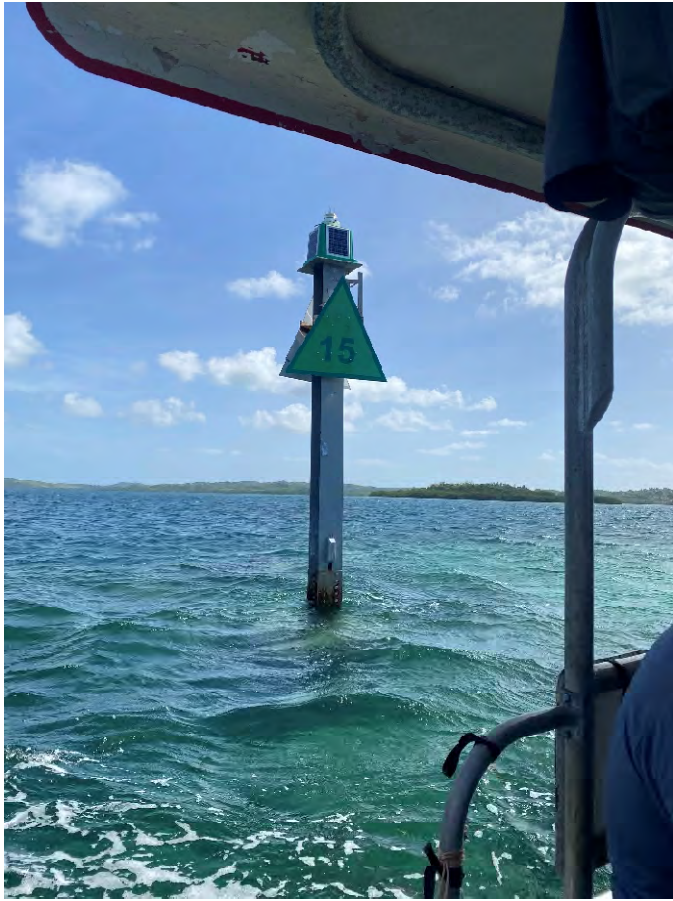
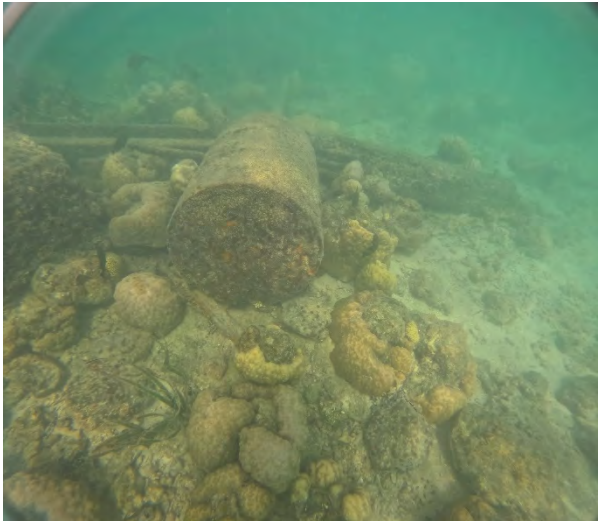
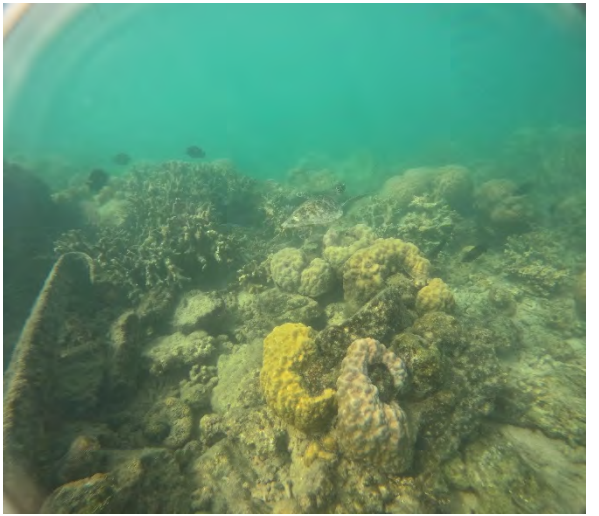
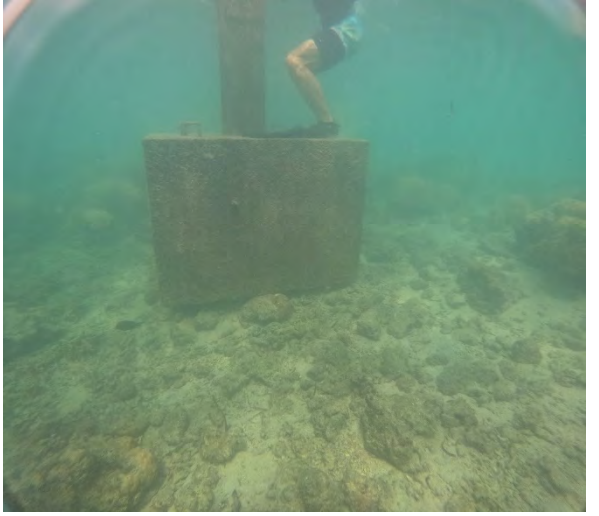
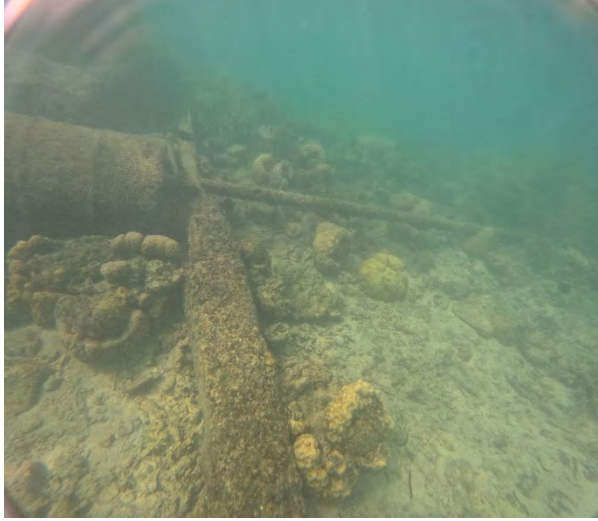
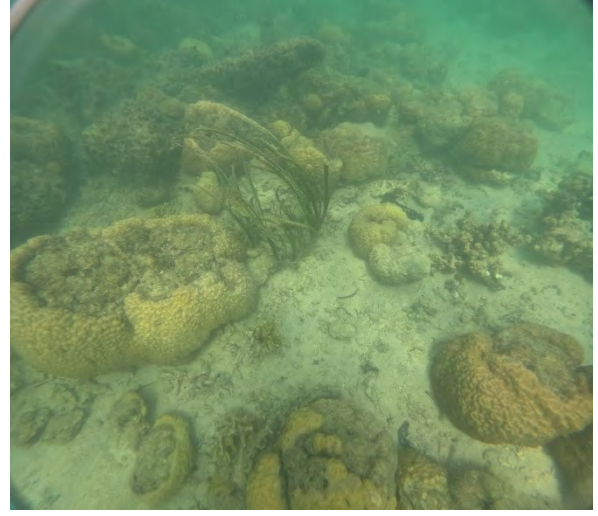
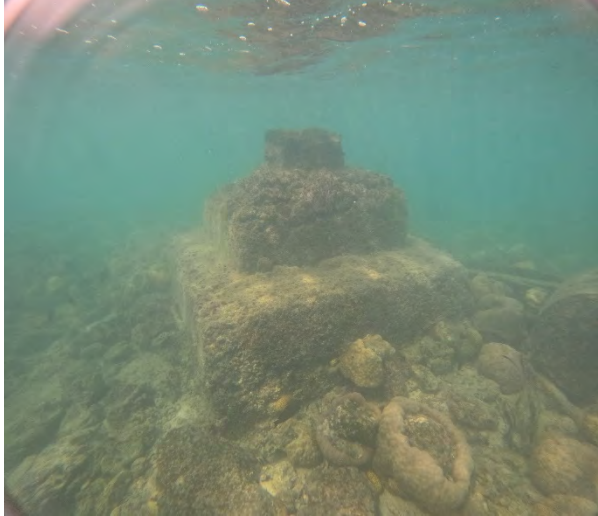
<p>G15</p>

<p>60" X 60" X 44"</p>	<p>7.9</p>	<p>Visible day boards front and back. This is a newer aid that was installed via a World Bank project within the past 5 years. Although there is corrosion protection installed on the pile, there is visible signs of surface rust at and above the splash zone. The foundation is resting on rubble with no coral in the immediate footprint. There are corals and seagrass in the general vicinity. Lots of debris from previous ATON's but not considered a navigational hazard. Visibility is poor in this area.</p>
------------	---	--	--	------------------------	------------	---

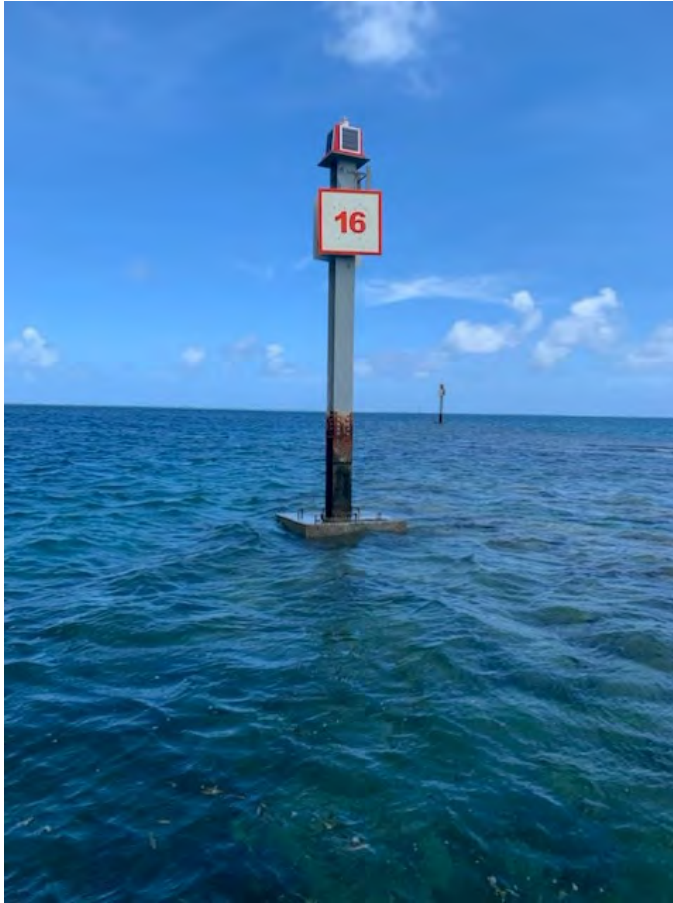
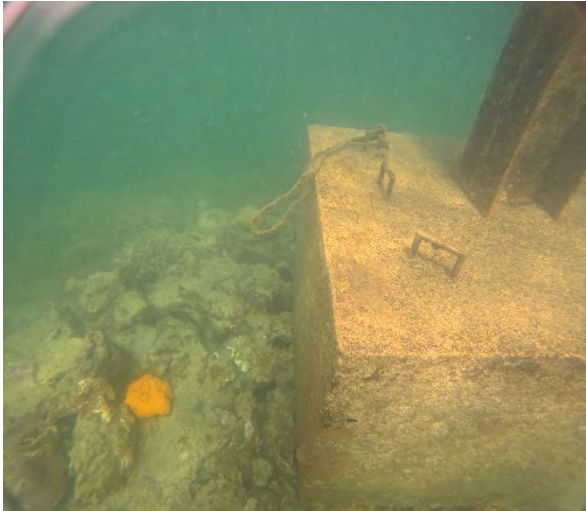
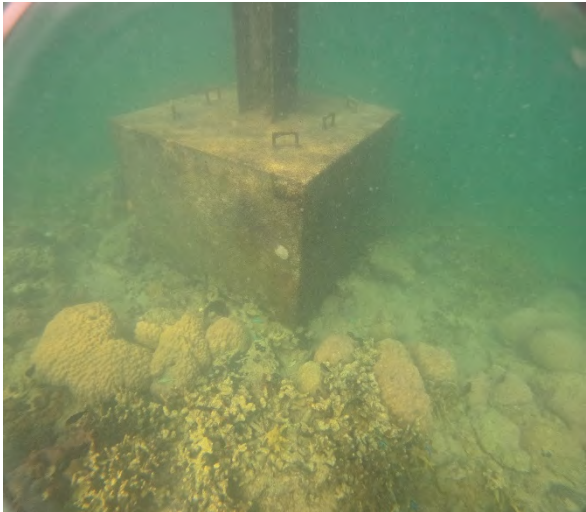
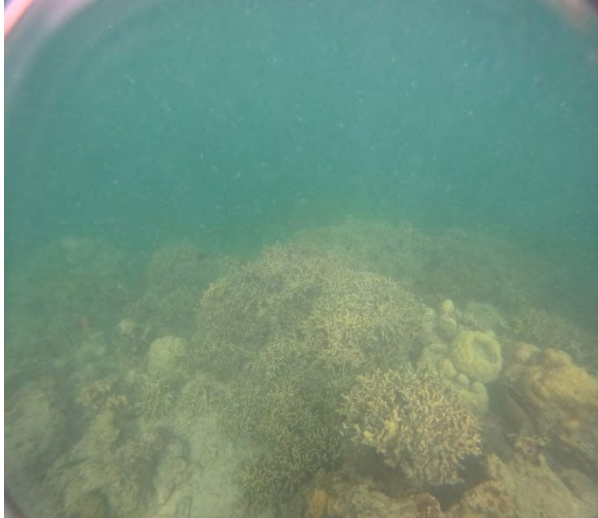
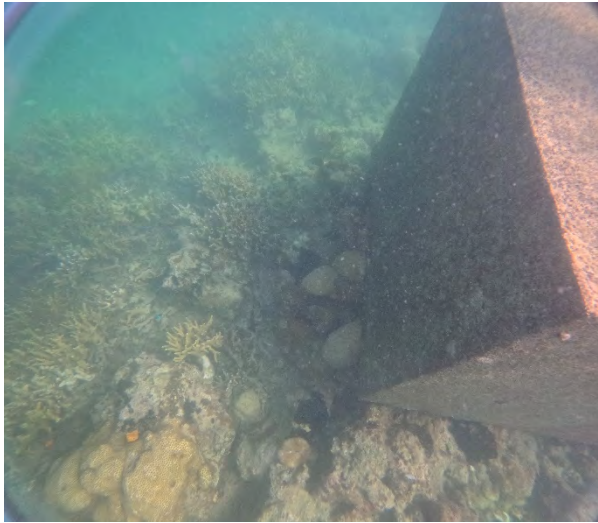
R16

60" X 60" X 44"	7.9	<p>Visible day boards front and back. This is a newer aid that was installed via a World Bank project within the past 5 years. Although there is corrosion protection installed on the pile, there is visible signs of surface rust at and above the splash zone. Foundation is placed on top of the coral. It does not appear as though any coral has attached to the foundation since it's installation. There is seagrass in the area. No additional debris was found in the area.</p>
-----	---	--	--	-----------------	-----	---

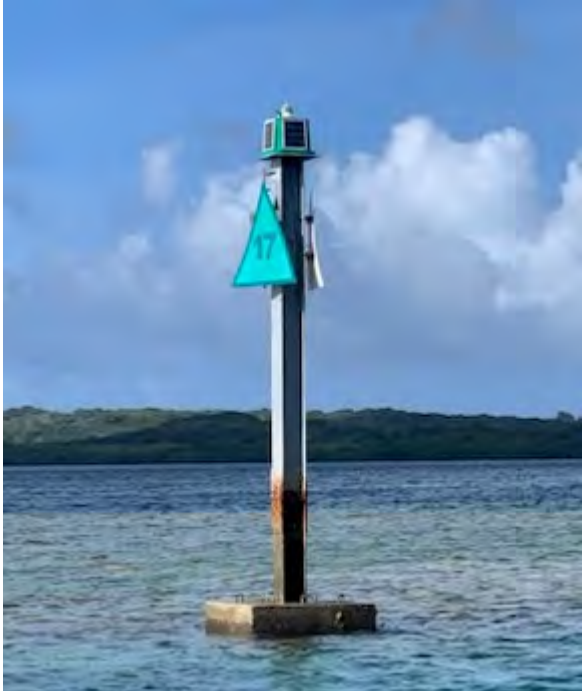
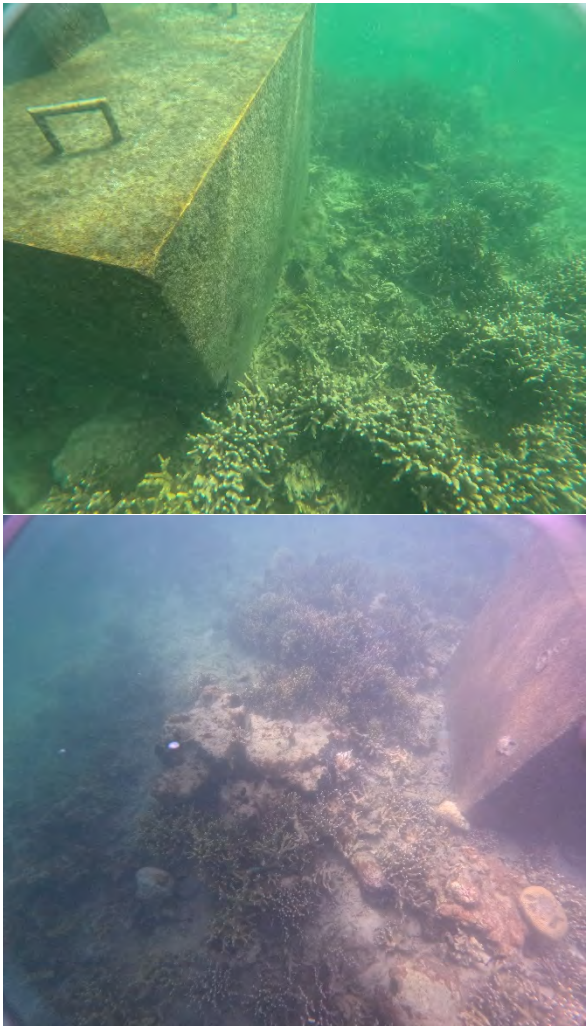
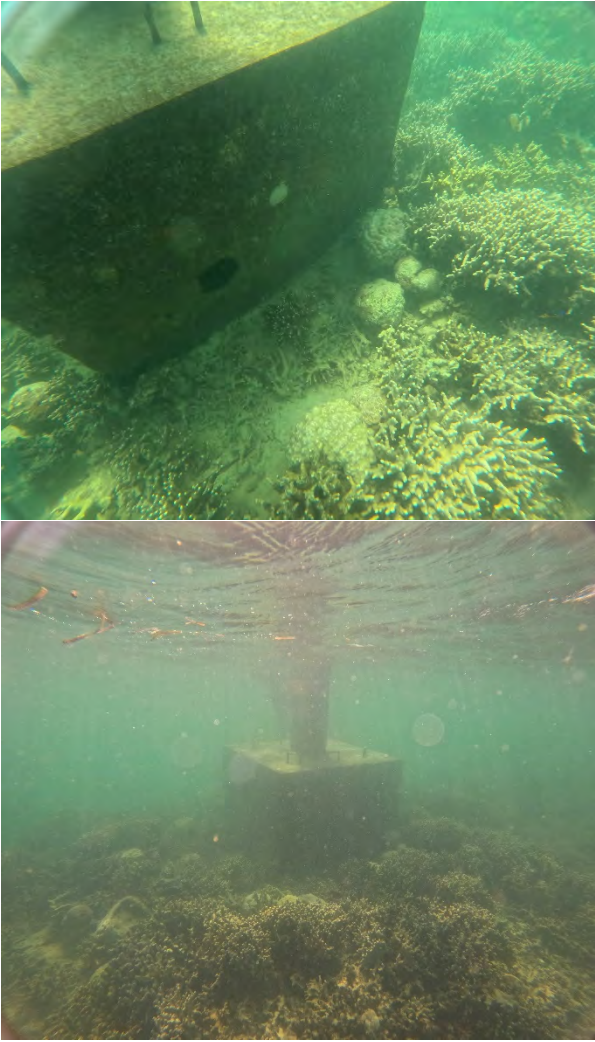
<p>G17</p>

<p>60" X 60" X 44"</p>	<p>7.5</p>	<p>Visible day boards front and back. This is a newer aid that was installed via a World Bank project within the past 5 years. Although there is corrosion protection installed on the pile, there is visible signs of surface rust at and above the splash zone. The foundation is resting in an area where corals are present but does not appear to have any corals attached to it. There is seagrass present in the vicinity. There is no debris or abandoned ATON's present. Visibility is low in this area.</p>
------------	---	--	--	------------------------	------------	---

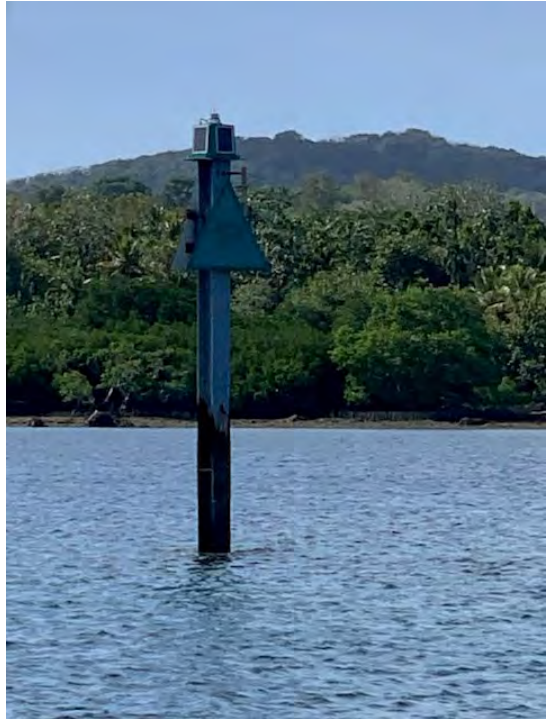
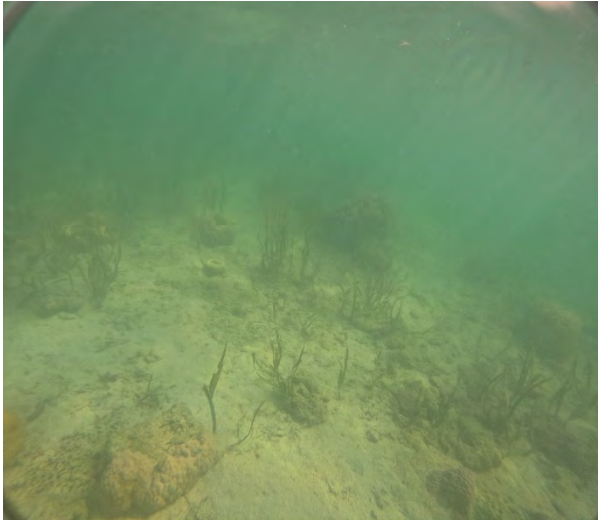
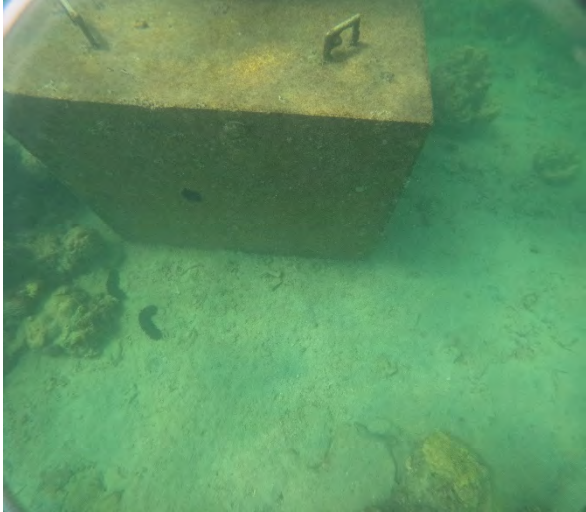
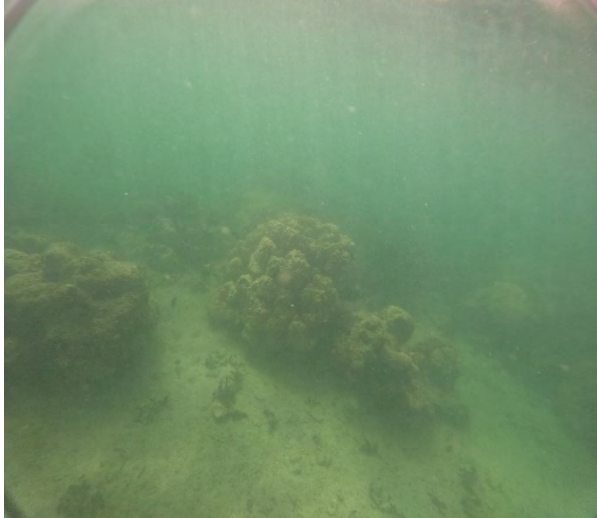
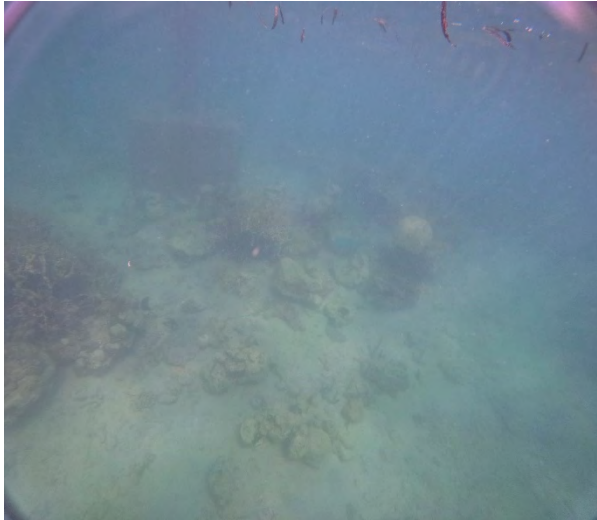
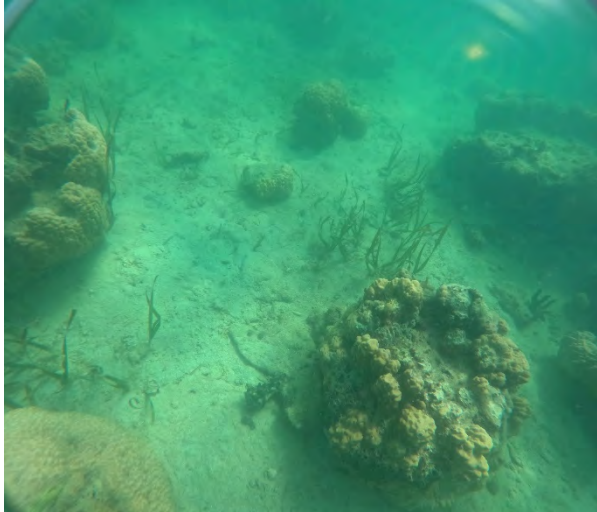
<p>G19</p>

<p>60" X 60" X 44"</p>	<p>8.5</p>	<p>Visible day boards front and back. This is a newer aid that was installed via a World Bank project within the past 5 years. Although there is corrosion protection installed on the pile, there is visible signs of surface rust at and above the splash zone. The foundation is sitting on sand with some corals and seagrass in the surrounding area. There is not signs of old ATONs debris in the area. Visibility is poor.</p>
------------	--	--	--	------------------------	------------	--
