**Phase I Environmental Site  
Assessment  
Yap Seaport**

**ISLAND OF YAP FEDERATED STATES OF MICRONESIA**

**May 2024**

Prepared for NAVFAC Pacific by  
**AECOM Technical Services Inc**  
**1001 Bishop Street Suite 1600**  
**Honolulu HI 96813-3698**

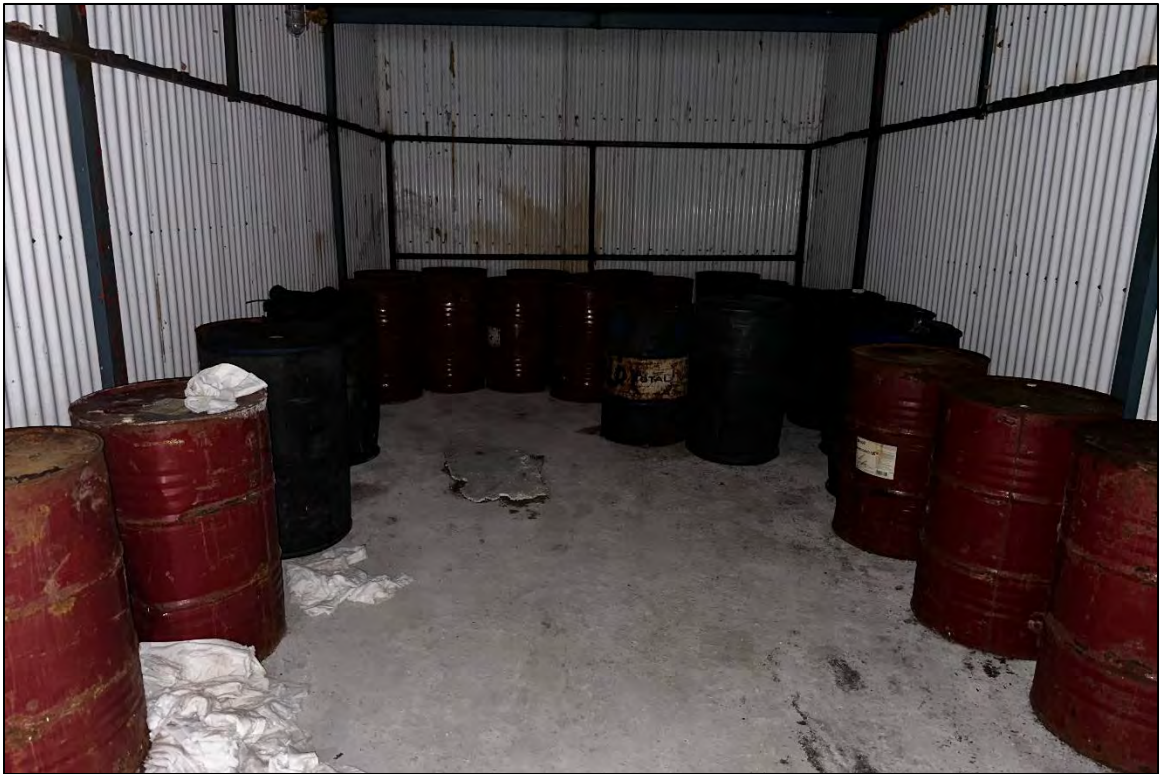
- Sixty-seven 55-gallon drums at the former tuna processing facility. Thirty-eight of the 55-gallon drums were observed in an enclosed room on a concrete floor, lacking spill pallets (Appendix A, Photos 1 and 2). Two 55-gallon metal drums were observed with corrosion and a dark colored oily substance present at their base. Only 10 of the 55-gallon drums contained labeling—Mobil Gard 525, 412, ADL 40, and 300 C—indicative of diesel engine oil. Based on gently touching each drum, it was suspected that all 38 drums in the room contained some amount of fluid (i.e., none were suspected to be empty).

Photo 1: Thirty-eight 55-gallon metal drums observed in a room near the side entrance of the former tuna canning facility.

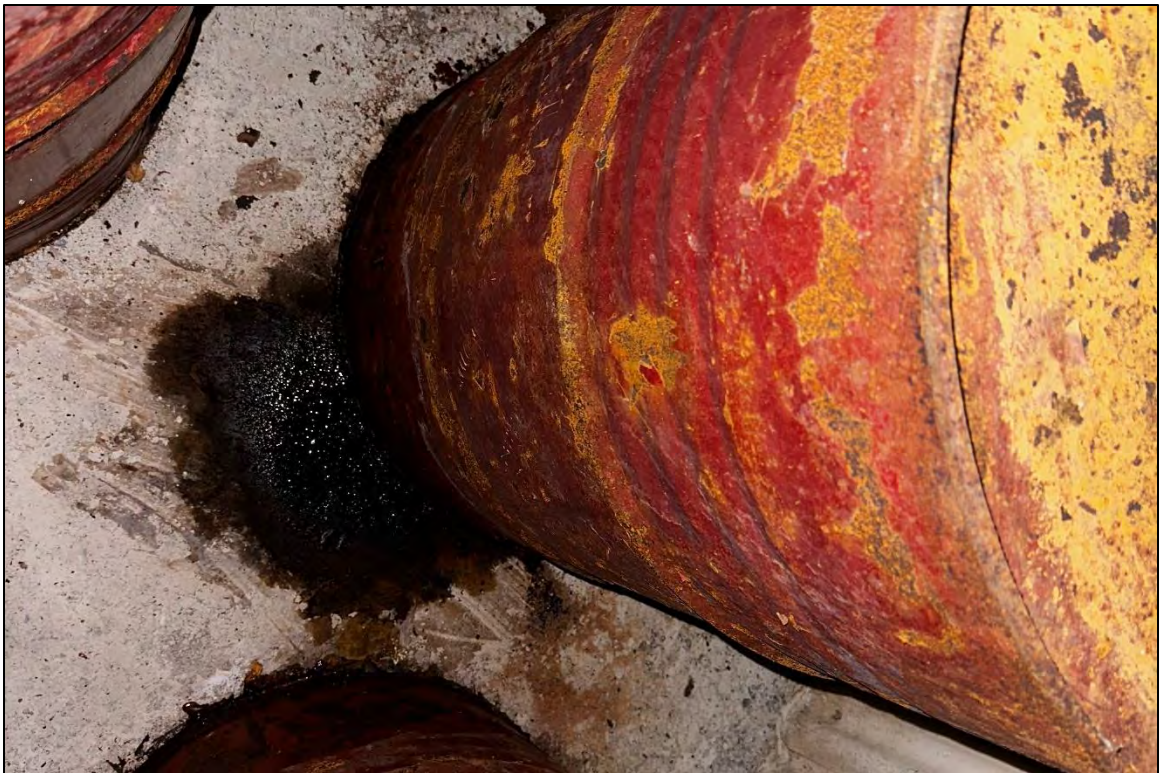
Photo 2: Close-up view of one of the drums leaking de minimis amounts of oily substance on the concrete floor.

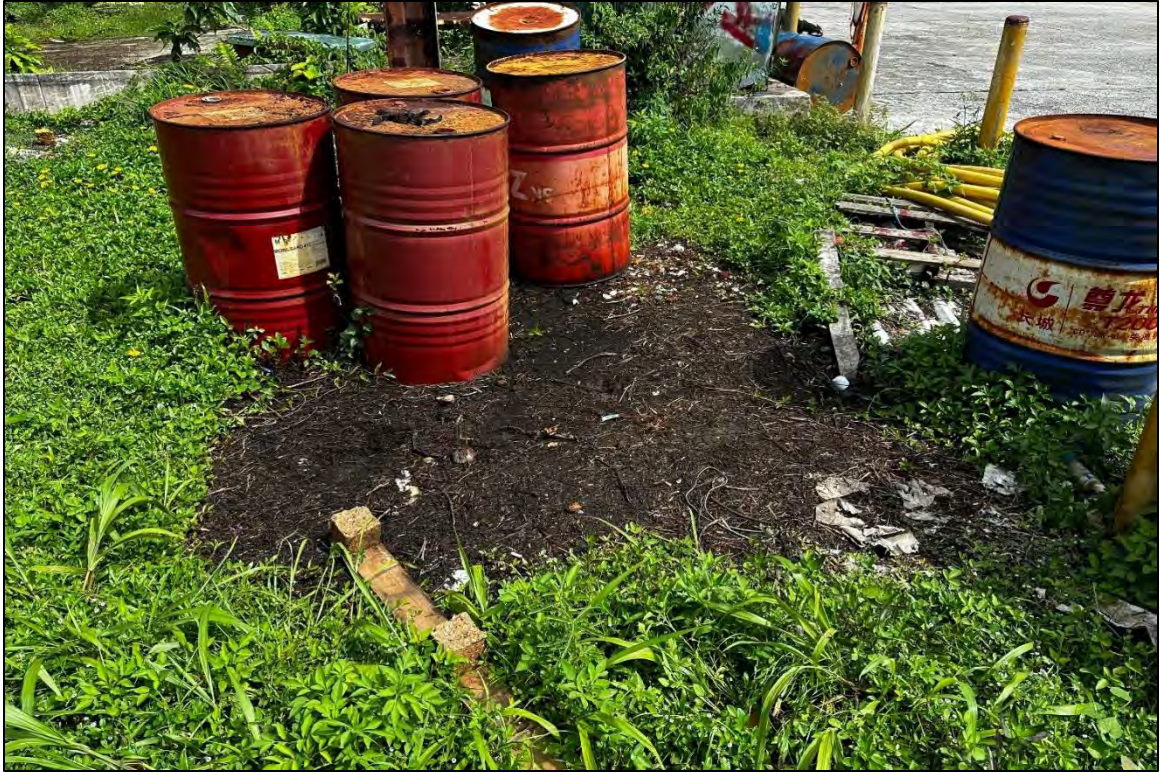
- The release of a suspected petroleum substance from four empty and unlabeled 55-gallon drums near the former tuna processing facility building is a REC, in AECOM's opinion. The approximately 20 square-foot stained area had a petroleum odor, and no vegetation was growing within the staining. Furthermore, the empty drums suggest that a significant volume of product may have leaked.

Photo 3: Four empty 55-gallon metal drums observed near the northeastern corner of the former tuna canning facility. Note stressed vegetation surrounding the drums. Photo is looking northwest.

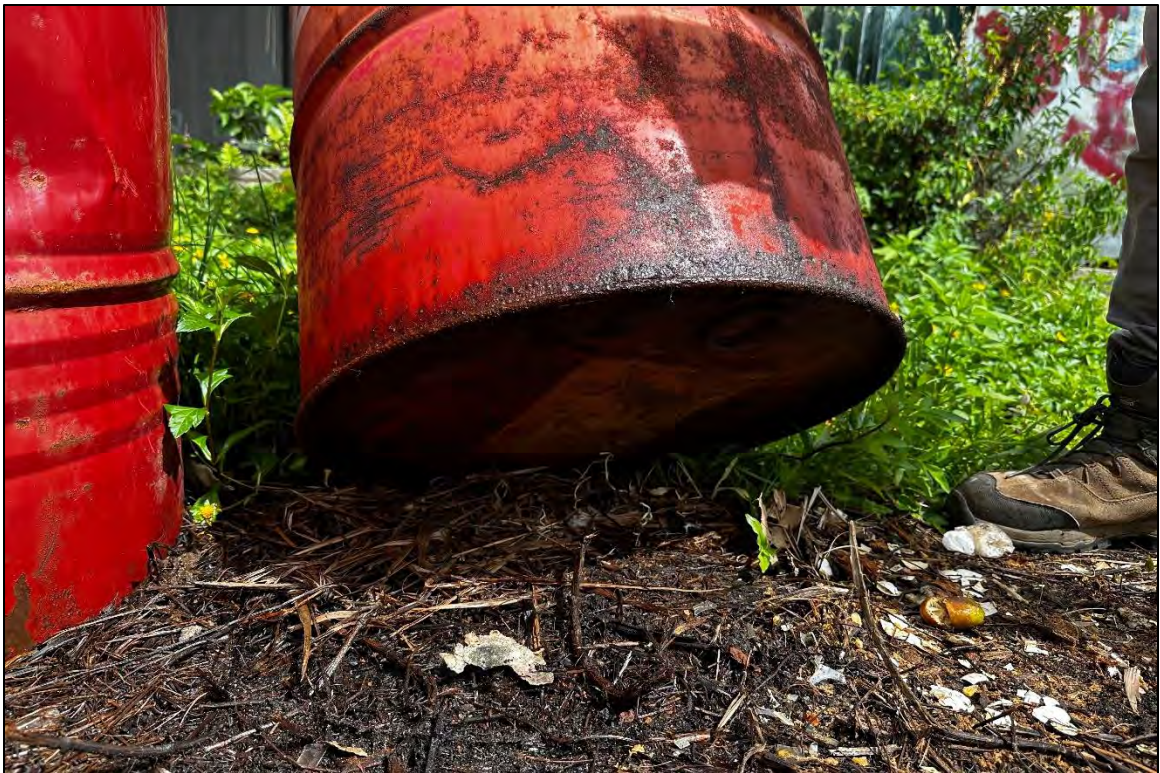
During the site visit, AECOM identified visual evidence of discolored soil and stressed vegetation surrounding four unlabeled drums located outside the former tuna processing facility. The discoloration was accompanied by a faint petroleum odor emanating from the soil. Additionally, AECOM observed medium to heavy staining on the concrete floor throughout the Division of Sea Transportation maintenance shop. No significant cracks were observed on the floor; however, floor drains, and channel drains were observed in the vicinity. No visual evidence of significant corrosion was identified on the floors or walls of most buildings within the subject property with the exception of the former tuna processing facility, which exhibited considerable deterioration. The corrugated aluminum sheet roof displayed significant degradation and detachment, with a section of the roof having already collapsed.

Photo 4: Close-up view of one of the four drums suspected to have leaked oily contents. Distinct petroleum odor noted emanating from dark and moist soil.

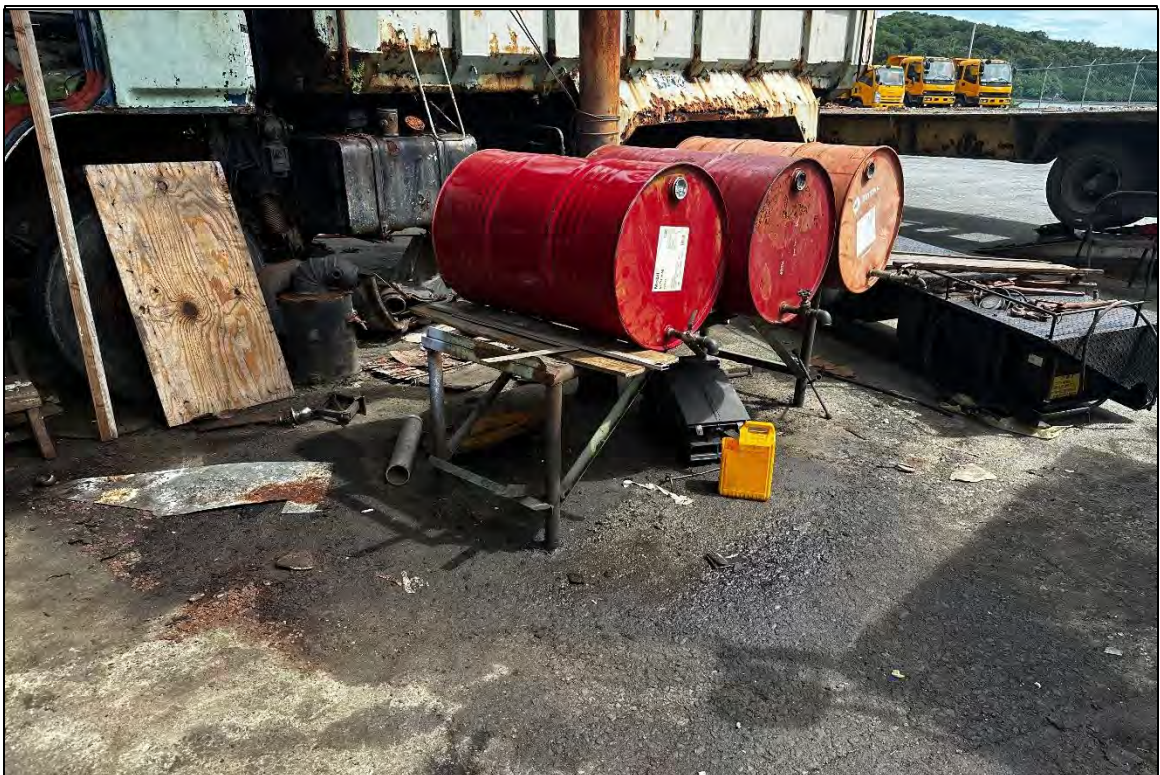
- Extensive oil staining at the Division of Sea Transportation maintenance shop, encompassing an area of approximately 200 square feet, is considered a REC, in AECOM's opinion. Petroleum hydrocarbons have likely leached to underlying soil and entered floor and trench drains.

Photo 6: Closer look at three 55-gallon drums containing hydraulic oil. Note: Extensive staining observed on the concrete surface. This type of staining was observed throughout the premises. Photo is looking north.

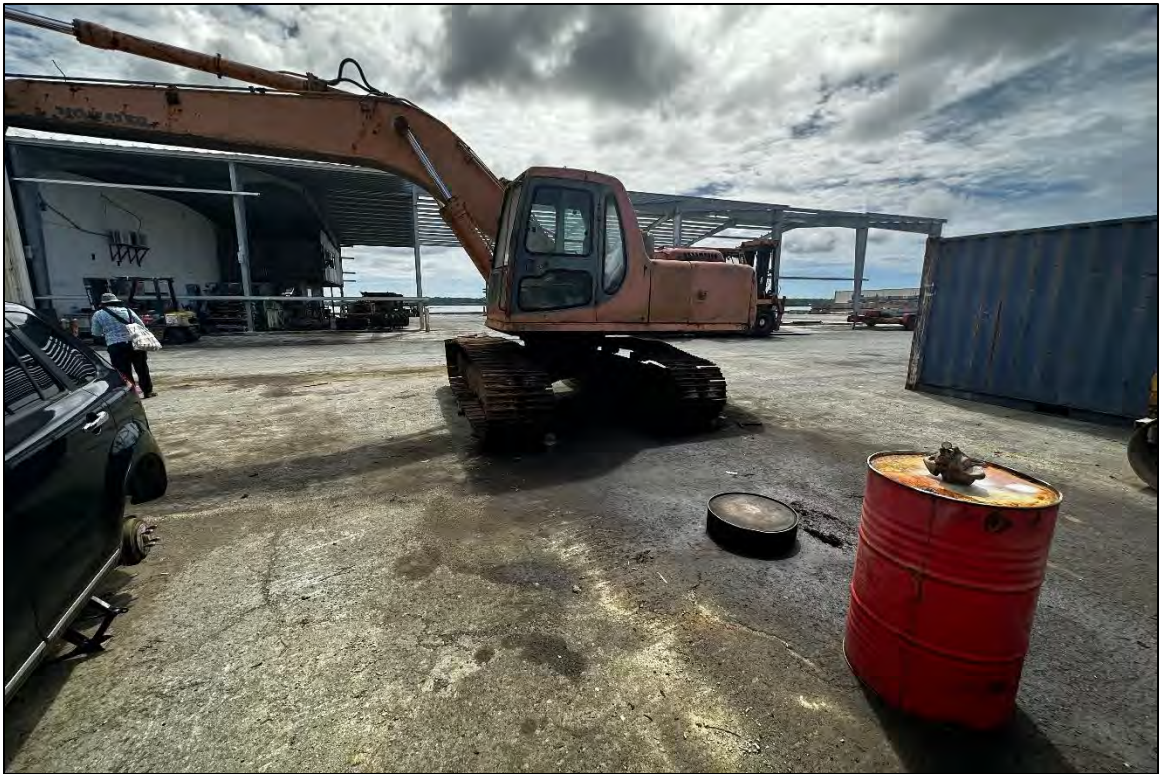
Photo 7: Closer look at other area within the main port maintenance shop displaying concrete staining. Photo is looking northeast.

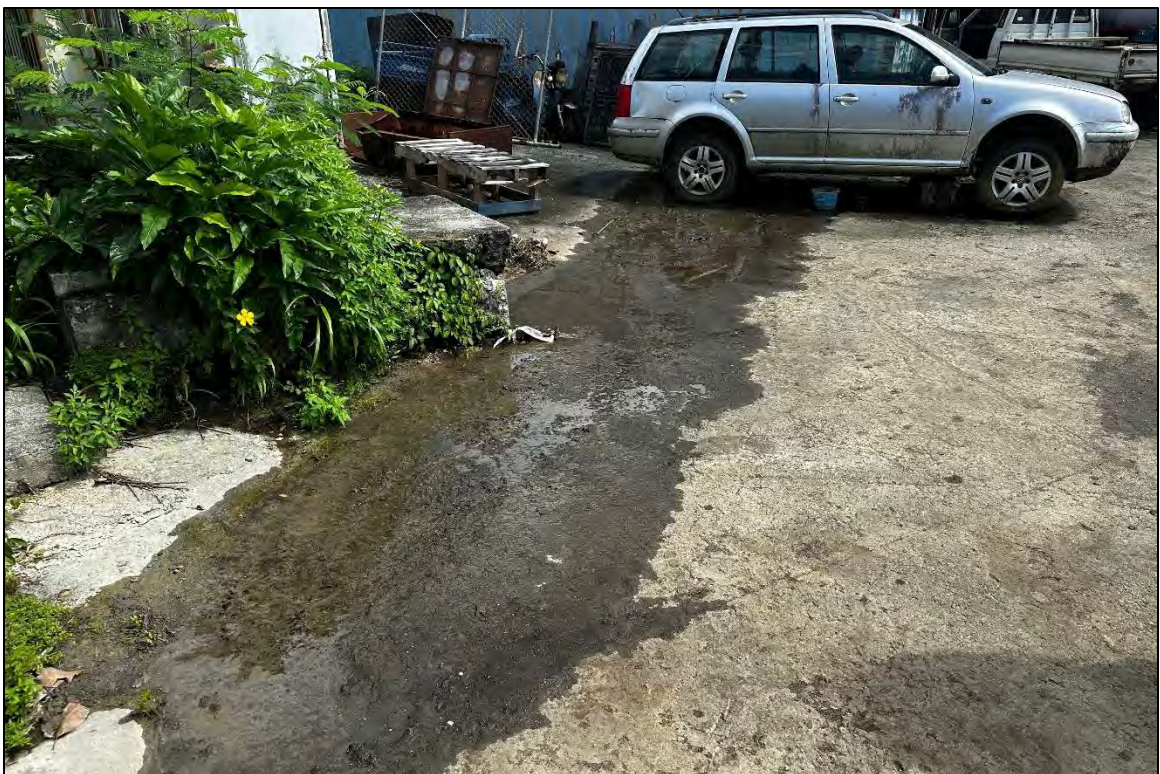
Photo 8: Runoff from washing activities at the maintenance shop heading toward a drainage channel nearby. Photo is looking northwest.

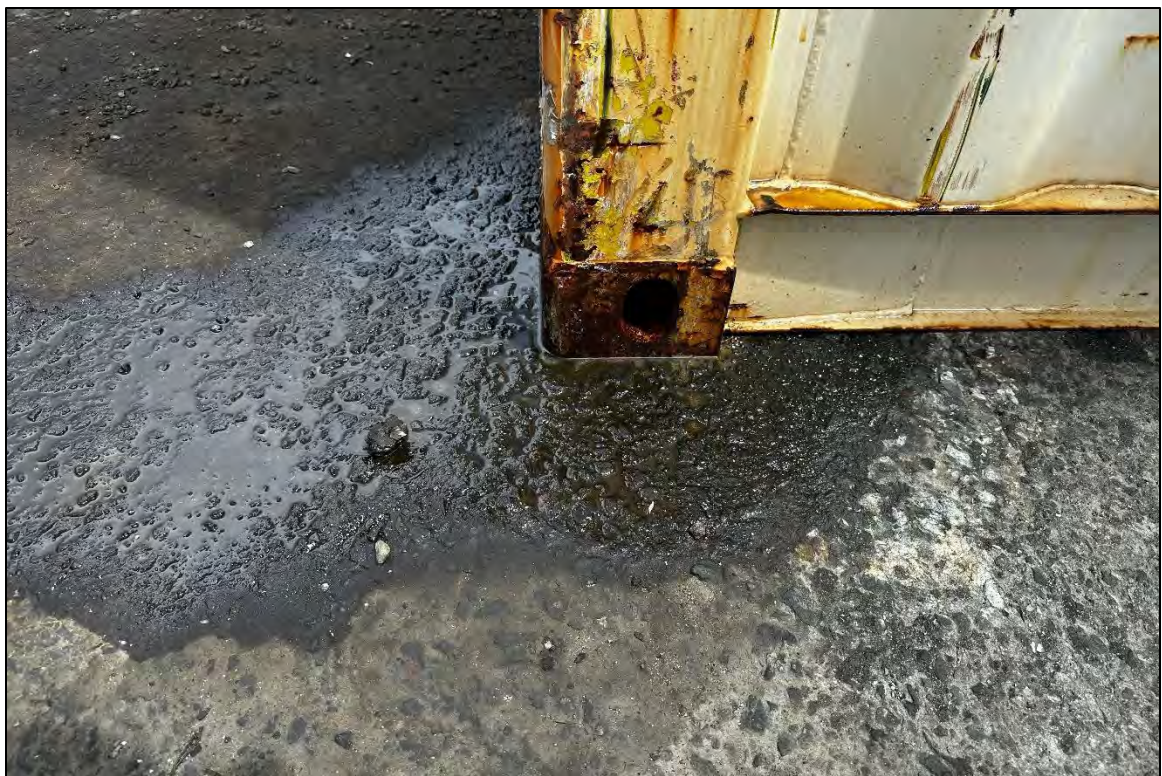
- A shipping container managed by Waab Transportation Company of unknown origin was observed leaking small quantities of a viscous, yellowish substance. The Port Officer at the Division of Sea Transportation Office was not aware of the contents of the container; however, due to the localized nature of the release, AECOM considers this staining a DMC.
- Four small oil stains (less than 2 square feet each) observed at the Yap Fishing Authority maintenance shop. Given the localized nature, AECOM considers this staining a DMC.

Photo 10: Close-up view of shipping container managed by Waab Transportation Company of unknown origin observed leaking small quantities of a viscous, yellowish substance.

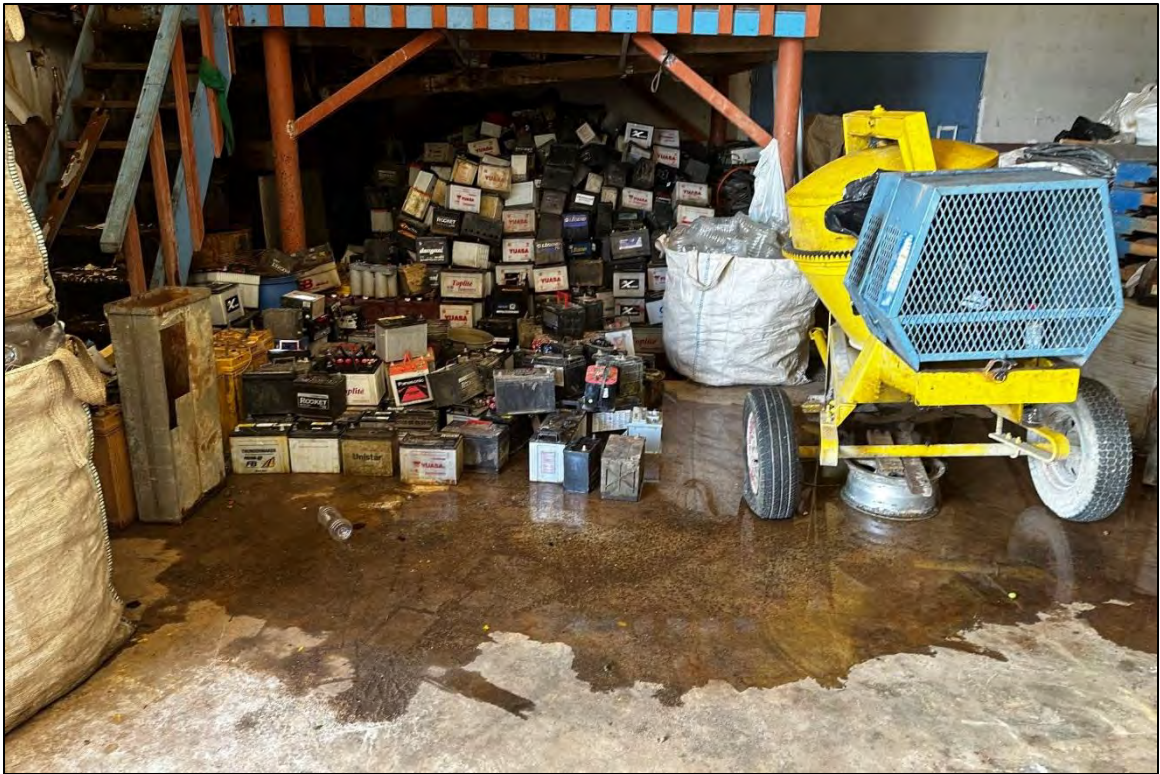
- A stockpile of automobile and other equipment batteries at the Recycling Center is a REC, in AECOM's opinion. These batteries were situated on a concrete floor atop a substantial pool of liquid, reportedly identified as rainwater by personnel on site. Although no significant floor cracks were observed, various floor drains were observed in the vicinity of the batteries.

Photo 15: Overview of a lead-acid battery pile located inside the Recycling Center observed sitting on a large puddle of rainwater. Approximately 200–300 batteries were estimated. Photo taken standing on top of floor drain.

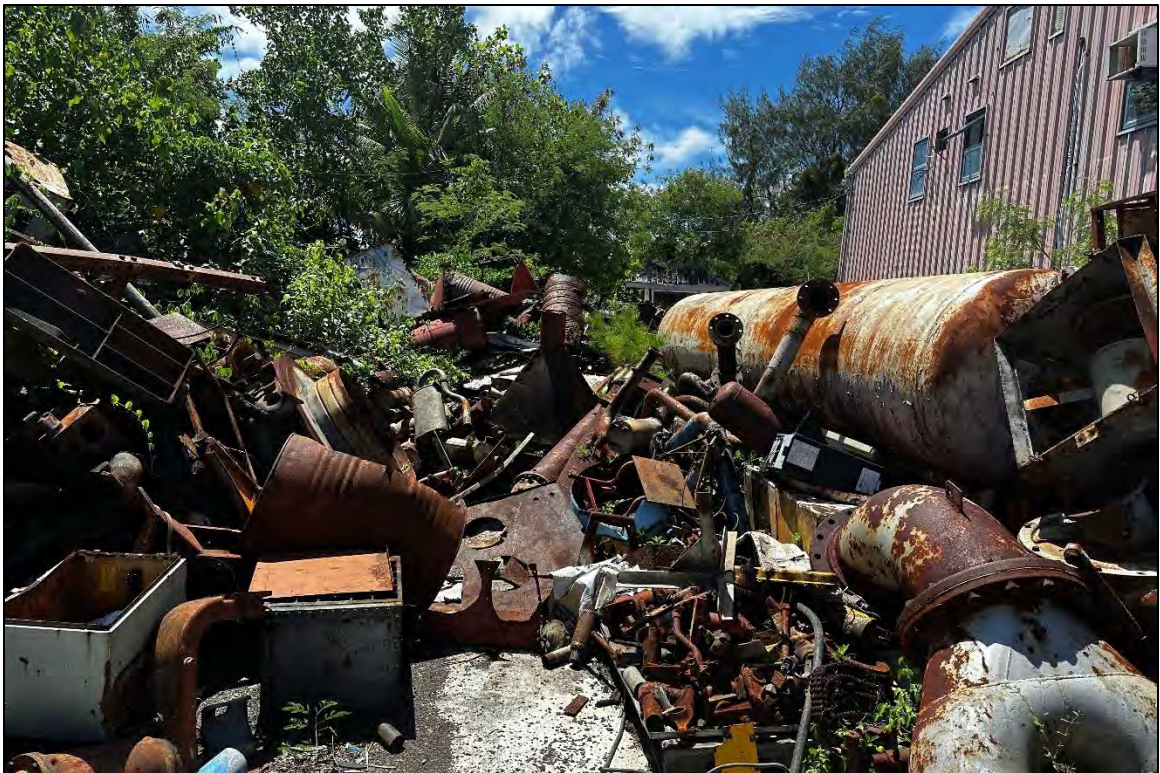
Photo 18: Overview of an approximately 1,500-square-foot scrap metal pile located adjacent to the Recycling Center. Photo is looking east.

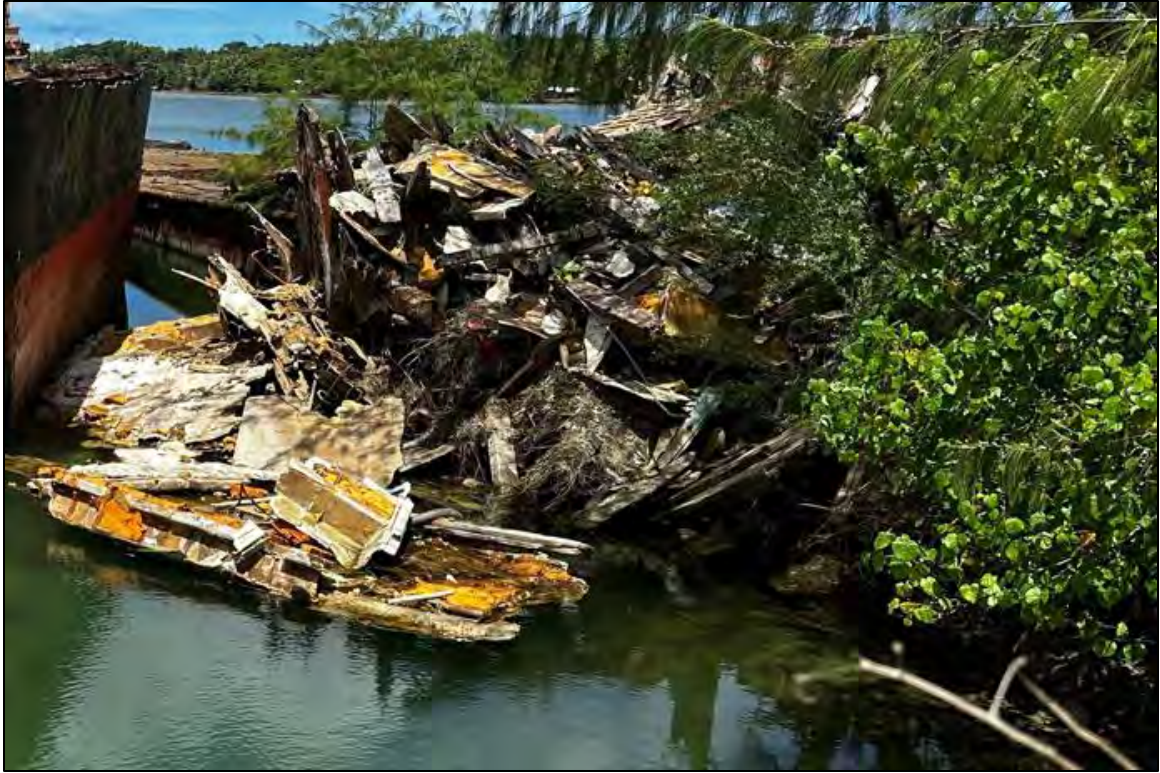
Photo 19: Overview of demolition debris mound located in the southeasternmost point of the subject property. A portion of the mound was observed eroding into the ocean. Photo is looking southeast.

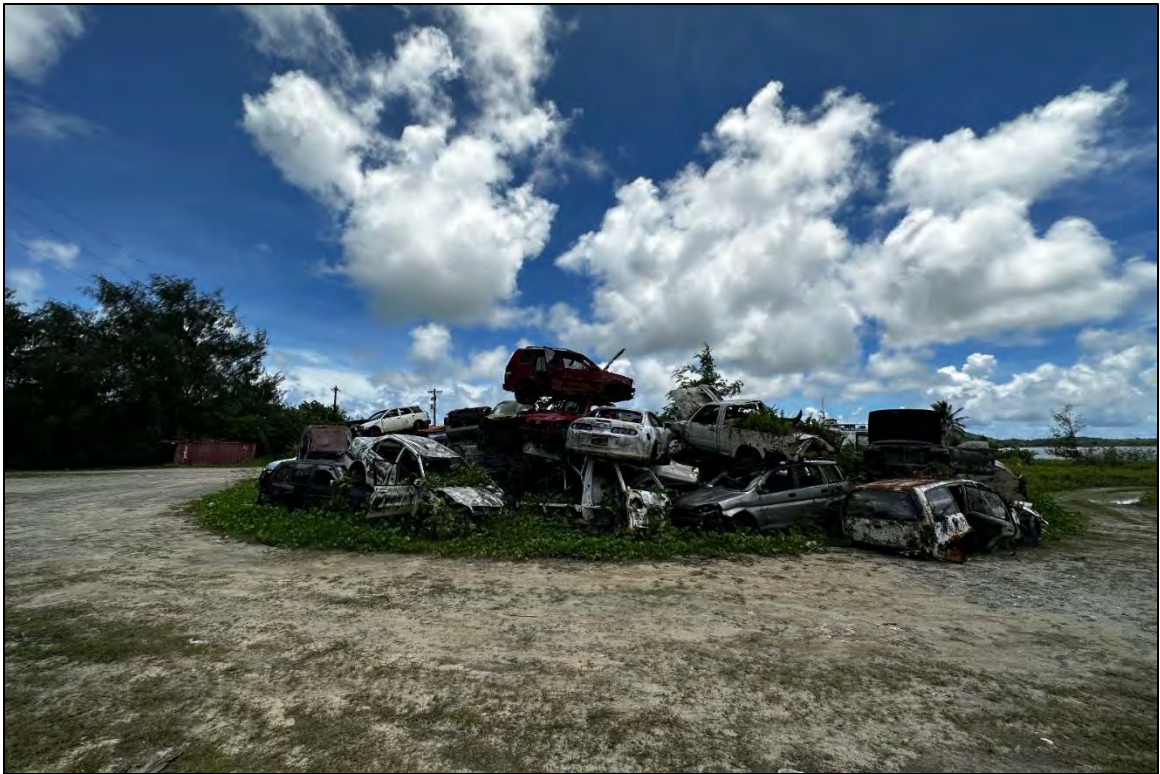
- Three piles of metal debris, primarily consisting of abandoned automobiles and automotive parts are present in the salvage yard within the subject property. The piles measured approximately 7,000, 1,500, and 1,300 square feet. In addition, a deteriorated 20-foot metallic tank marked as "unleaded gas," was identified and exhibited substantial corrosion and perforations. The condition of such an abandoned tank may indicate a release of hazardous substances or petroleum products into the surrounding environment. The piles have not been previously investigated, and it is unknown whether metals or other contaminants are present at concentrations that represent a hazard to human or ecological health; therefore, this finding is considered a REC in AECOM's opinion.

Photo 21: Overview of one of the three non-contiguous abandoned vehicle piles. Photo is looking north.

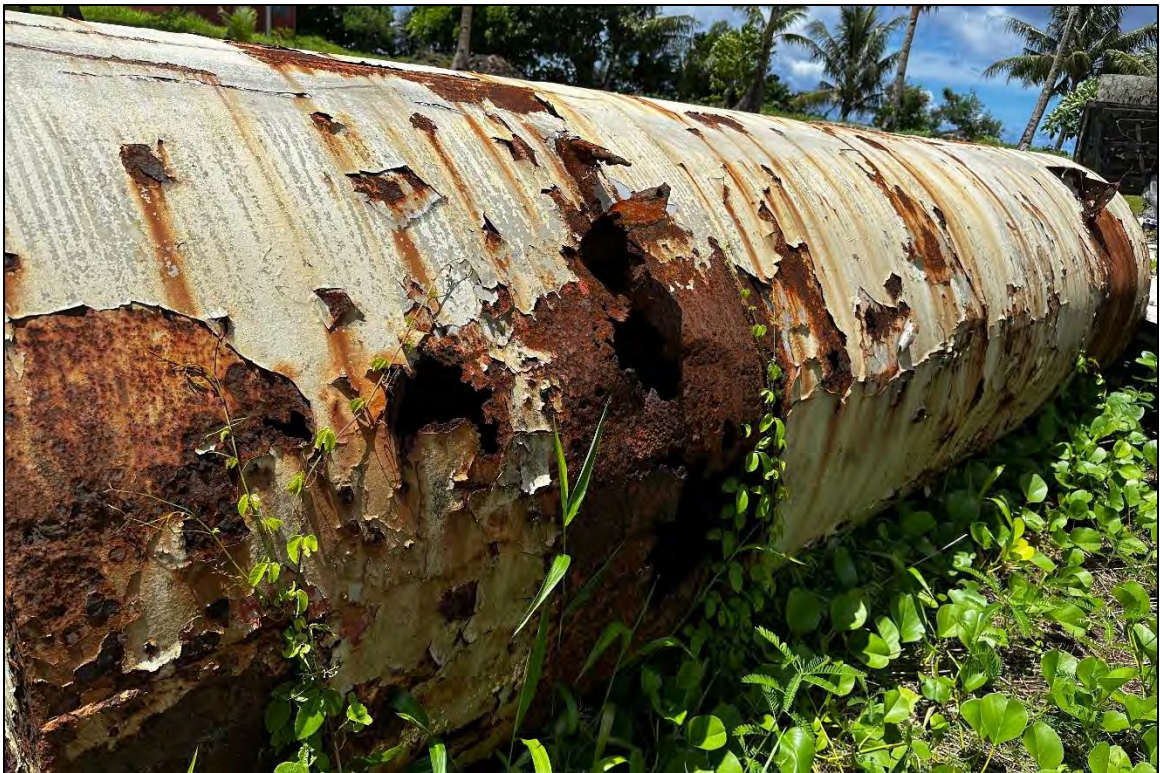
Photo 22: Close-up view of empty, deteriorated AST observed adjacent to the abandoned vehicle piles. Photo is looking west.

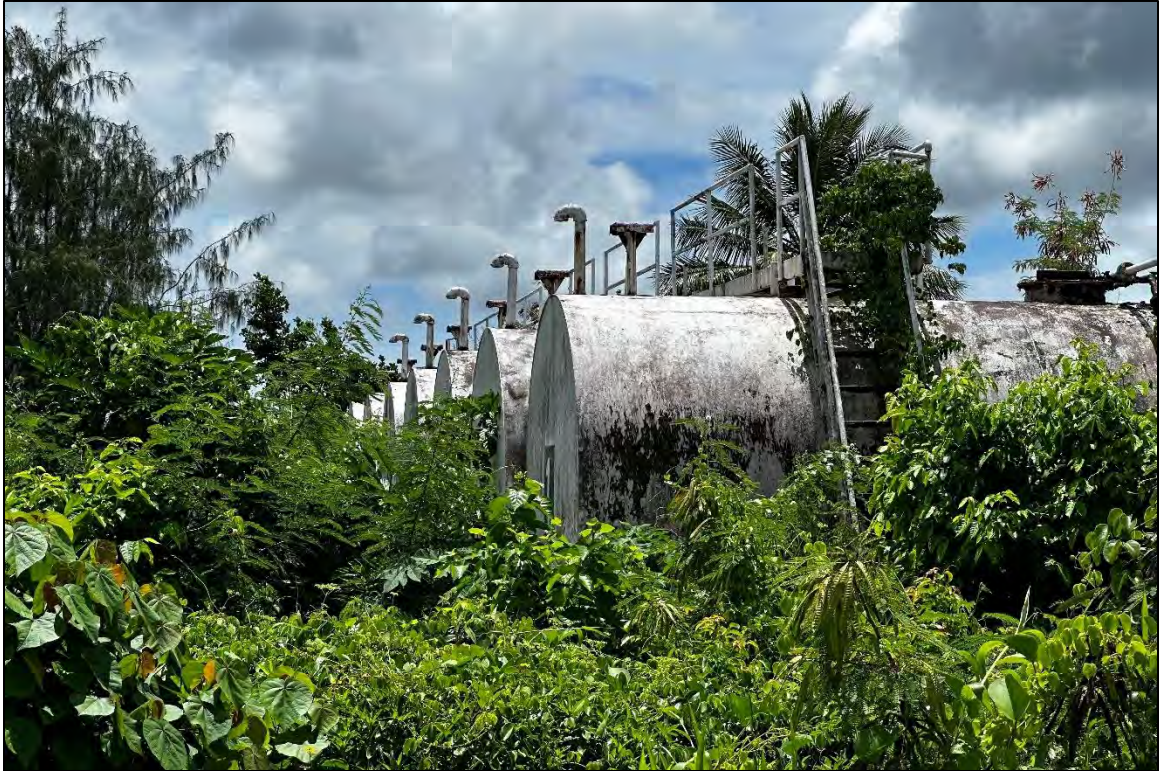
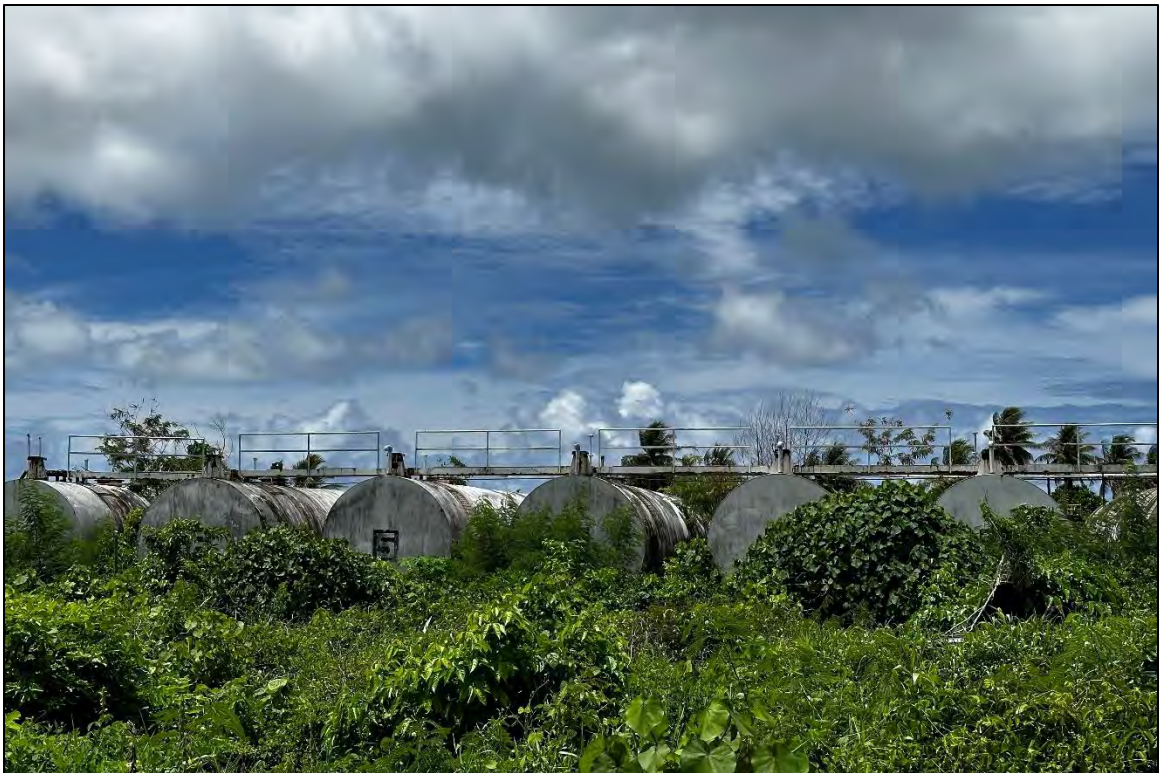
- Seven fuel tanks previously utilized by the U.S. Coast Guard on the subject property are considered a REC, in AECOM's opinion. The ASTs could only be observed from a distance during the site visit because of overgrown dense vegetation and the surrounding terrain; however, they appeared to be slightly corroding. It was not ascertainable from interviews whether any fuel remains in the ASTs and abandonment documentation was not available.

Photo 23: Zoomed-in photograph of the seven abandoned former U.S. Coast Guard fuel tanks.  
Photo is looking southeast.

Photo 24: Zoomed-in photograph of the seven abandoned former U.S. Coast Guard fuel tanks.  
Photo is looking west.

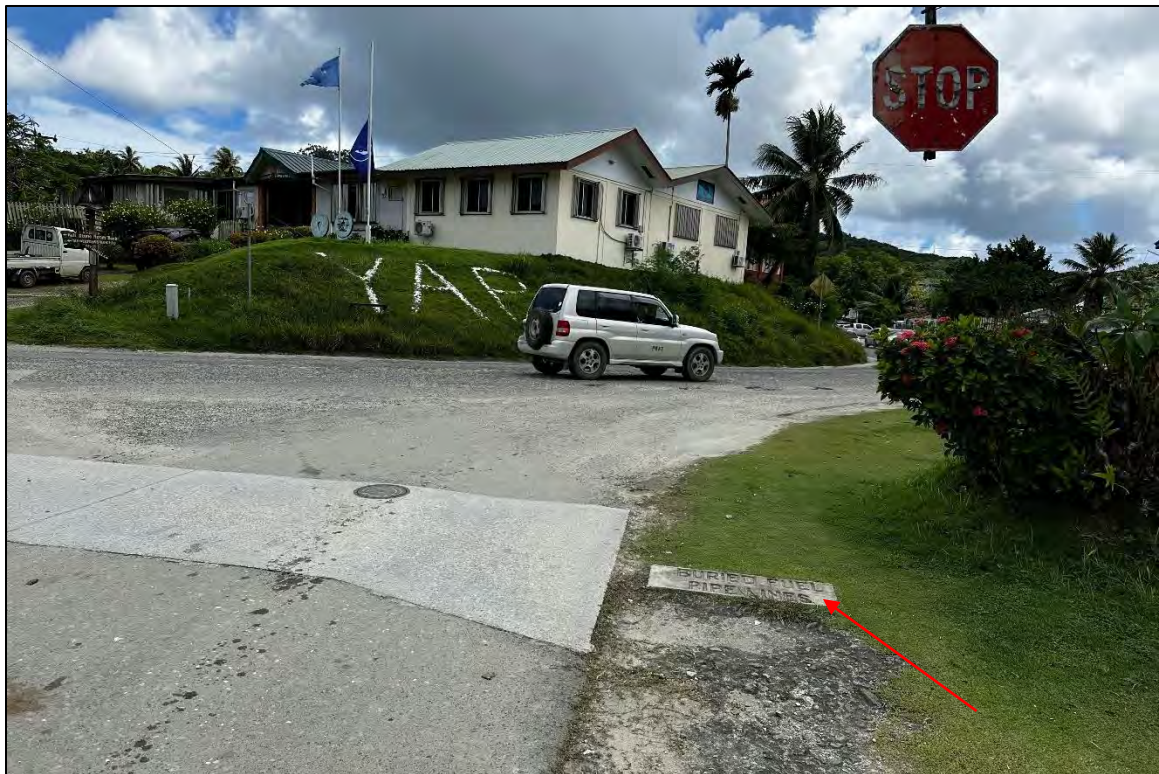
- The underground fuel pipeline that transports fuel from the PetroCorp fuel farm to the port is present throughout the subject property. It could not be determined during this Phase I ESA whether the pipeline is regularly leak tested, the leak testing methods, and testing results. Based on this lack of information, the pipeline represents a material threat of a potential future release and a REC, in AECOM's opinion.

Photo 25: Overview of the northern border of the subject property. Note: A buried fuel line marking exists on the street (denoted by red arrow). Photo is looking northwest.

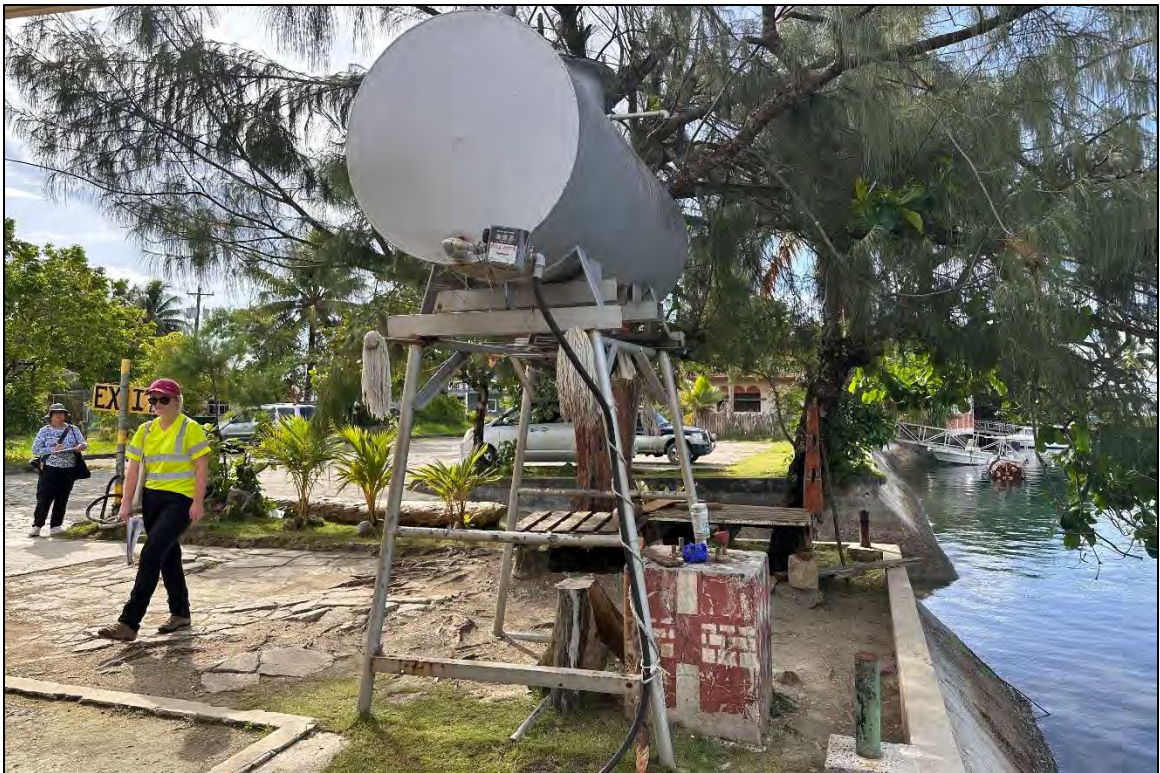
Photo 28: Overview of 320-gallon kerosene AST lacking secondary containment. Photo is looking east.

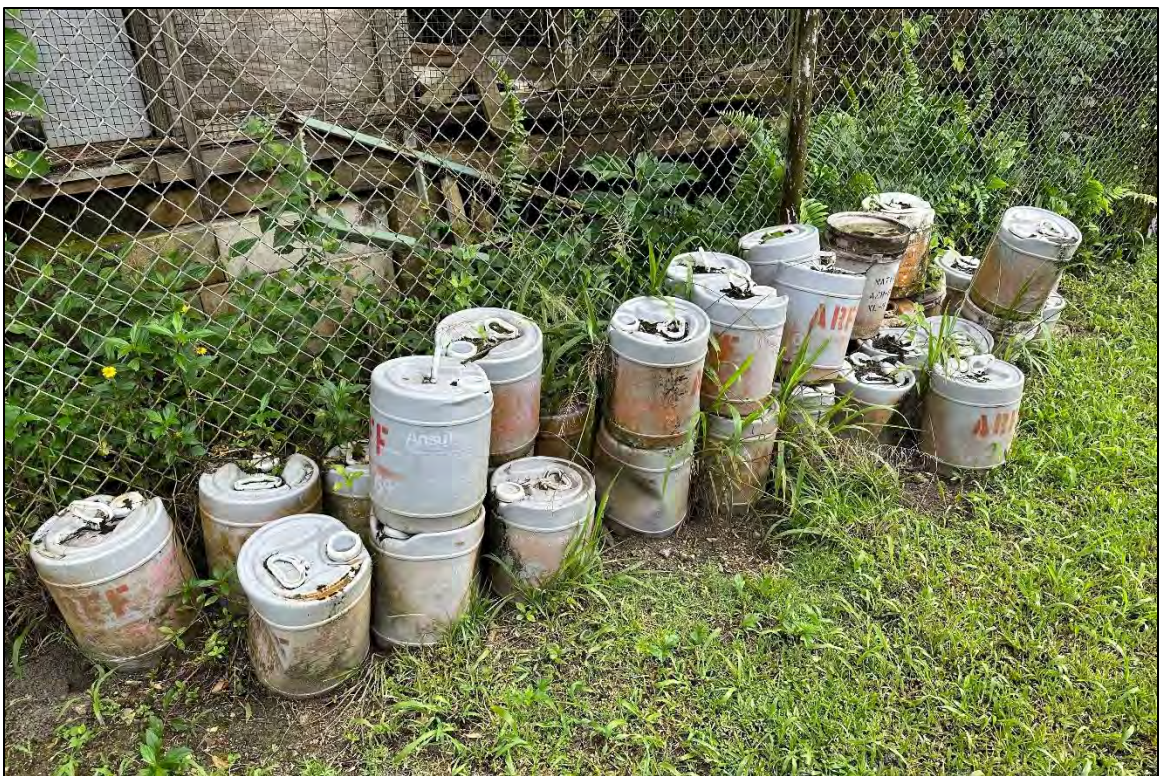
Photo 32: Close-up view of 55-gallon Ansulite buckets sitting on the lawn at the rear end of the fire department building.
