Draft Environmental Impact Statement

Infrastructure Improvements at

the Yap International Airport and

the Yap Seaport

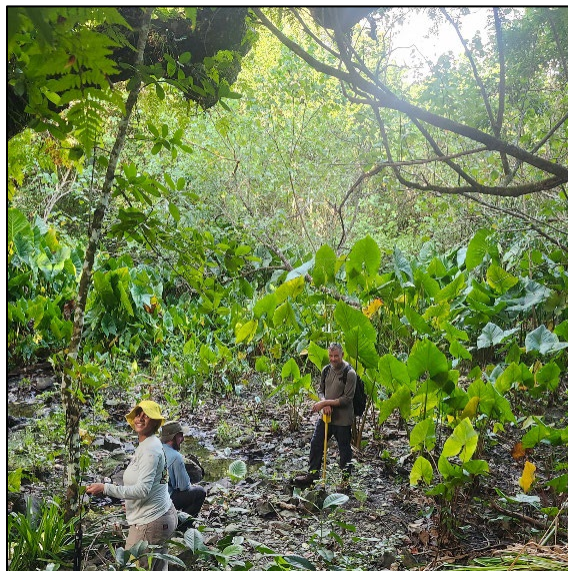
Figure 2. Altered wetland vegetation embedded within an active Taro patch.

Wetland delineations can be impacted by both anthropogenic activities that alter environmental conditions (i.e., altered wetlands) and by naturally occurring conditions that pose challenges to determining wetland boundaries (i.e., problematic wetlands). The procedure for conducting delineations under these difficult wetland scenarios was applied in accordance with the guidance outlined in chapter five of the regional supplement (USACE 2012). Landscape disturbances from agricultural practices, silvicultural operations and historic impact craters (and other World War II activities) were the most commonly altered wetland situations encountered during the field investigations (Figure 2). Additionally, stream incision and head cutting were observed in some

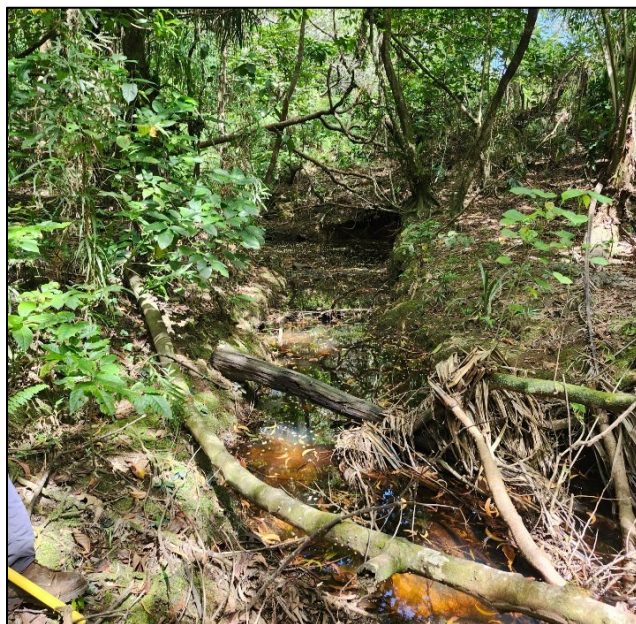
Figure 3. Example of incised channel with head cut area within a narrow wetland and stream network.

areas, potentially altering wetland hydropatterns (Figure 3). Most of these stream channel degradations were likely associated with some anthropogenic activity or feature (i.e., road crossing). Some disturbed and altered areas may not reflect the normal circumstances with regards to the plant community composition or wetland hydrology. However, the extent and severity of disturbances observed within the priority area did not alter the outcomes of the wetland delineation.

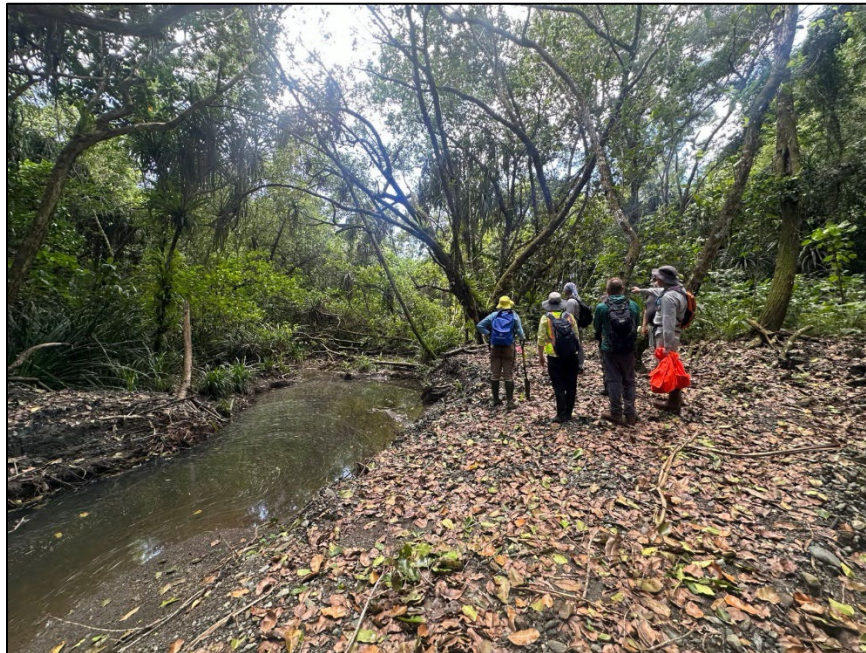
Figure 4. Example of a riverine wetland within the project area.

Riverine wetlands—The observed riverine wetlands in the project area were found in floodplains adjacent to small rivers and streams. The river channels and adjacent floodplains are inundated following large rain events when water overflows the banks, or when downstream discharge capacity is exceeded inducing backwater flooding (Figure 4). These wetlands may become dry during low rainfall and runoff portions of the year especially during periods of drought. Riverine wetlands in the survey area, occurring across a gradient of headwater streams, creeks, and larger rivers. The ecosystem functions provided by riverine wetlands are described below.

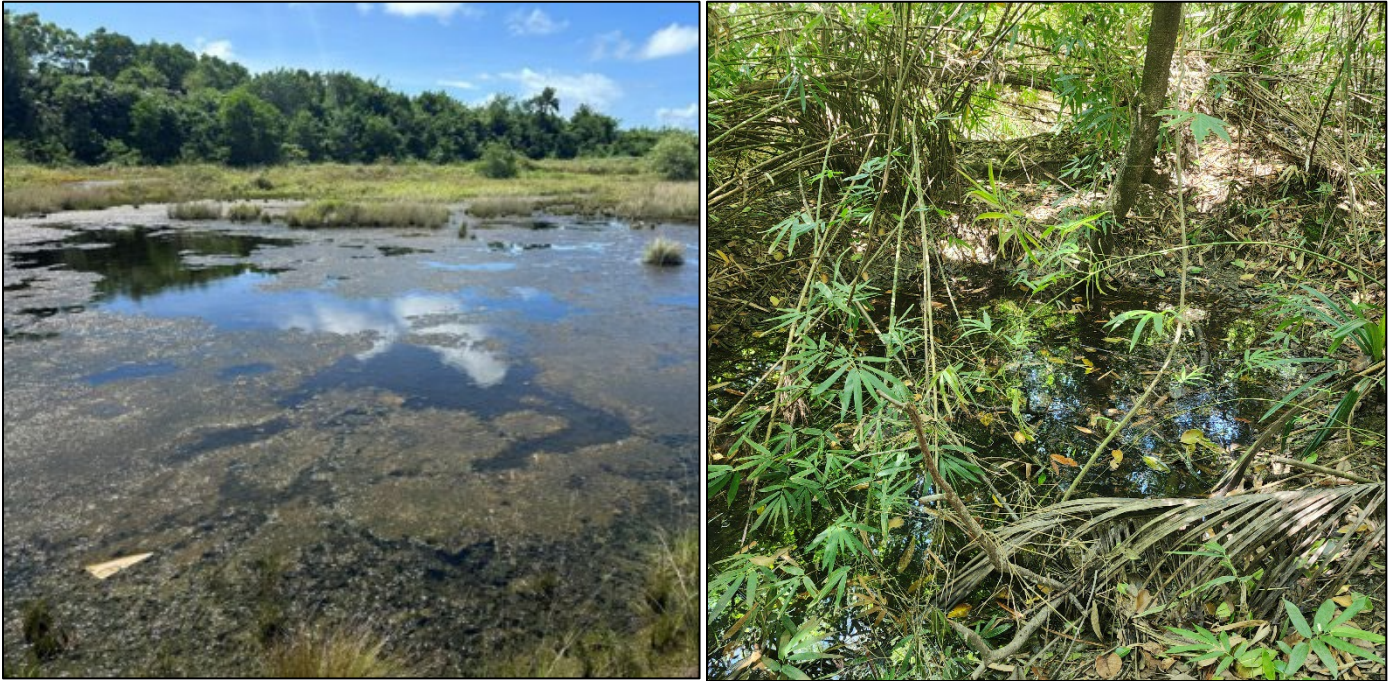
Figure 5. Examples of emergent (borrow area; left) and forested (impact crater; right) depressional wetlands within the project area.

Depressional and fringe wetland habitats—These wetlands occur in low lying depressions and fringes along the border of pools and ponds. These habitats are saturated or inundated by water that accumulated in areas of lower topographic relief than the surrounding landscape where runoff accumulates (Figure 5). Some depressional and fringe wetlands stay saturated most of the year, but these ecosystems may also become dry during drought periods or when seasonal drawdown occurs as the result of evapotranspiration. The ecosystem functions provided by depressional and fringe wetland habitats are described below.

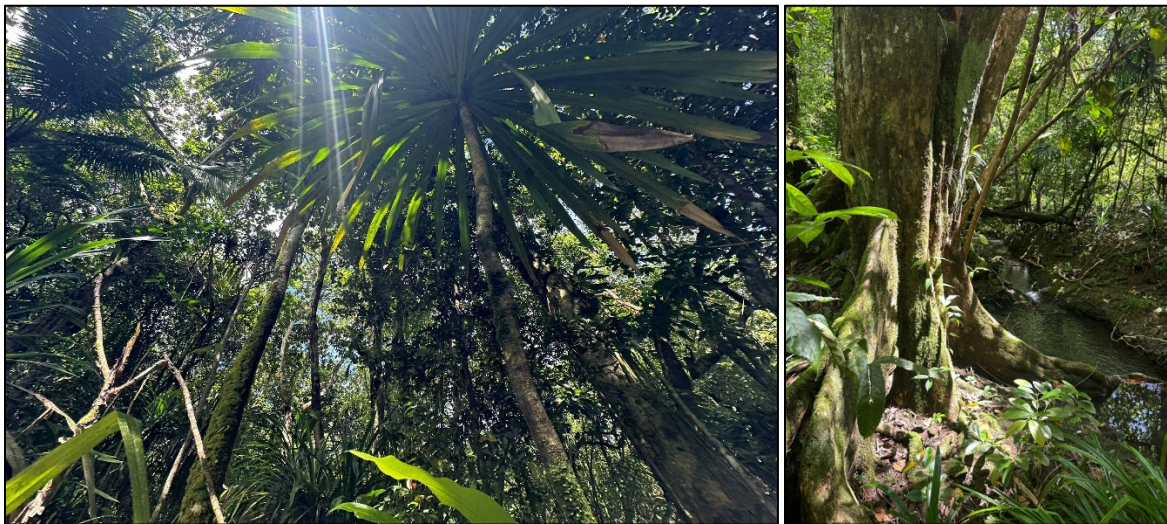
Figure 6. Examples of forested wetland habitats within the project area.

Forested wetland habitat—Forested wetlands are abundant across a variety of landforms in the project area. The observed forested wetlands in the project area were found on floodplains, slopes, and depressional areas (Figure 6). The ecosystem functions provided by forested wetland habitats are described below.

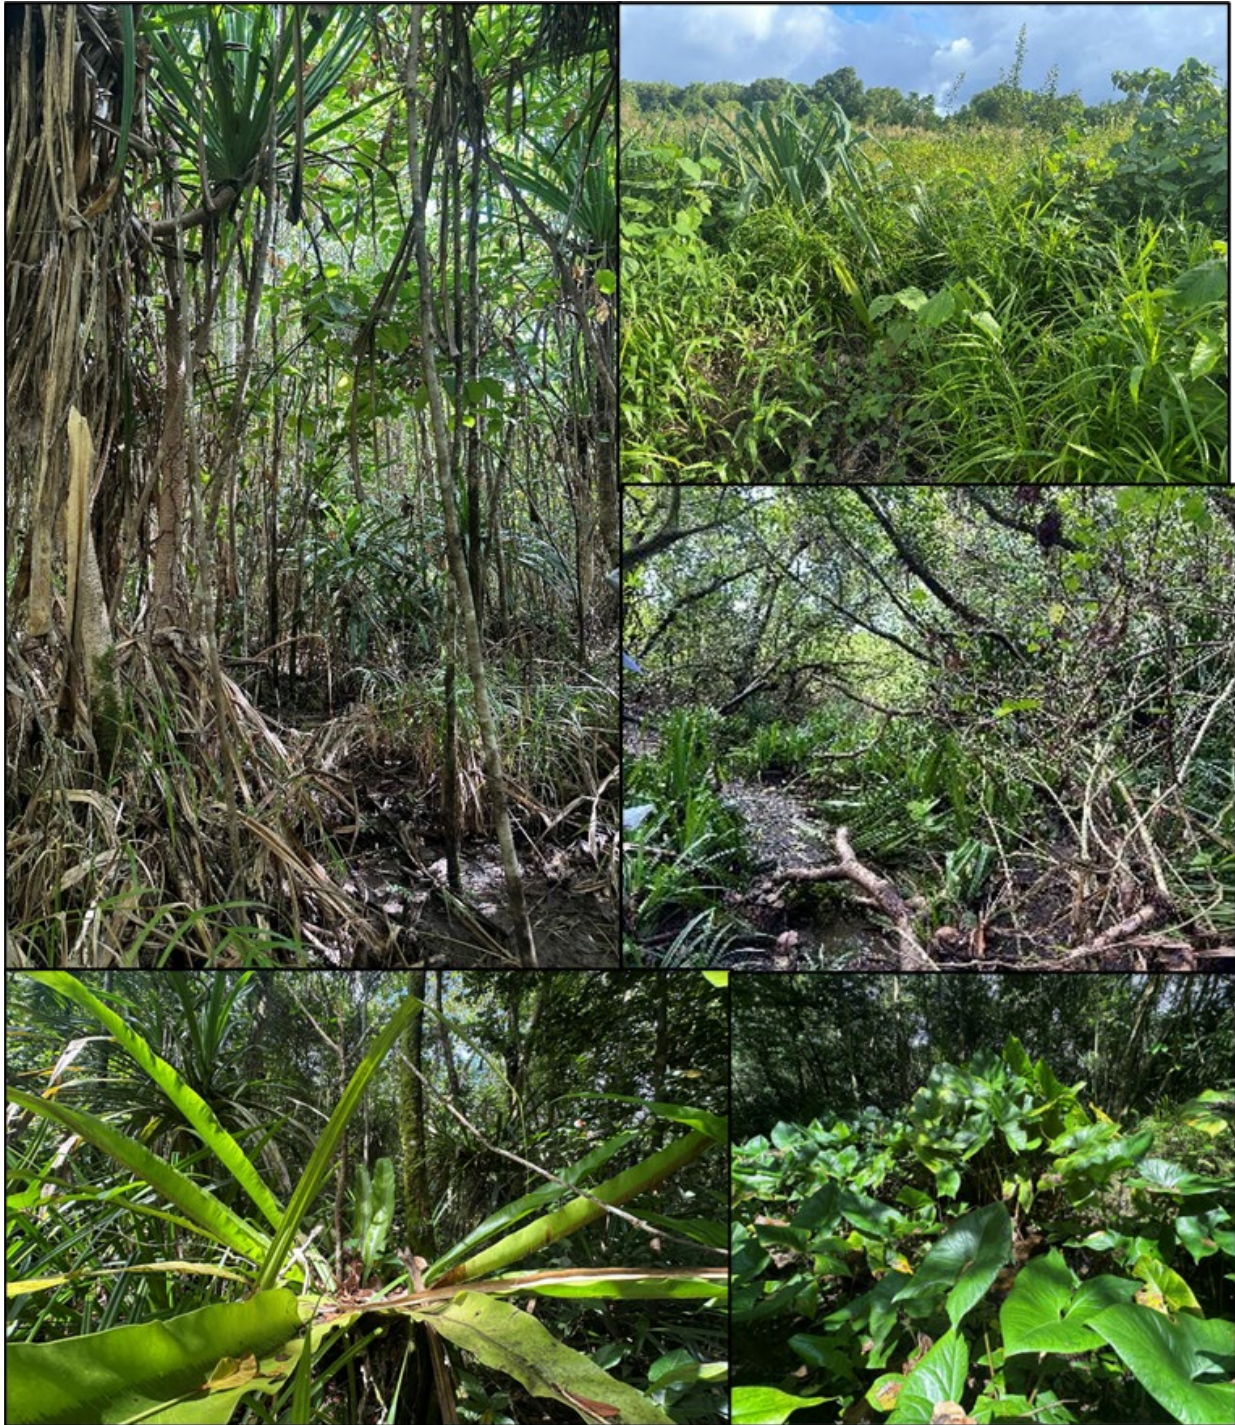
Figure 7. Examples of hydrophytic vegetation communities in the wetland delineation area.

The following section describes common wetland plant communities observed during field investigations. These descriptions are not designed to be exhaustive, but to provide general context for the wetland delineation. Most of the wetlands encountered in the priority areas were characterized by dense vegetation, with canopy cover commonly higher than 75% and often approaching or exceeding 100% due to overlapping foliage (Figure 7). Woody vegetation was dominated by the tree and sapling strata, with lower abundances of herbaceous plants on the forest floor. Hydrophytic vegetation communities were identified using the Dominance Test, wherein greater than 50% of vegetative cover was composed of dominant plant species with wetland plant indicator status ratings of Facultative, Facultative Wetland, or Obligate (Table 1). Prevalence Index scores were also calculated but did not alter any hydrophytic vegetation outcomes.

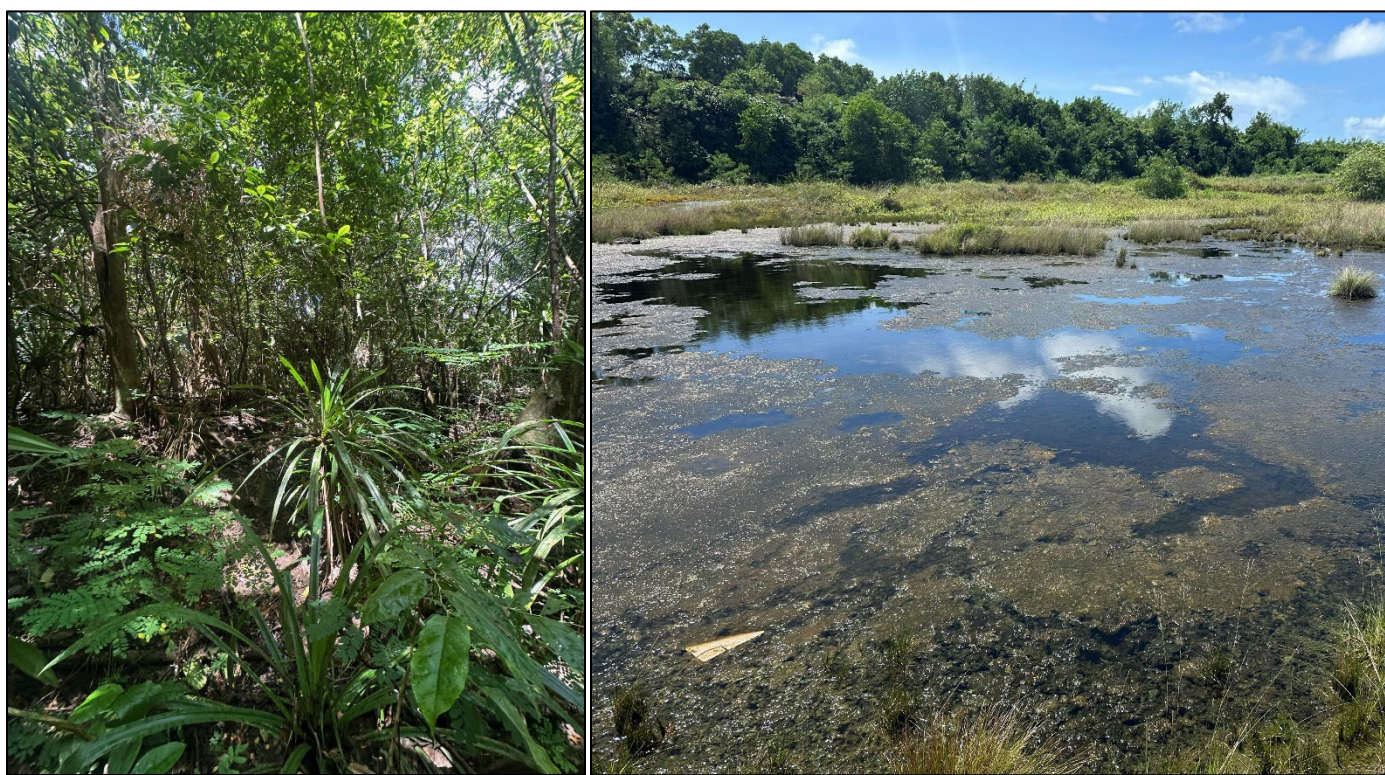
Figure 8. Examples of wetlands that failed to exhibit hydrophytic vegetation due to the presence of dominant non-wetland plants or disturbance.

Frequently encountered dominant species observed in wetlands included *Pandanus tectorius*, *Hibiscus tiliaceus*, *Camptosperma brevipetiolata*, *Bruguiera gymnorrhiza*, *Cyrtosperma merkusii*, and *Scleria polycarpa*. Note that six wetland areas (Wetlands 3, 4, 10, 15, 19, and 22) failed to meet a hydrophytic vegetation indicator but were determined to be wetlands based on the presence of wetland hydrology and hydric soils in conjunction with appropriate landscape positions, and the presence of upland vegetation occupying higher elevation ‘hummocks’ (small, raised areas) interspersed within several wetland areas (Figure 8). This approach aligns with the “Difficult Wetland

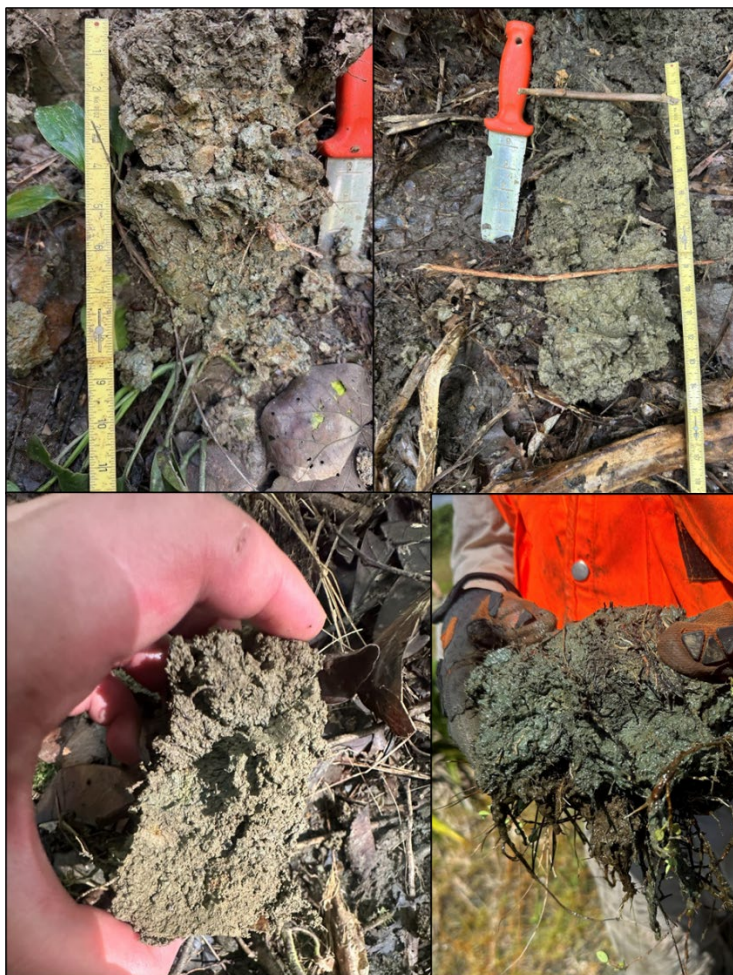
Figure 9. Examples of hydric soils observed in the study area.

Hydric soils within the wetland delineation priority areas exhibited depleted matrices, common to many redoximorphic features, and other hydromorphic features associated with wetland soils elsewhere in the Pacific Basin (Figure 9). The soils were predominantly composed of loamy/clayey textures. Organic soil horizons were infrequent, and when encountered were restricted to thin surficial layers within the wetland delineation area. However, thick organic layers did occur in the mangrove assessment areas described in subsequent sections of this report. Field indicators of Hydric Soils, identifiable soil morphologic patterns indicative of anaerobic conditions, were readily observable within each wetland area evaluated. The most commonly encountered field indicators included F3 - Depleted Matrix and F8 – Redox Depressions (USDA-NRCS, 2025). Additionally,

indicators A11 Depleted Below Dark Surface was documented at three locations and A8 – Thin Muck Surface were observed at one heavily disturbed area with compacted soils (Wetland 10).

No problematic hydric soil situations were encountered during the study, and the application of the Field Indicators of Hydric Soils (USDA 2025) proved effective for identifying hydric soils on Yap Island. One location (Upland 2) exhibited hydric soil indicator F3 – Depleted Matrix, but lacked all indicators of wetland hydrology. While soils in that location appear to have formed under anaerobic conditions, changes in local stream channel morphology and hydrodynamics (i.e., incision and downcutting) likely disconnected the area from contemporary inundation or saturation. Additionally, Upland 2 was dominated by Facultative plants suggesting a potential shift towards drier conditions near the wetland-upland boundary.

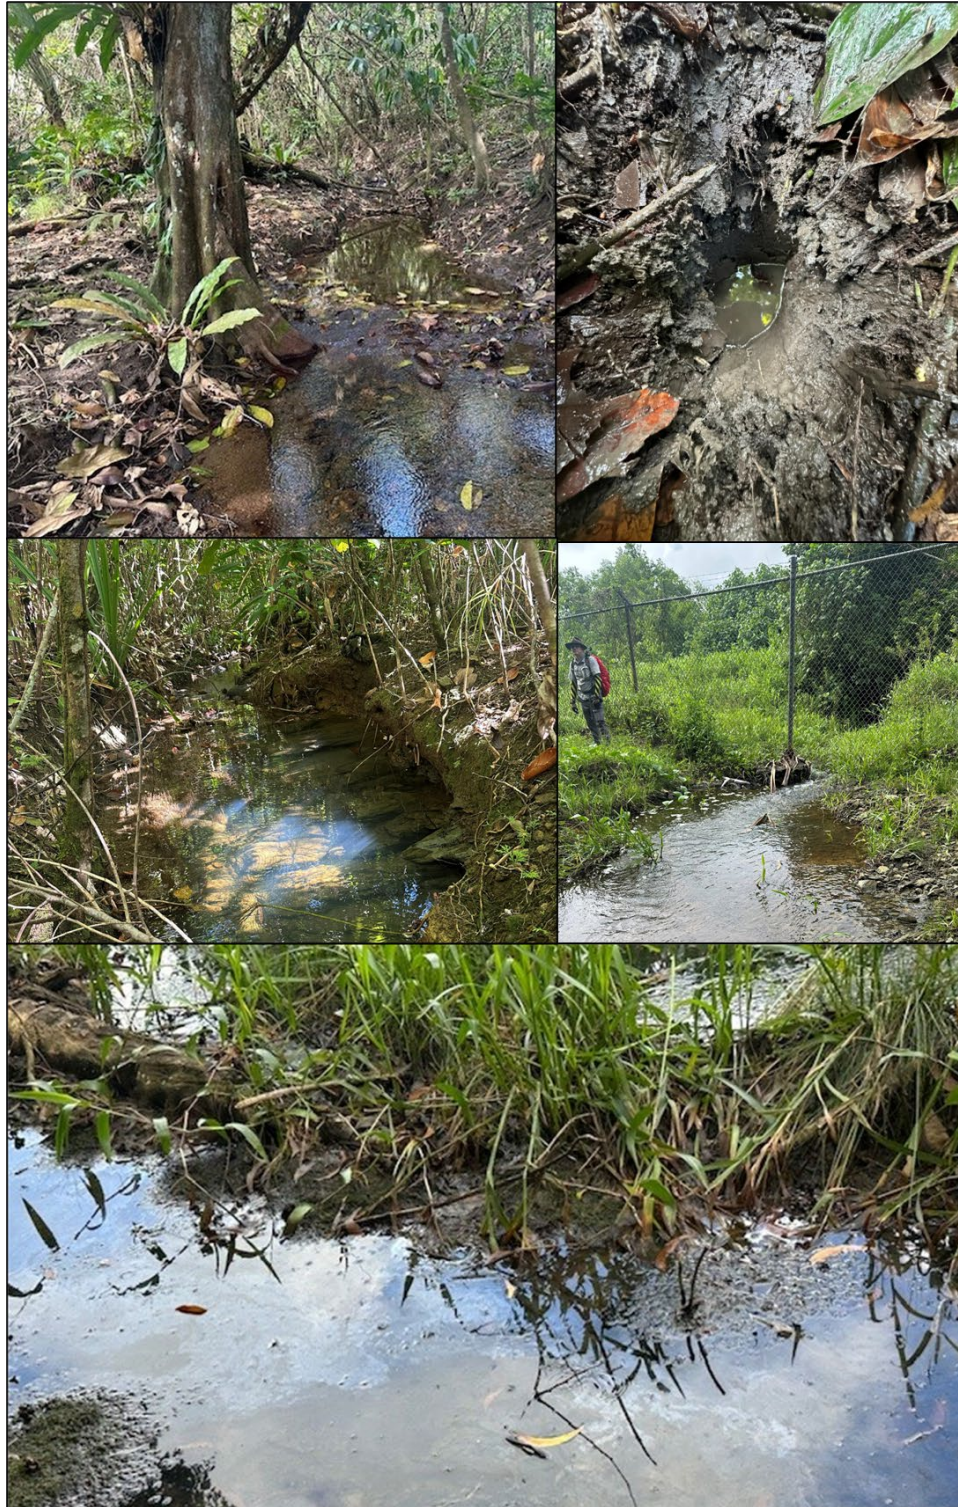
Figure 12. Examples of wetland hydrology indicators observed in the study area including: Surface water (A1), High water table (A2), Saturation (A3), Presence of reduced iron (C4), Drainage patterns (B10), and Geomorphic position (D2).

Indicators of wetland hydrology include observations of surface water or saturated soils, evidence of recent inundation, evidence of current or recent soil saturation, and other site conditions indicative of wetland hydroperiods (USACE 2012). Eighteen wetland hydrology indicators were documented within the priority areas, including at least one primary or two secondary indicators within each wetland delineation area (Figure 12). High water tables, soil saturation, and water-stained leaves were most commonly observed primary indicators, along with secondary indicators such as drainage patterns, geomorphic position, and the FAC neutral test (Table 1, 2).

Wetland hydrologic conditions were considered normal during the data collection period, because the site visits occurred near the end of the wettest season when antecedent soil moisture levels are anticipated to be high. Most surface water features (including stream channels, depressions, and ephemeral drainages) contained water during the site visits and soil saturation was documented at the majority of the wetland locations.

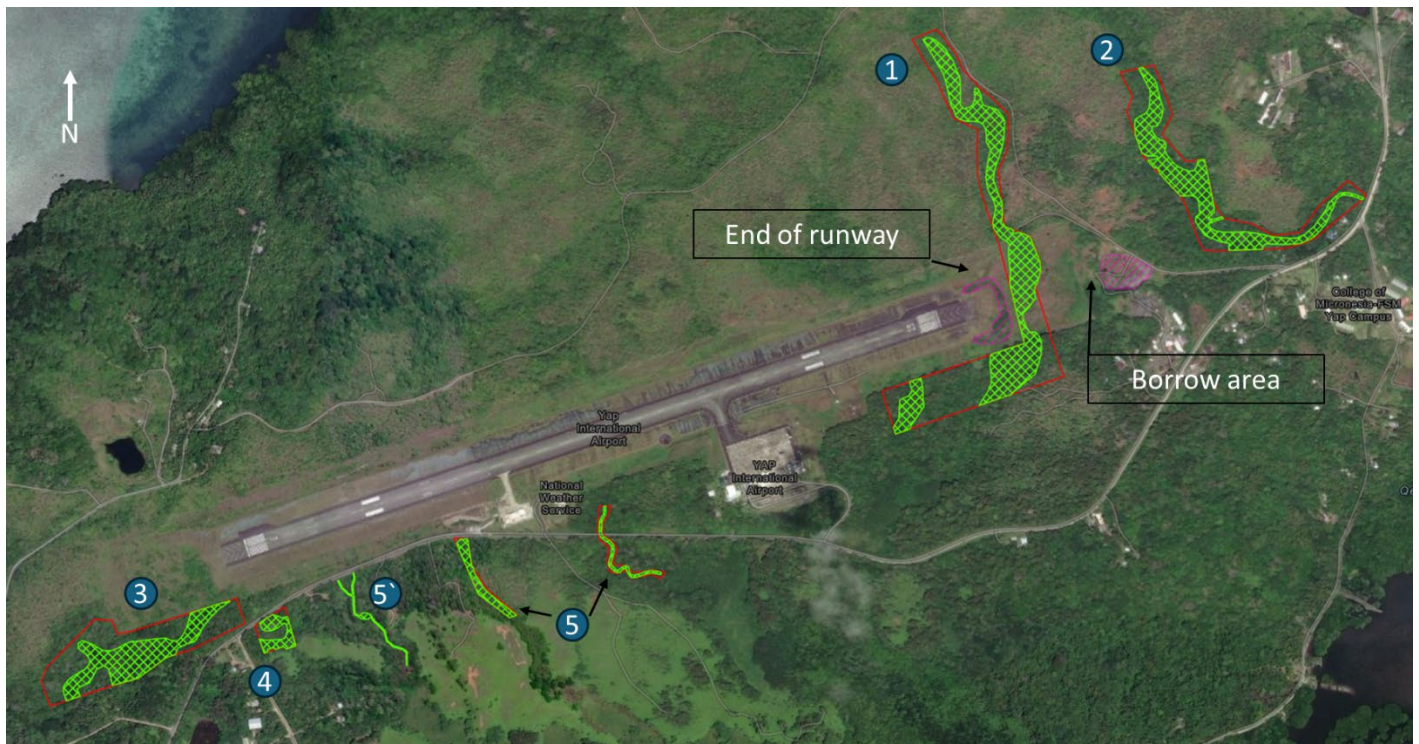
Figure 13. Overview of connected wetlands (green polygons) and isolated wetlands (pink polygons) identified within the project area. Priority survey area boundaries are denoted with red outlines.

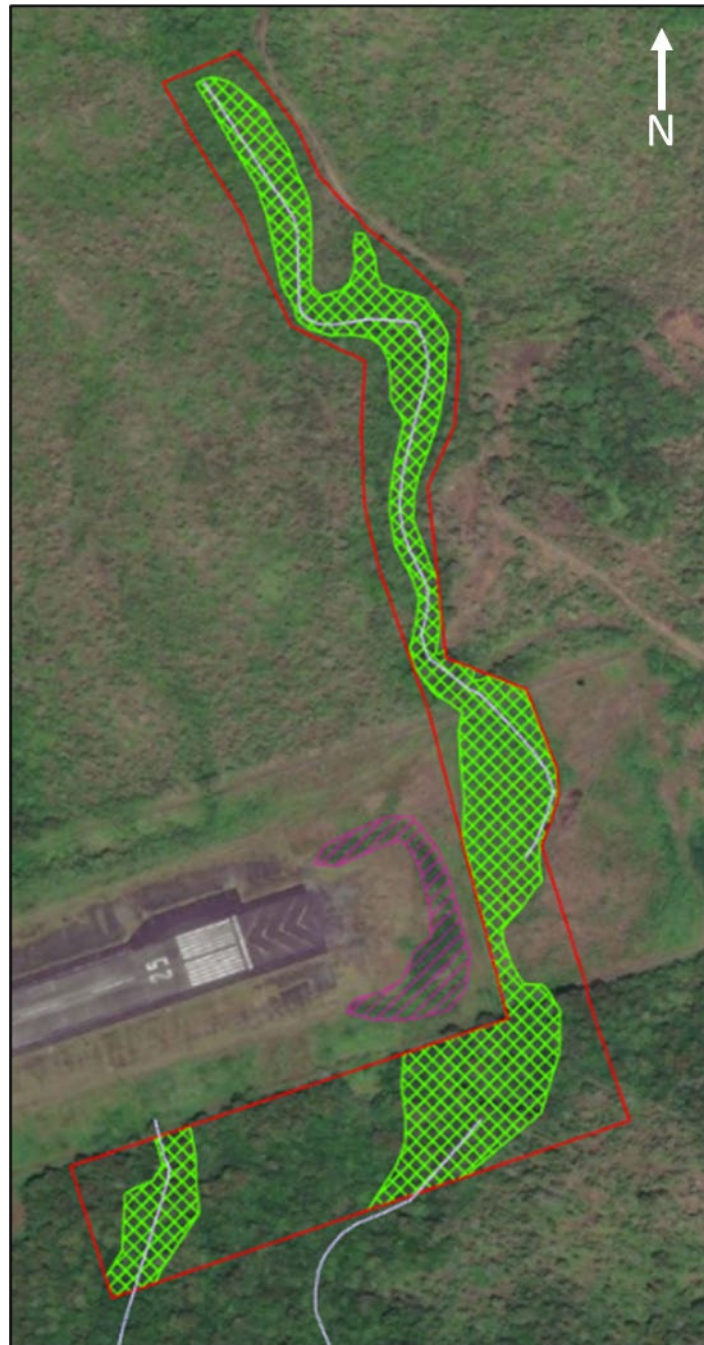
Figure 14. Connected wetland areas (green polygons) identified within priority area 1. The area includes two wetland features, a smaller 1.37 acre wetland to the south of the runway and a larger 11.45 acre wetland east side of the runway. Priority survey area boundaries are denoted with red outlines. An isolated wetland (pink polygon) also appears in the image).

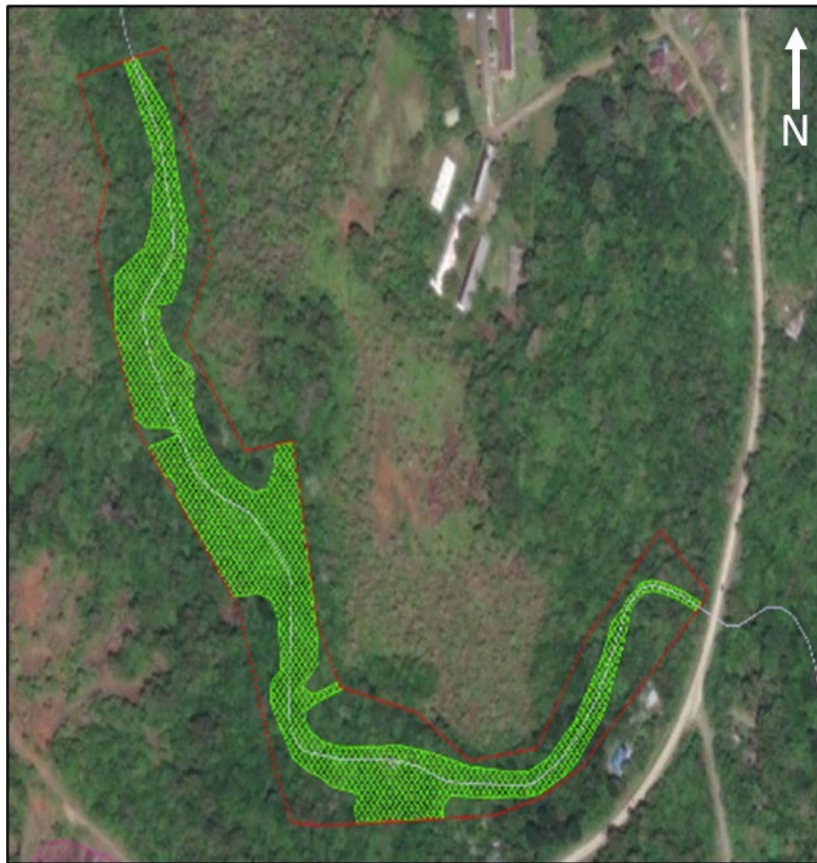
Figure 15. Connected wetland areas (green polygons) identified within priority area 2. Priority survey area boundaries are denoted with red outlines.

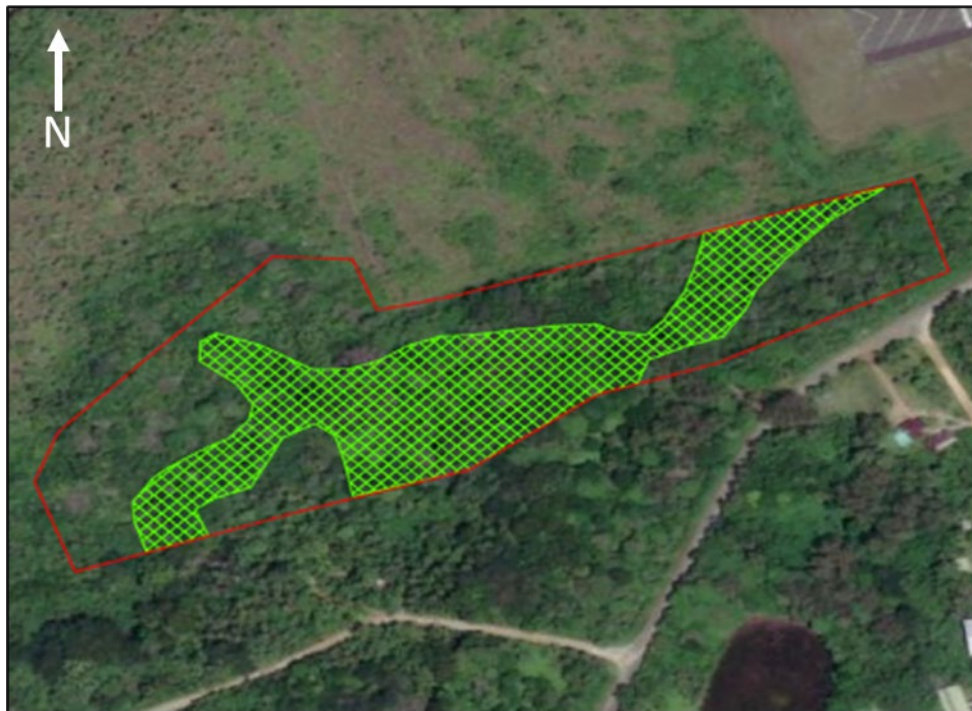
Figure 16. Connected wetland areas (green polygons) identified within priority area 3. Priority survey area boundaries are denoted with red outlines.

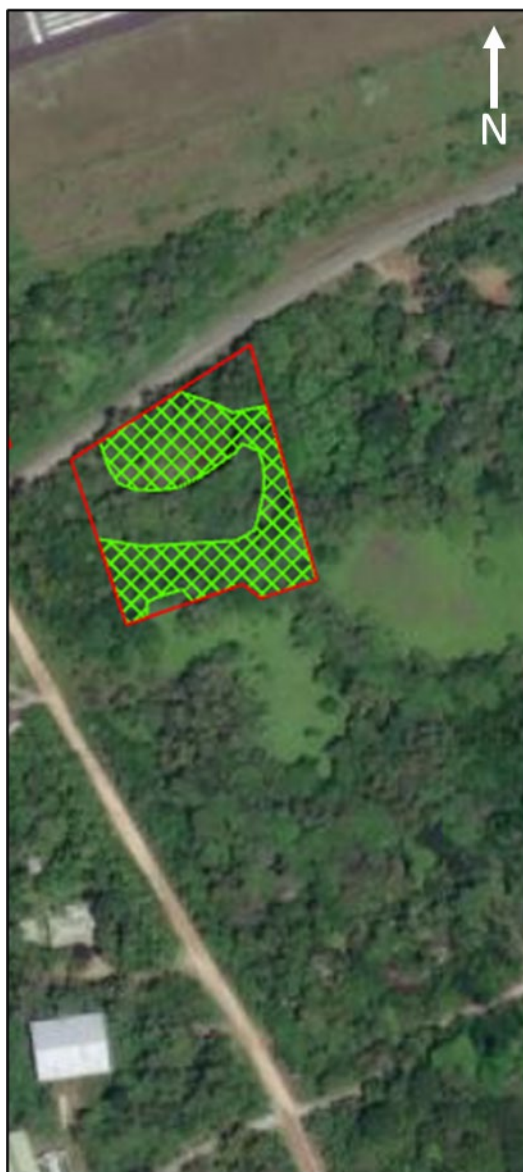
Figure 17. Connected wetland areas (green polygons) identified within priority area 4. Priority survey area boundaries are denoted with red outlines.

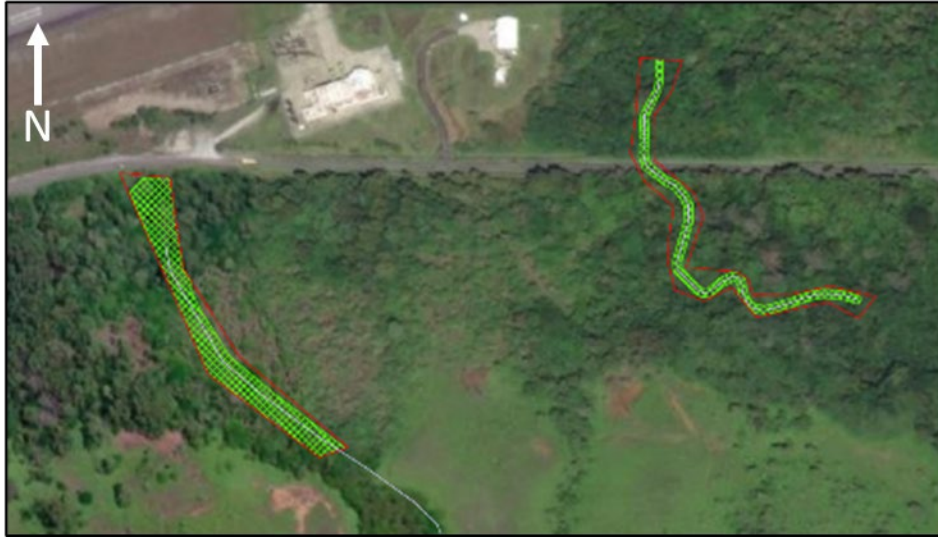
Figure 18. Connected wetland areas (green polygons) identified within priority area 5. The area includes two wetland features, a larger 1.05 acre wetland to the west and a smaller 0.46 acre wetland to the east. Priority survey area boundaries are denoted with red outlines.

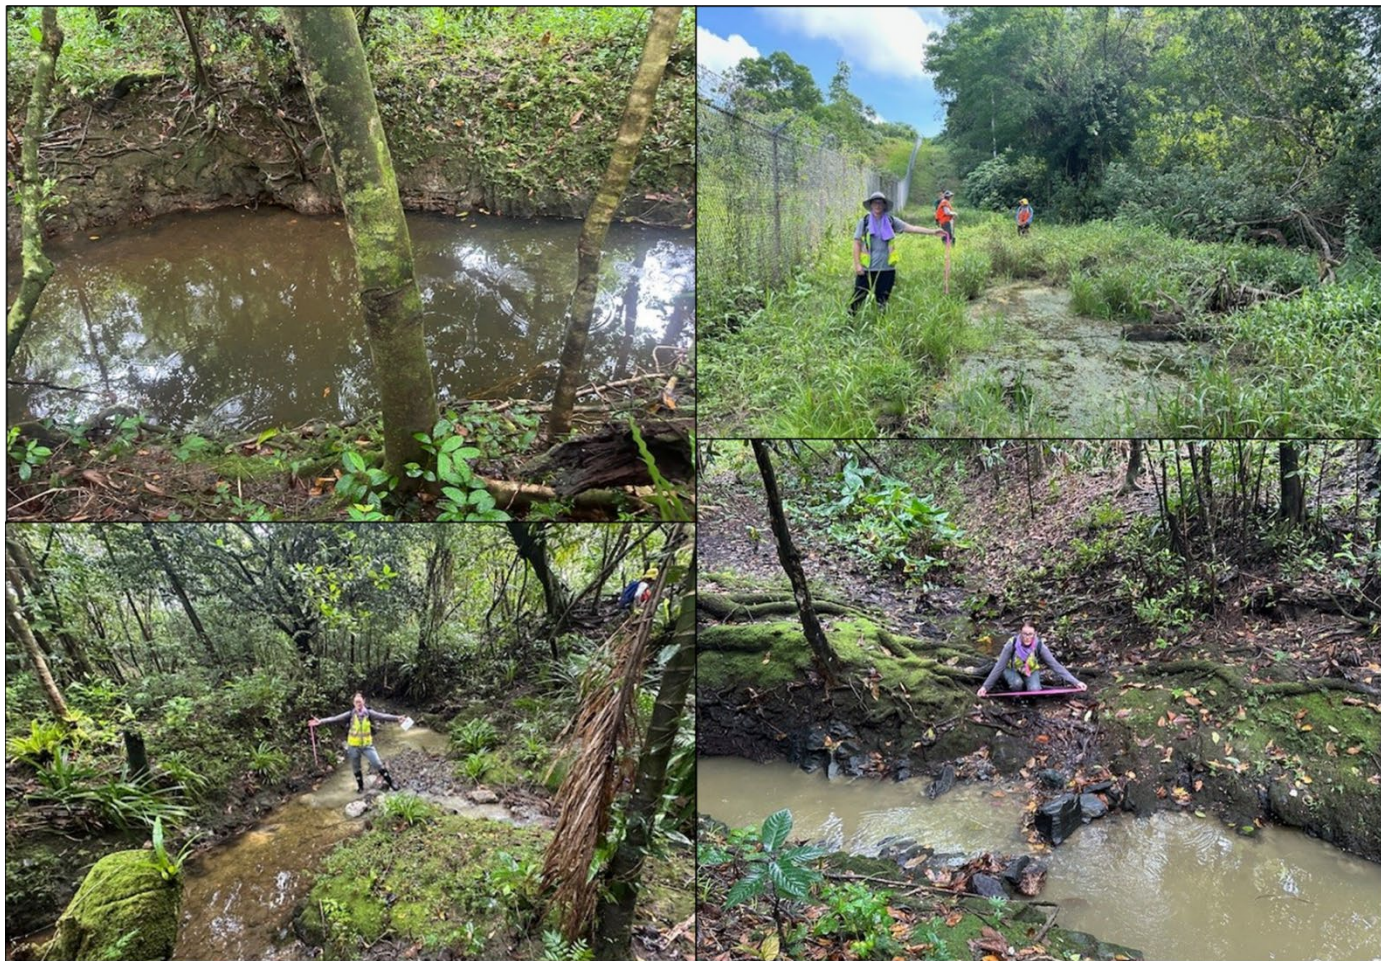
Figure 19. Examples of wetland boundaries displaying clear topographic breaks at transitions to upland areas.

Wetland boundaries were abrupt in most areas, characterized by readily distinguishable changes in landform topography and slope (Figure 19). Most wetlands were associated with active stream channels, which provided the major source of hydrology to riverine floodplain wetlands, as well as most of the depressions and fringe wetlands observed in the project area. Small headwater slope wetlands occurred adjacent to larger first and second order channels. As a result of the landscape position, all wetlands within the priority areas (including wetland mosaics) were considered to maintain connectivity with surface water features at least during portions of the year (Figure 20). Additionally, a small (0.35 acre) wetland feature was identified between priority areas 4 and 5 (denoted 5`), the wetland was connected with a headwater stream feature (Figure 21). Alternatively, two areas located at the end of the runway berm and in a borrow area (Table 3) appeared to be isolated features disconnected from other wetlands or surface water bodies (Figure 22).

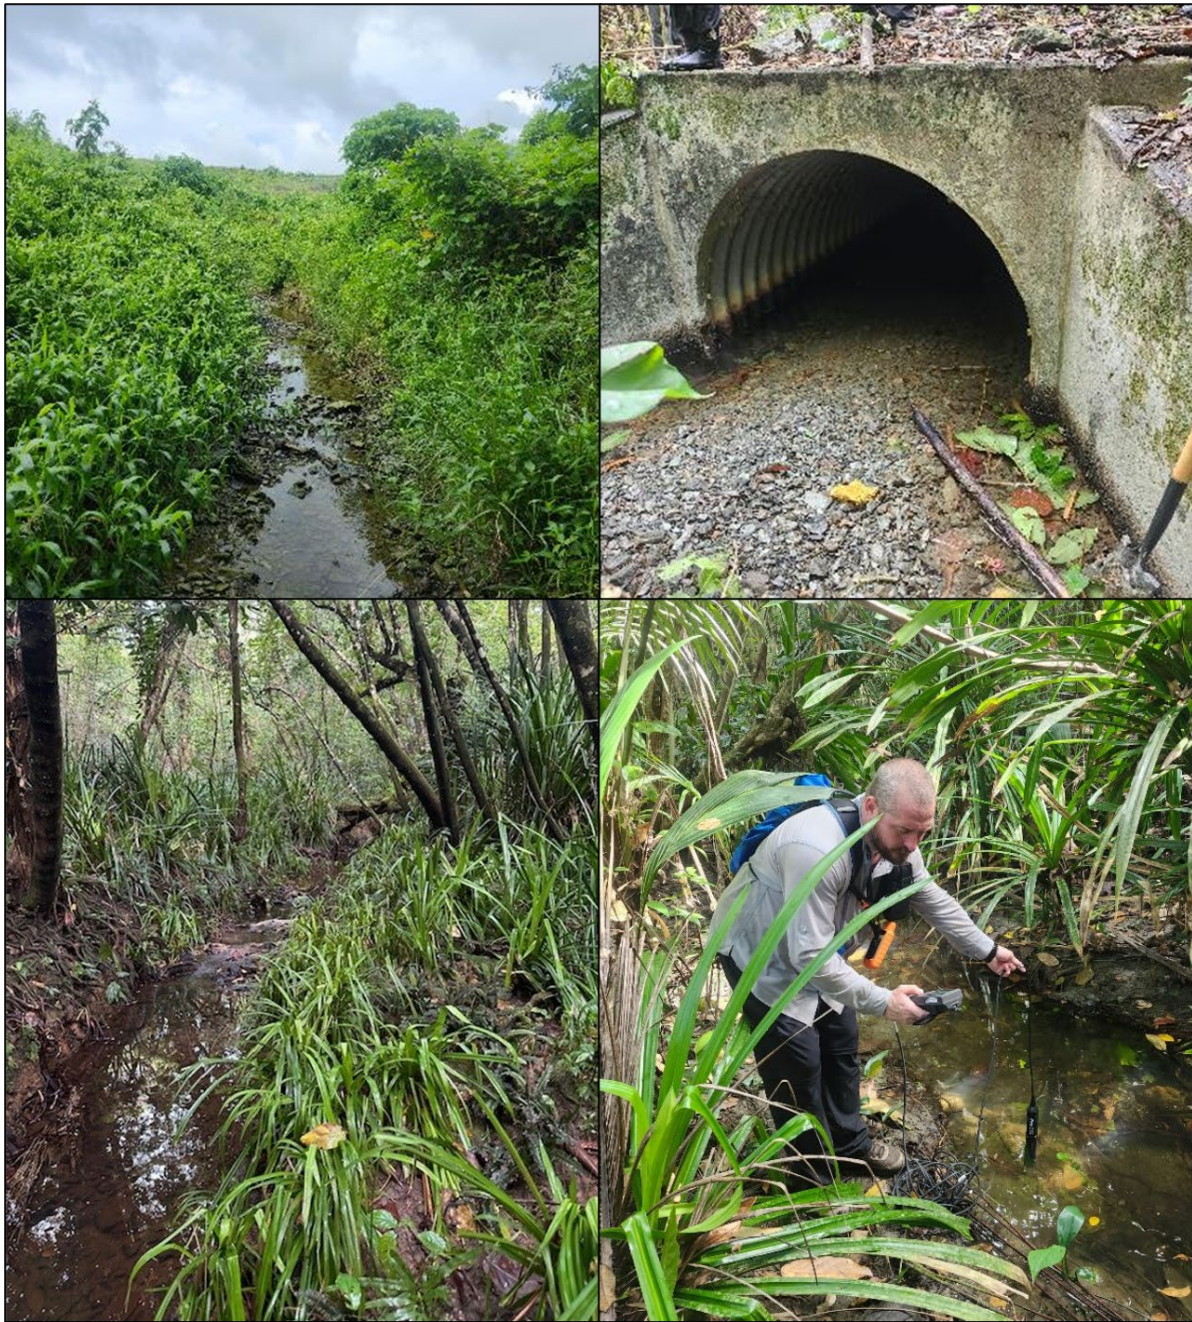
Figure 20. Examples of continuous surface water connections with wetlands in priority areas to larger drainage features.

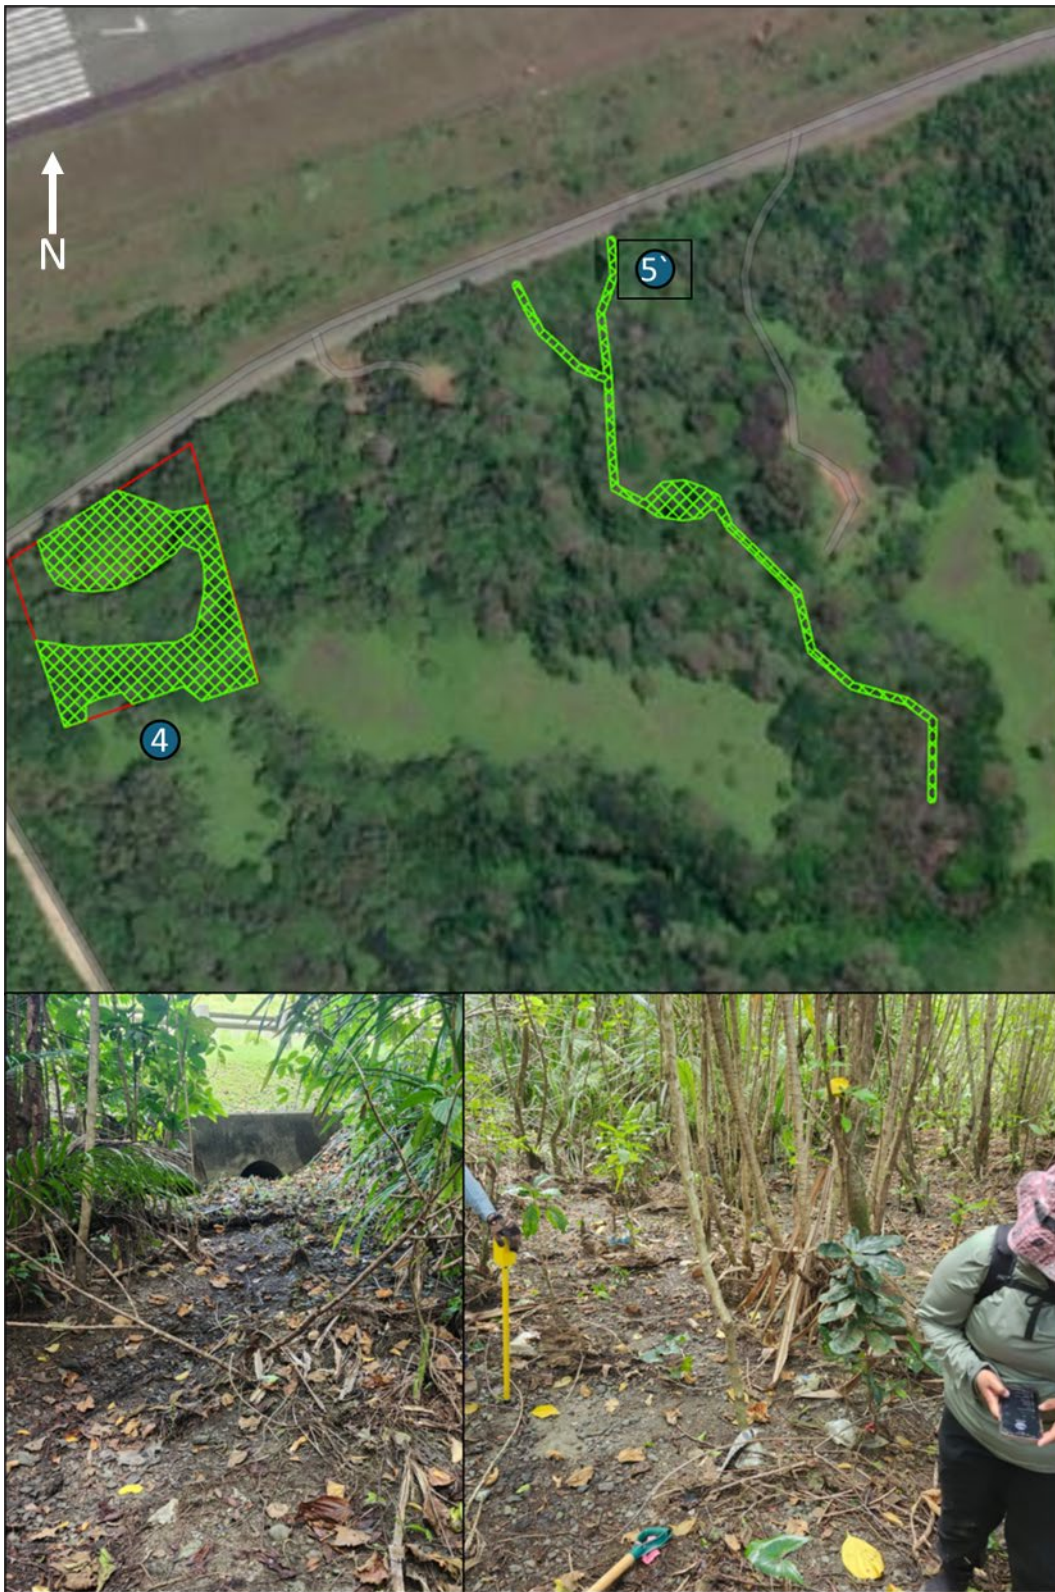
Figure 21. Location and representative photos of a small 0.35 acre wetland feature (denoted as 5; green polygon) associated with a small drainageway east priority areas 4 (outlined in red).

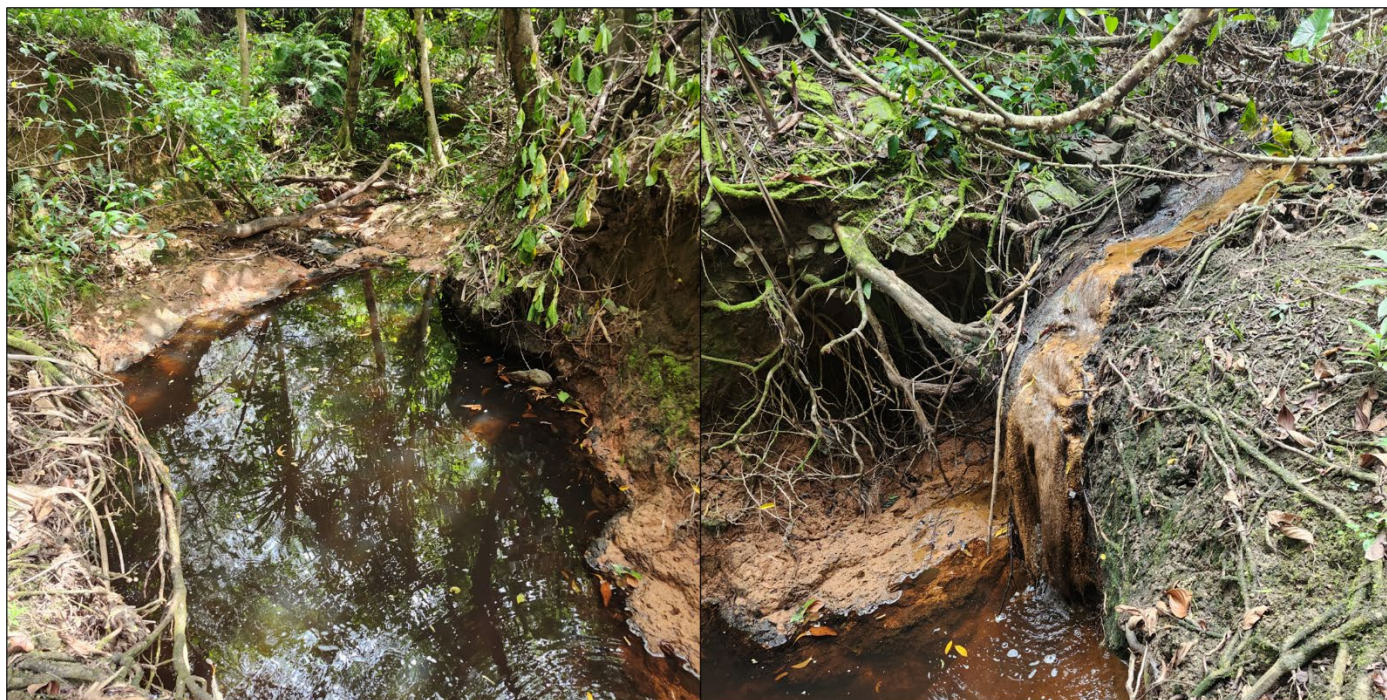
Figure 23. Examples of erosion and stream incision in the vicinity of area 5`, providing opportunities for erosion control and wetland restoration/enhancement.

Multiple head cuts were observed in priority areas 1, 2, and 5 that could be addressed using a variety of techniques. Large head cuts can be effectively remedied using structures such as drop pipes, weirs, sills, and other grade control features. In particular, large head cuts occur in the vicinity of the area denoted 5', wetlands 18 and 19, that could be included in a mitigation strategy. Smaller head cuts can be addressed using deliberately placed and maintained check dams, debris jams, root balls, and/or rock structures that stabilize channels and maintain the riffle and run morphology typical of the lotic features encountered during the site visits. Many opportunities to reduce erosion and stream channel incision were observed in the project area and elsewhere in the vicinity of the airport property to assist with wetland impact mitigation (Figure 23). Reducing head cuts precludes additional channel incision, promotes floodplain connectivity, and enhances wetland hydroperiods, all of which improves functions of the wetland classes evaluated in the study area. Additionally, these approaches reduce channel bank and bed erosion, decreasing sediment loading to downstream environments and improving habitat for a variety of wetland and aquatic species. Streambank stabilization using vegetation re-establishment, geotextiles, or other erosion reduction strategies would likely also provide appropriate mitigation opportunities given the interconnectivity of wetland and stream features within the project area.
