Draft Environmental Impact Statement

Infrastructure Improvements at

the Yap International Airport and

the Yap Seaport

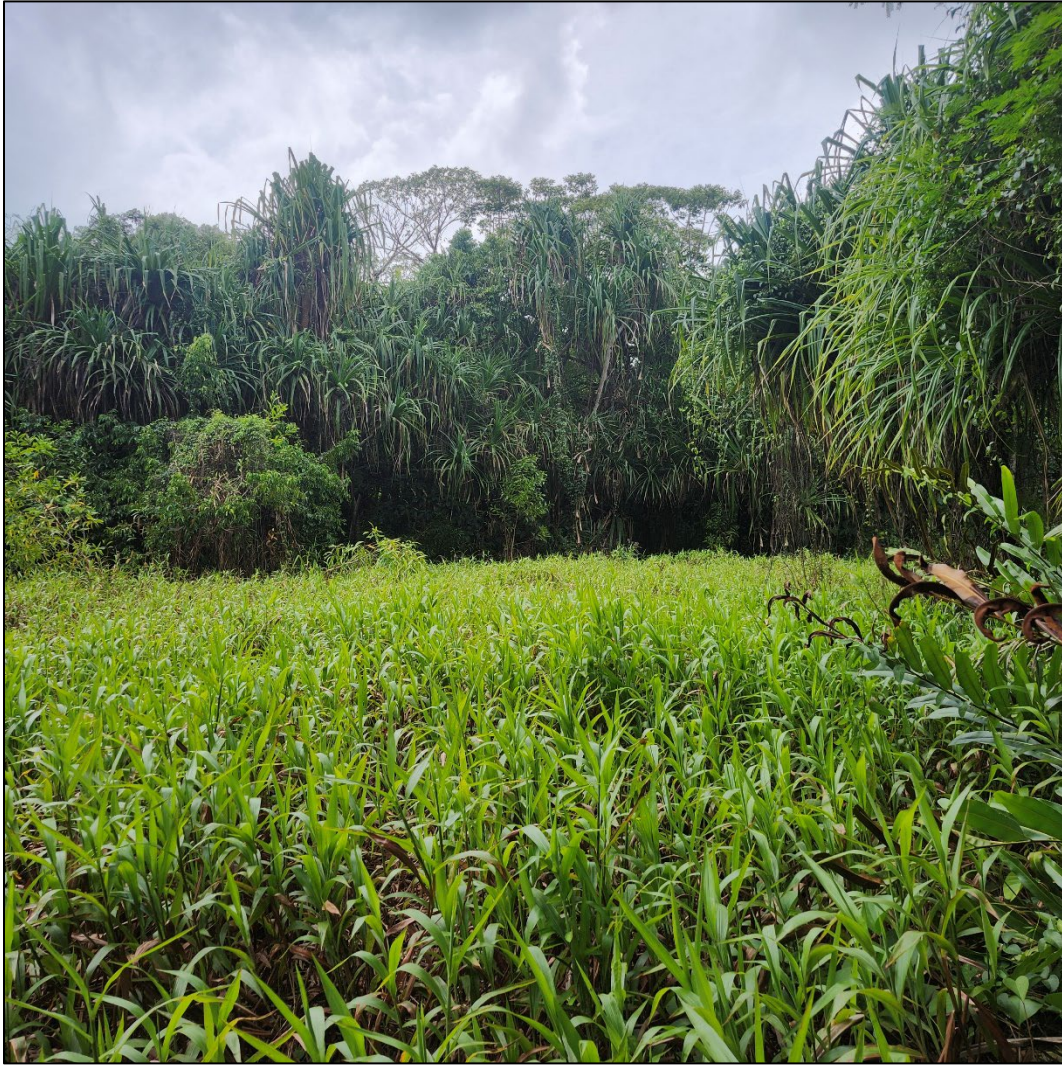
Figure 24. Area of potential vegetation restoration dominated by non-native *Hymenachne amplexicaulis*.

Vegetation and hydrology management provides additional opportunities to improve wetland functions within the project area. In particular, wetlands in the vicinity of Wetland 20 (priority area 4) have undergone alteration and appears to be dominated by *Hymenachne amplexicaulis* (West Indian marsh grass) a species native to Mexico, South and Central America, and the Caribbean Islands (Figure 24). The species readily occupies disturbed areas and often thrives as near monocultures that reduce native species diversity by invading marshes, river edges and wet pastures (Florida Natural Areas Inventory 2026). Wetland restoration in the identified areas would include removal of the invasive species and restoration of native plant communities. Additionally, opportunities exist to improve wetland hydrology in this portion of the project area, including settings conducive to water management in support of agroforestry such as additional taro cultivation (Figure 25). Restoration activities would include channel improvement to ensure connectivity between the channel and the floodplain. This could be accomplished using weir and baffle structures allowing the community to manage water levels in support of forested wetland crop cultivation, to maintain surface water during dry periods for aquatic species, habitat, and to provide for sediment entrapment to benefit downstream environments.

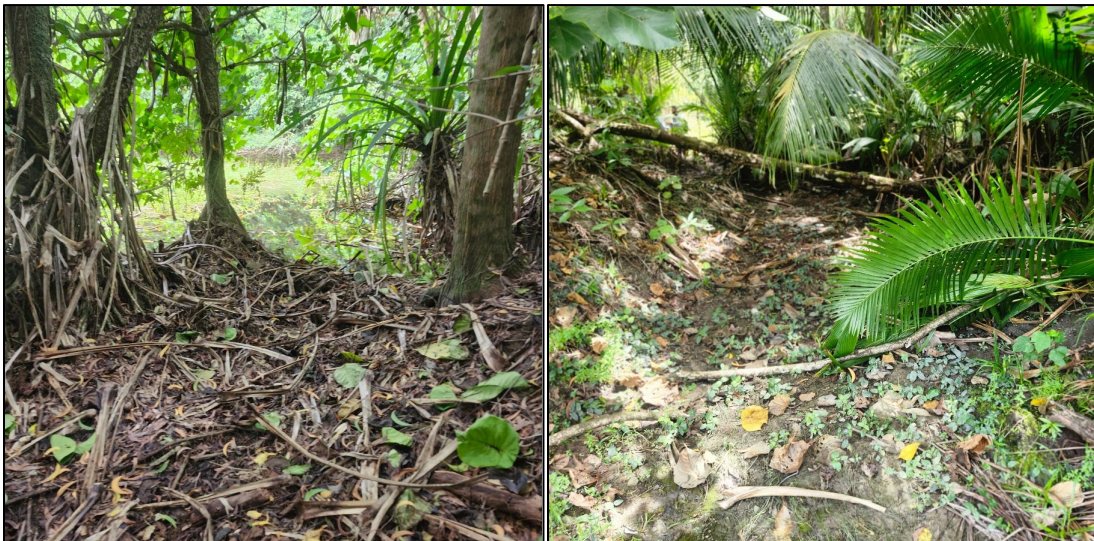
Figure 25. Wetlands within the vicinity of priority area 4 that could be targeted for hydrologic restoration and potential taro cultivation.

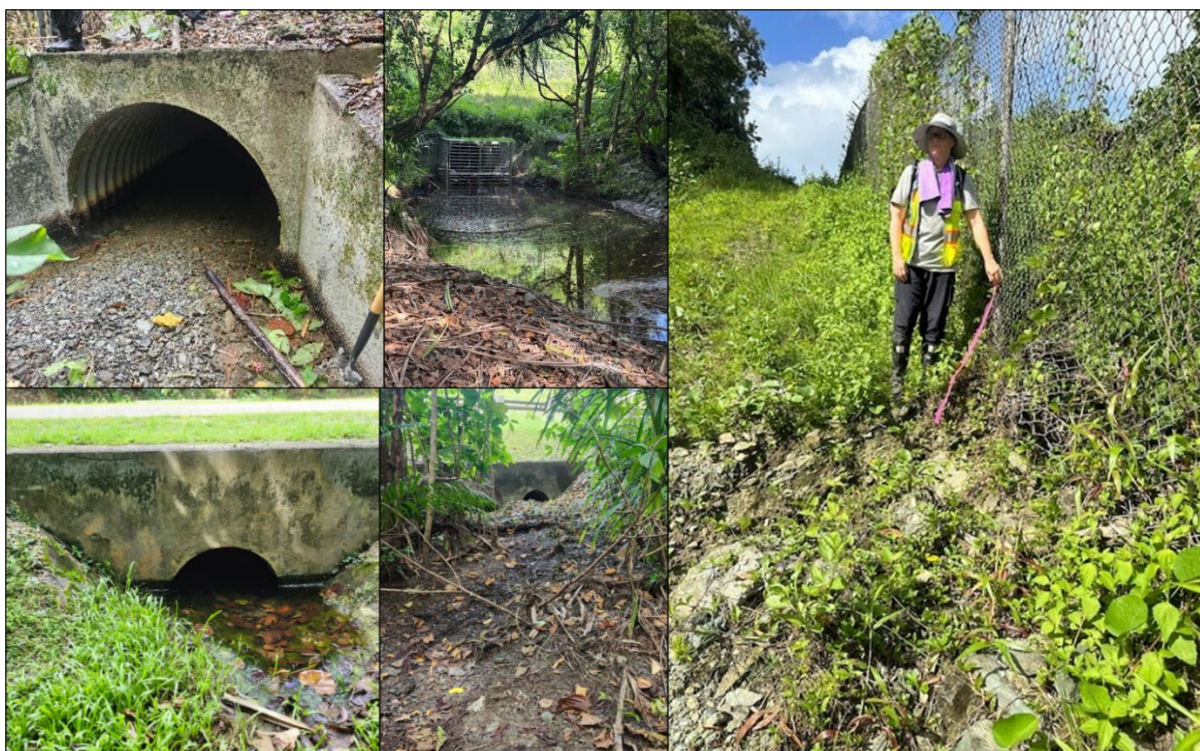
Figure 26. Examples of water control structures where wetland hydrology management could be applied as potential mitigation measures.

Opportunities exist to improve wetland and aquatic health through additional water management activities south of the airport property. A number of culverts, water control structures, bridges and road crossings, and other infrastructures can be evaluated to enhance sediment retention, nutrient assimilation and transformation, and habitat and water quality (Figure 26). Target areas would include culverts, drainage features, and other conveyances that channelize flow, increase erosive force, and alter stream-wetland floodplain dynamics. Examples of these opportunities can be found in all priority areas but are most evident south of the airport fence line, where drainage structures have induced hillslope erosion, and south of the main roadway where culverts and other structures have become partially buried with sediment, coarse gravels predominate, and bank erosion becomes more extensive.

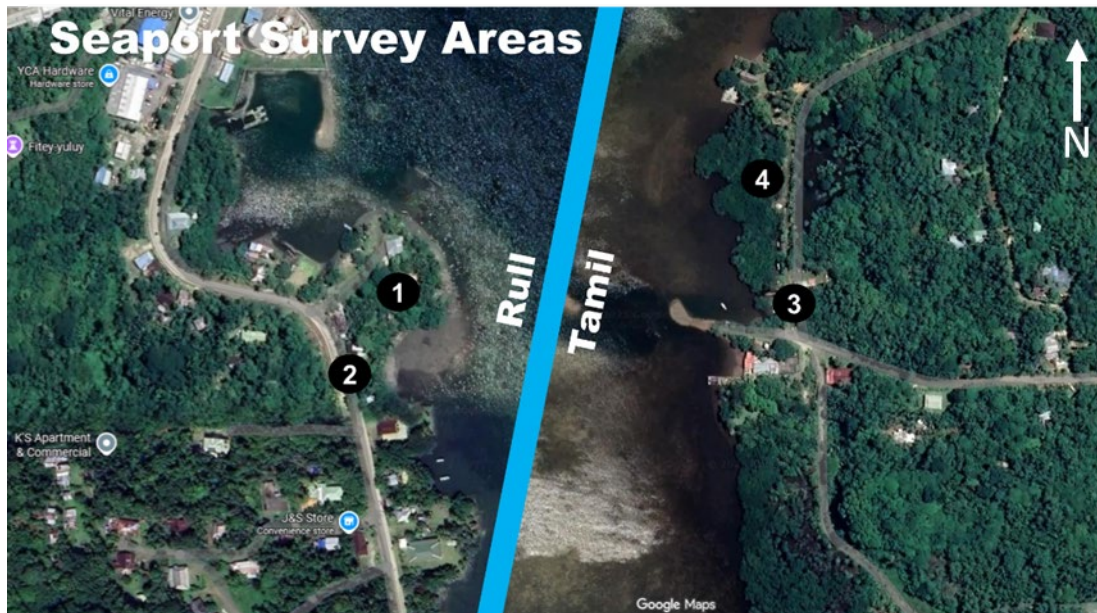
28. Seaport survey mangrove priority areas.

This assessment evaluated mangrove ecosystems within priority areas identified in the vicinity of the proposed airport and seaport projects. The assessment documented mangrove forest composition and structure to inform planning and management decisions. Seven areas were surveyed using quantitative sampling or qualitative observations to document current conditions. The study locations included Mangrove priority area 1 near the airport footprint; Mangrove priority areas 2 and 3 along the coast, which were assessed by boat (Figure 27); Tamil mangrove areas 3 and 4, and the small clusters of mangrove trees near the Rull community coastline (Figure 28).

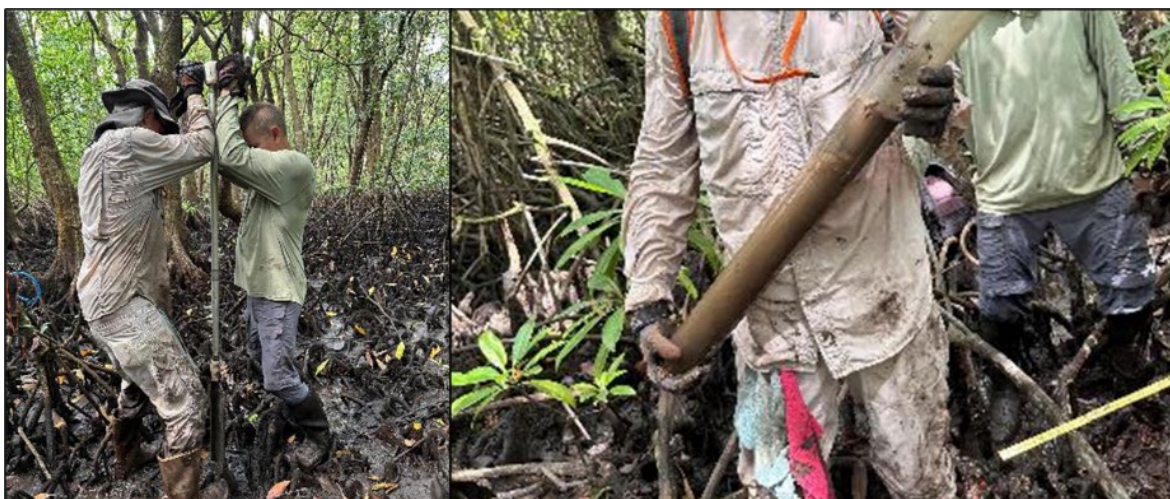
Figure 29. Soil samples were collected using a peat auger (left) and soil core (right) for organic matter and isotope analysis, respectively.

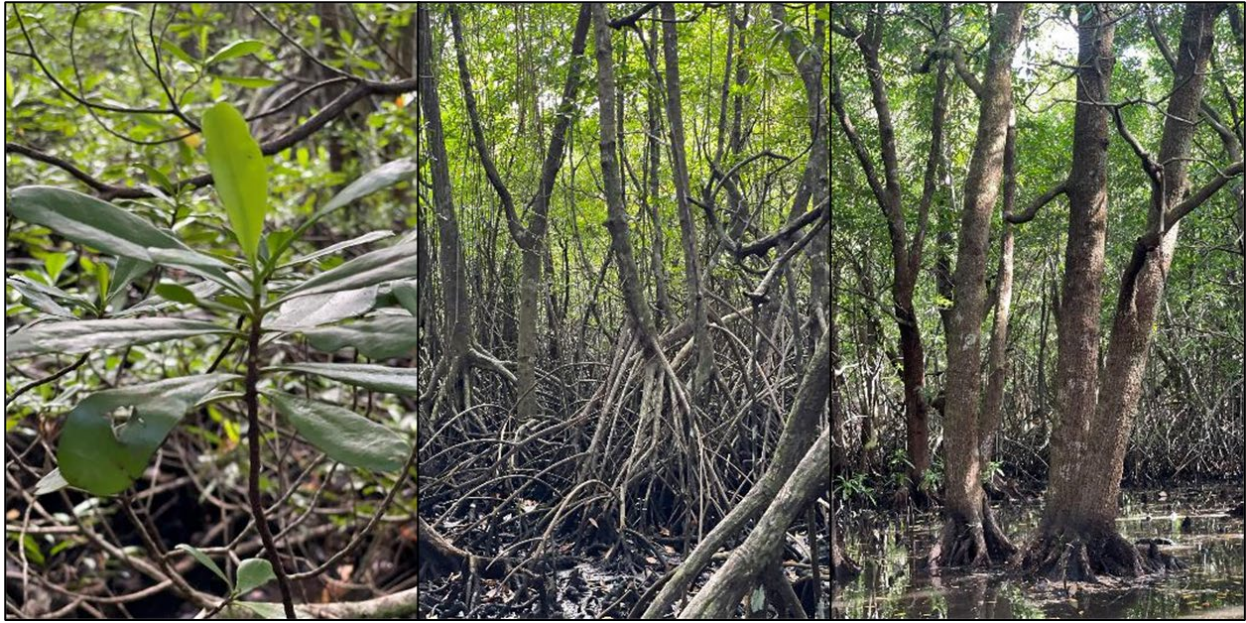
Figure 30. Examples of documented mangrove species including (from left) *Lumnitzera littorea*, *Rhizophora* sp., and *Bruguiera gymnorrhiza*.

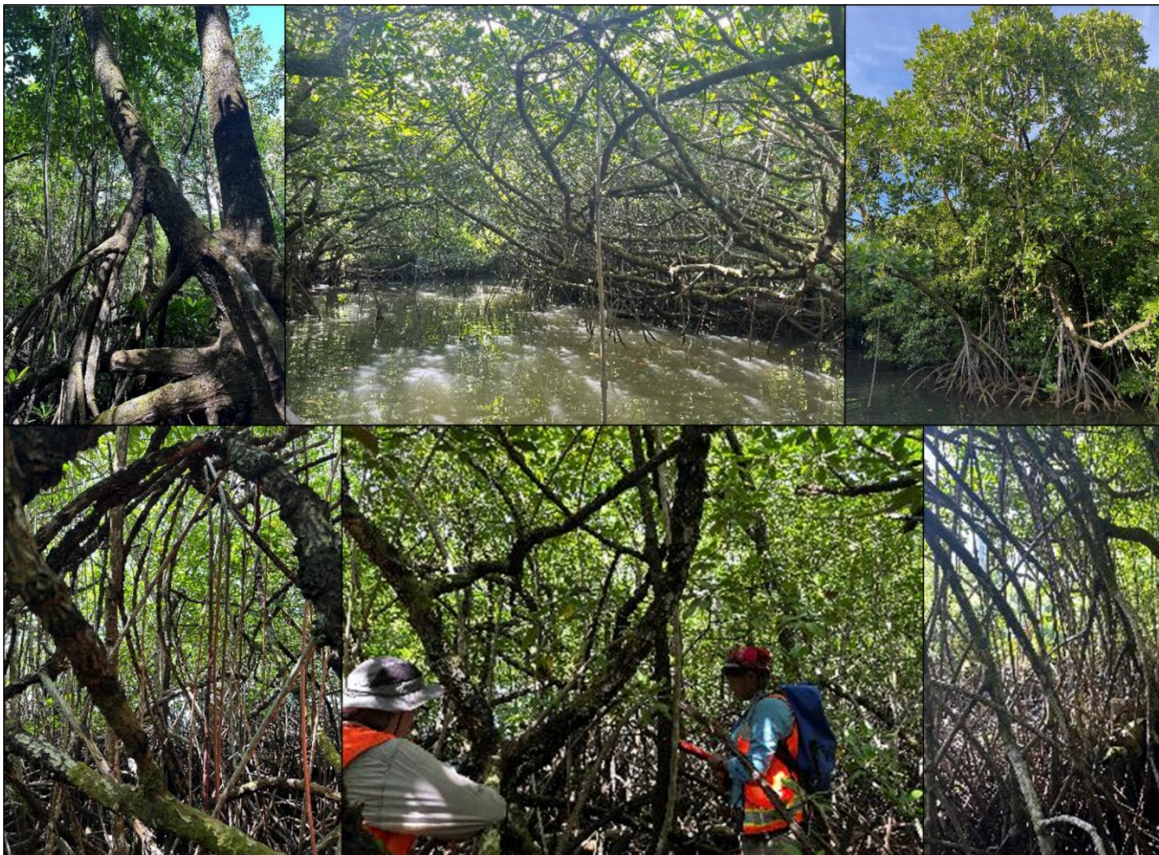
Figure 31. Examples of mangrove forest structure from Mangrove priority area 1 near the airport (top row) and Tamil Area 4 (bottom row).

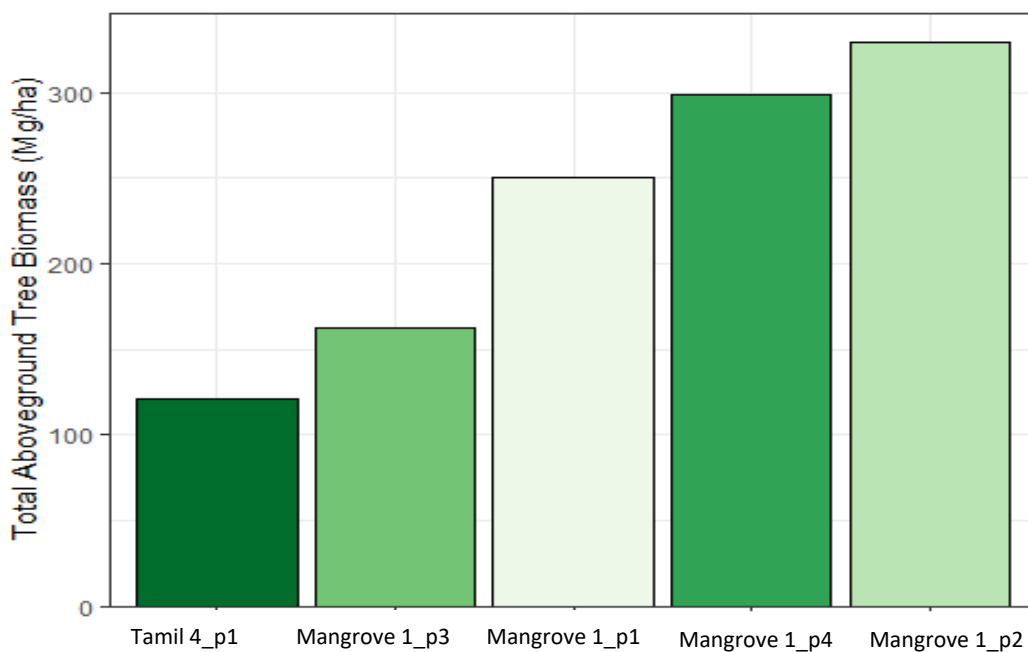
Figure 34. Total aboveground live tree biomass (Mg/ha) by plot.

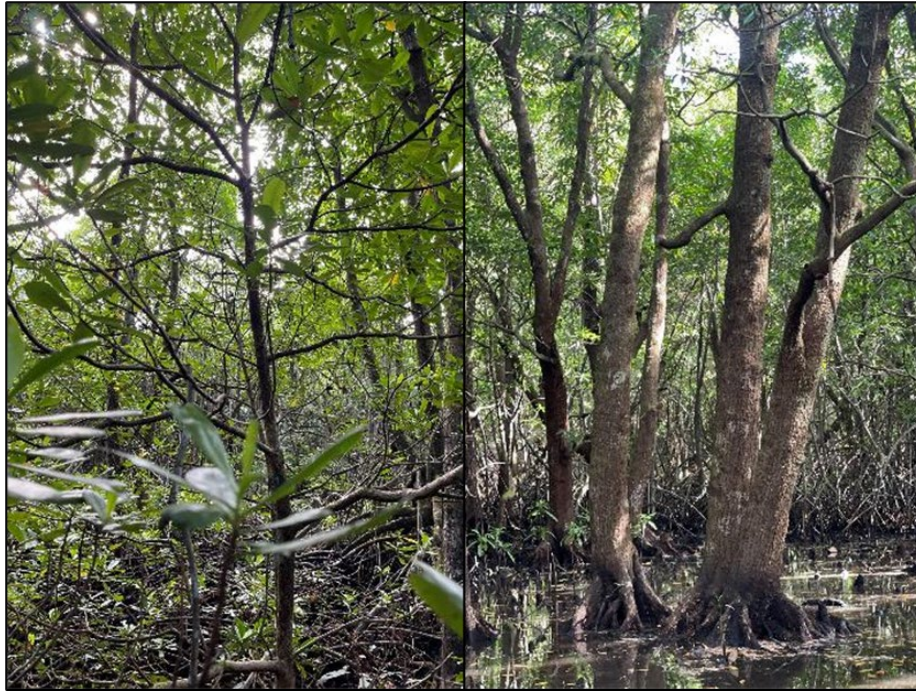
Figure 37. Examples of forest regeneration near the airport Mangrove priority area 1.

density was higher in Mangrove priority area 1 plots than the Tamil Area 4 site, with the highest total in Mangrove 1, plot 2 (Figure 37; Table 6).

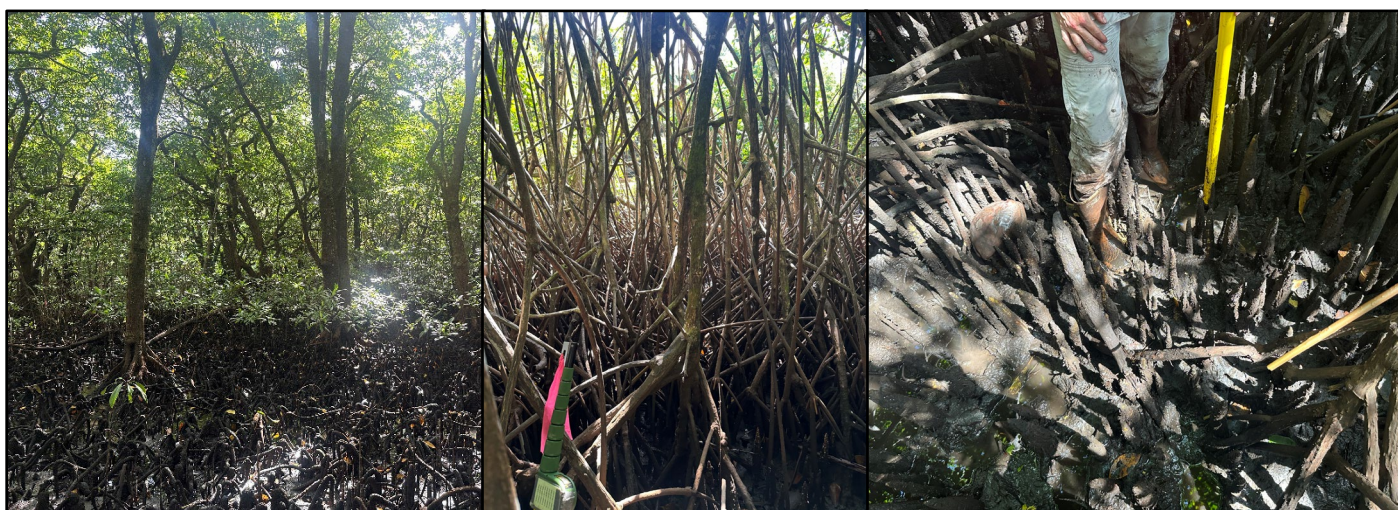
Figure 38. Examples of knee roots, prop roots, and pneumatophores (left to right).

Knee roots of *B. gymnorrhiza* density were sampled in the Mangrove priority area 1 plots, with the highest observed density in Mangrove priority area 1, plot 4 site (Table 7). Due to the sparse presence of pneumatophores and the dense network of prop roots at Tamil Area 4, pneumatophore density measurements were not collected (Figure 38). Prop roots are aboveground aerial roots used for stability and some gas exchange (characteristic of *Rhizophora* spp.) while pneumatophores are breathing roots that stick up from the soil used for gas exchange (characteristic of *B. gymnorrhiza* and *S. alba*). *S. alba* produces true pneumatophores, vertical pencil like projections, while *B. gymnorrhiza* forms knee roots – horizontal roots that bend upward and back down, creating a “knee” that protrudes above the soil and are used for support and aeration.

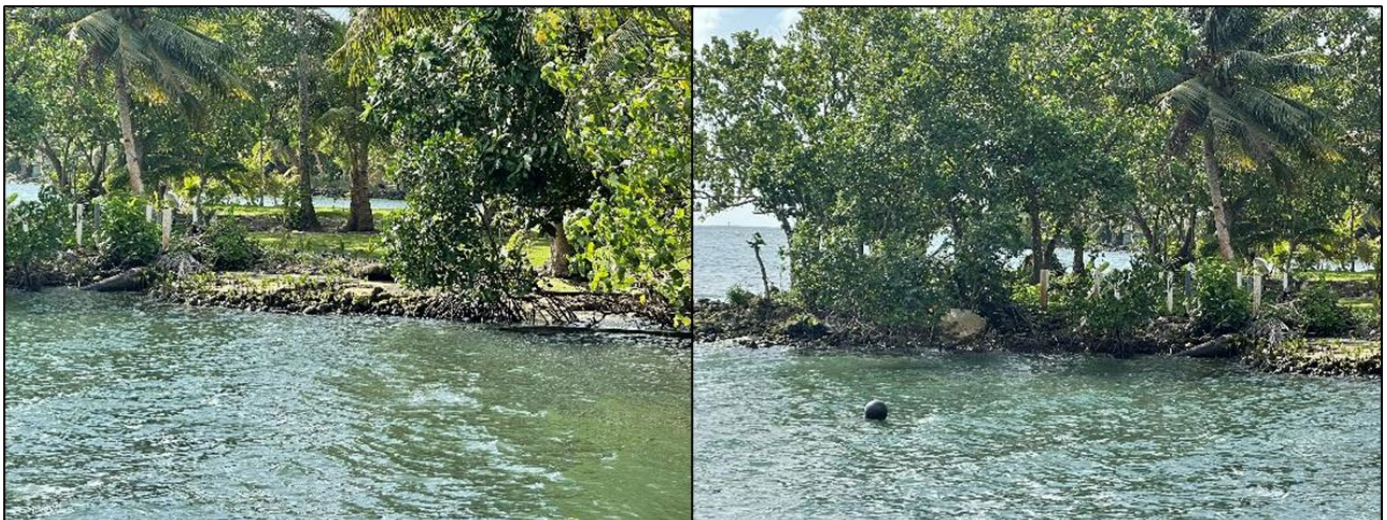
Figure 42. Photos of the sparse mangroves in the Rull community.

The rapid assessment was conducted along the Rull coastline due to the limited extent of mangroves in the area (Figure 42). Three species were observed: *Bruguiera gymnorrhiza*, *Rhizophora mucronata*, and *Xylocarpus granatum*. A total of 15 mangrove trees were recorded, including six *B. gymnorrhiza*, eight *R. mucronata*, and one *X. granatum*. Average tree height ranged from 3 to 7 m, height to live canopy ranged from 2-4 m, and average DBH ranged from 5 to 18 cm. The *X. granatum* and several *R. mucronata* located south of the Men’s House were smaller, measuring approximately 1-2 m in height with DBH values around 2.5 cm.
