Aids to Navigation Foundation Survey Report

**FY26 MCON Project P-1200 Yap Port and Channel
Improvements**

Yap Island
Federated States of Micronesia

15 January 2025

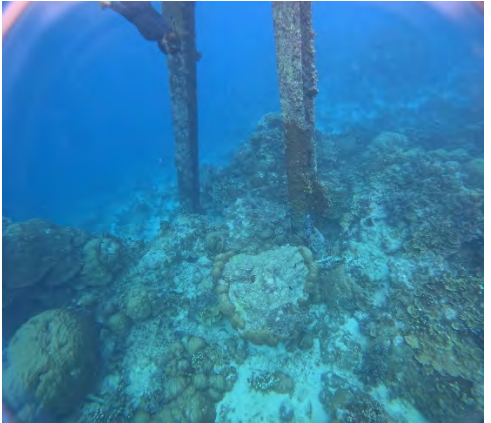
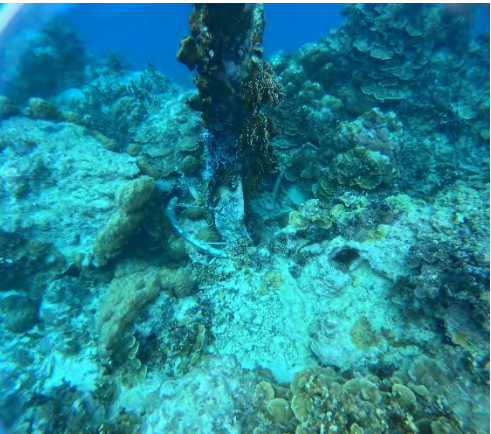
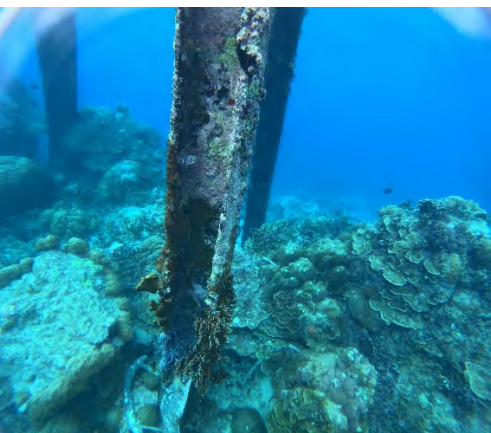
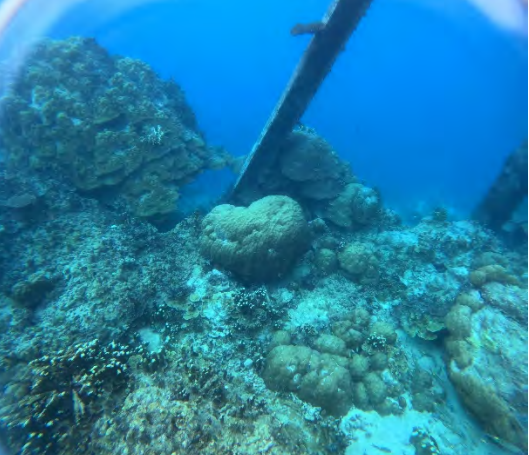
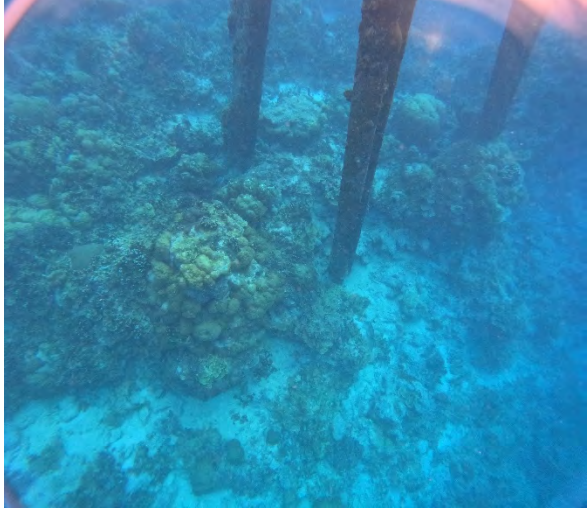
N/A	22.1	<p>Fixed aid #1 is a three pile structure with driven piles. Large coral heads are present around the three legs. The World Bank project replaced the light and dayboards but left the piles in place. Cathodic protection is installed on one of the three legs. Surface rust is present at and above the splash zone, however steel pile cross sections appear to be intact.</p>

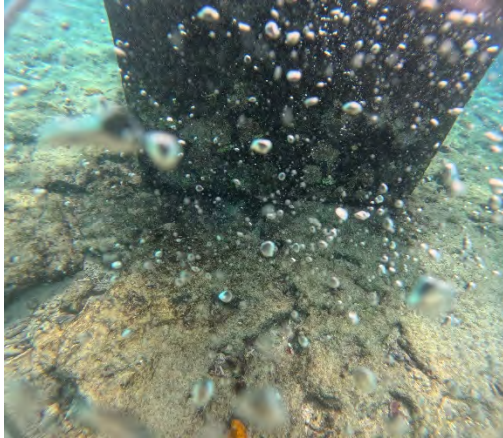
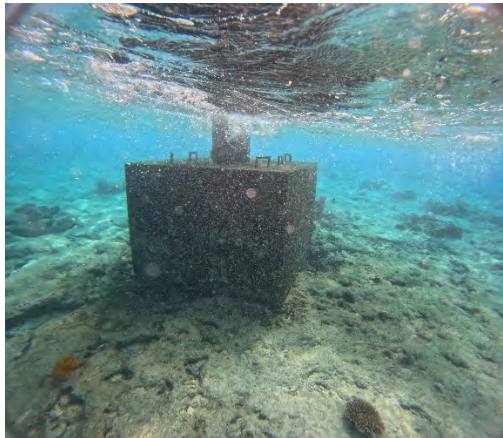
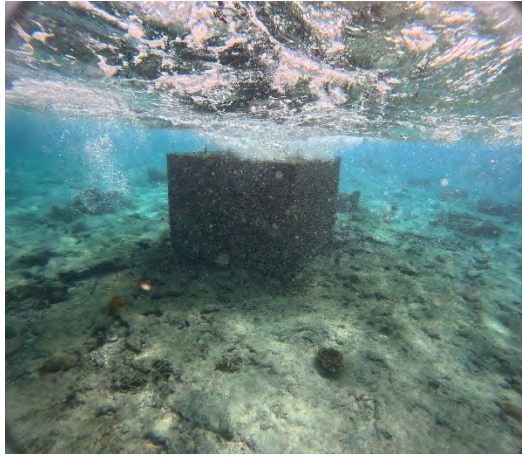
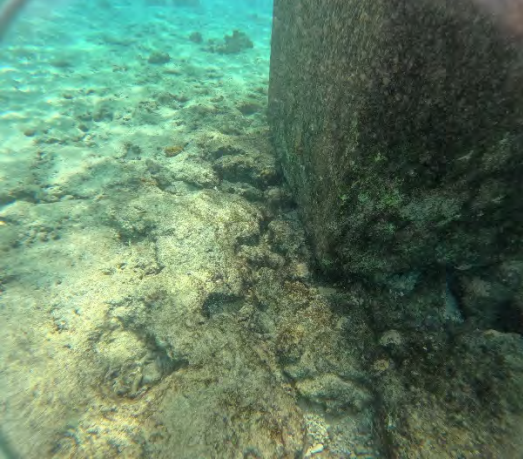
G3

60" X 60" X 44"	5.8	<p>Little to no coral present at this location. This is a newer aid that was installed via a World Bank project within the past 5 years. Although there is corrosion protection installed on the pile, there is visible signs of surface rust at and above the splash zone Dayboard is broken on one side.</p>
----	---	---	---	-----------------	-----	--

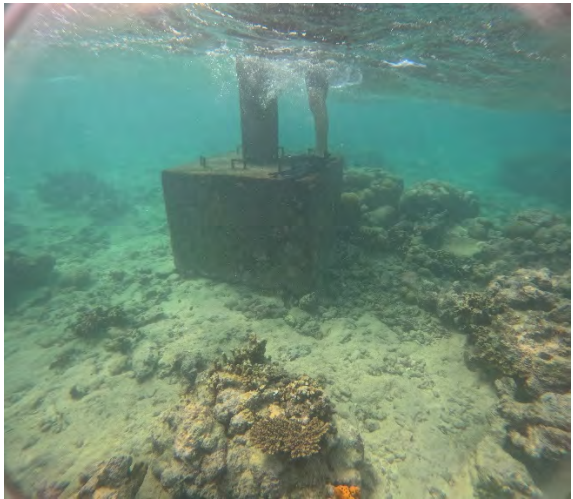
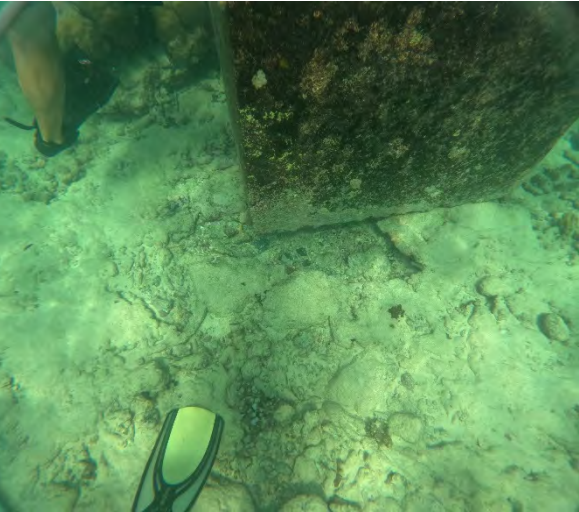
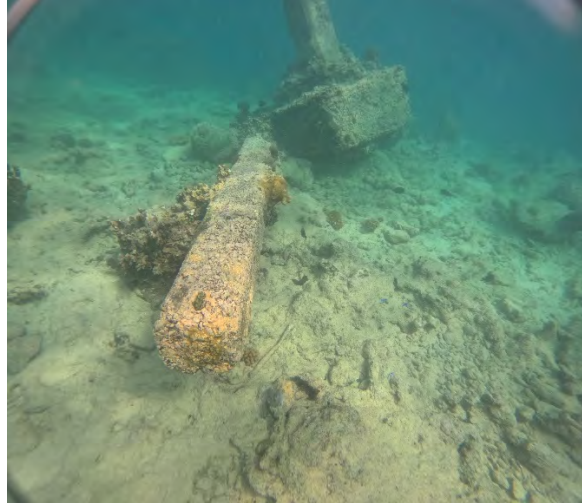
<p>R4</p>

<p>60" X 60" X 44"</p>	<p>6.9</p>	<p>Little to no coral present at this location. This is a newer aid that was installed via a World Bank project within the past 5 years. Although there is corrosion protection installed on the pile, there is visible signs of surface rust at and above the splash zone. Old concrete bases and driven pile remnants remain on the bottom along with other debris.</p>
-----------	---	---	---	------------------------	------------	---

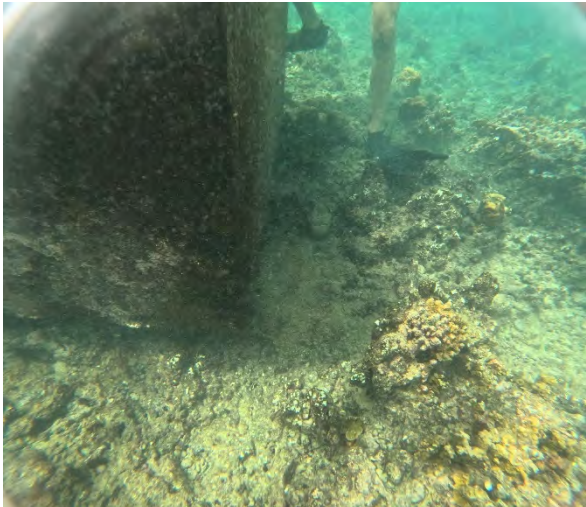
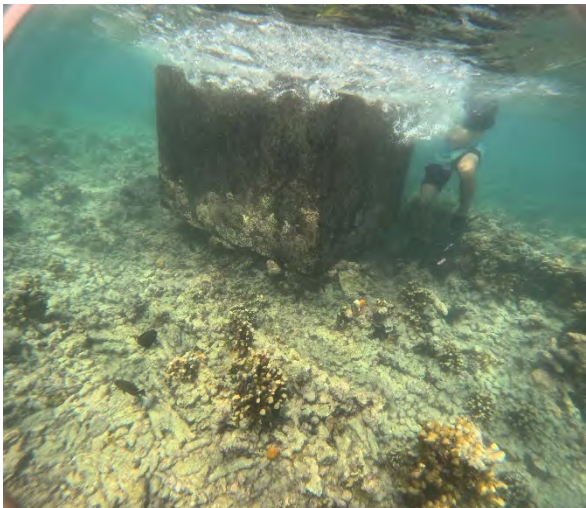
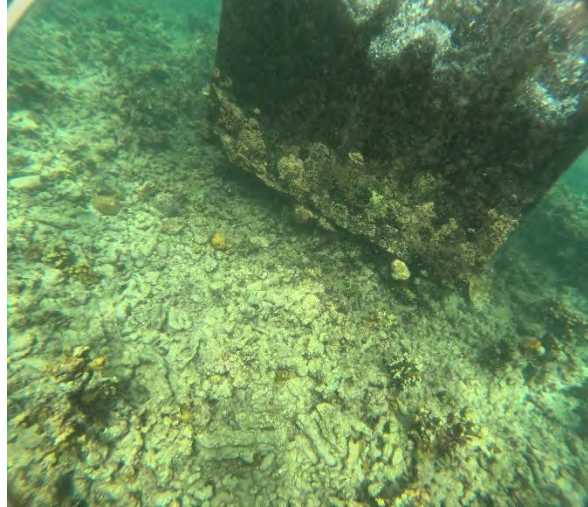
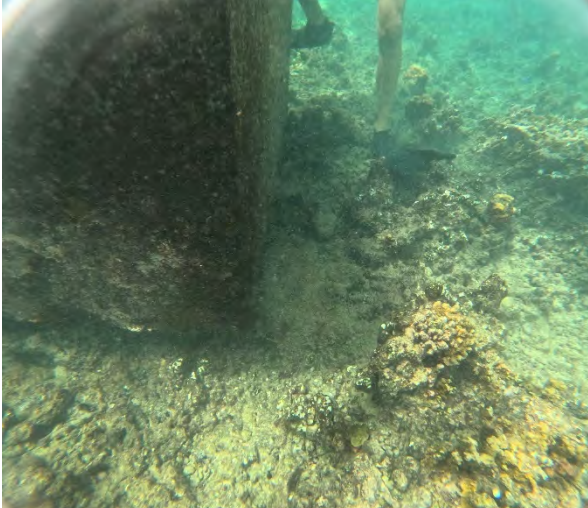
<p>R6</p>

<p>60" X 60" X 44"</p>	<p>6.2</p>	<p>This aid was initially planned to be the site of the new front range, however due to a shift in the channel centerline the location will no longer work for the front range. It is recommended to replace this aid with a standard single pile aid. Visible day boards front and back. This is a newer aid that was installed via a World Bank project within the past 5 years. Although there is corrosion protection installed on the pile, there is visible signs of surface rust at and above the splash zone.</p>
-----------	---	---	---	------------------------	------------	---

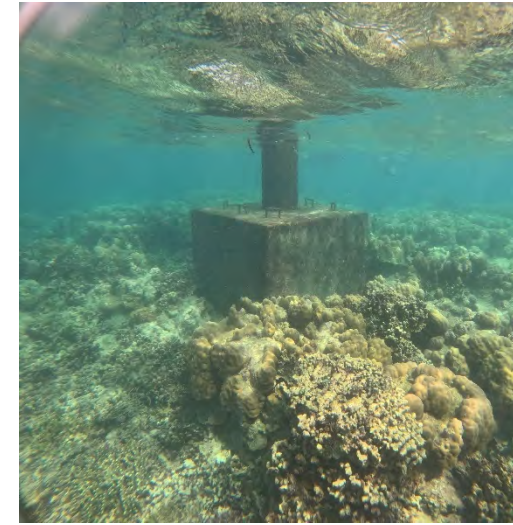
R8

Visible day boards front and back. This is a newer aid that was installed via a World Bank project within the past 5 years. Although there is corrosion protection installed on the pile, there is visible signs of surface rust at and above the splash zone. There is a lot of coral around this foundation. It appears that either a hole in the coral was found or created when this aid was placed as it sits below the surrounding coral heads. Evidence of older aids are present, but not hazardous to navigation.

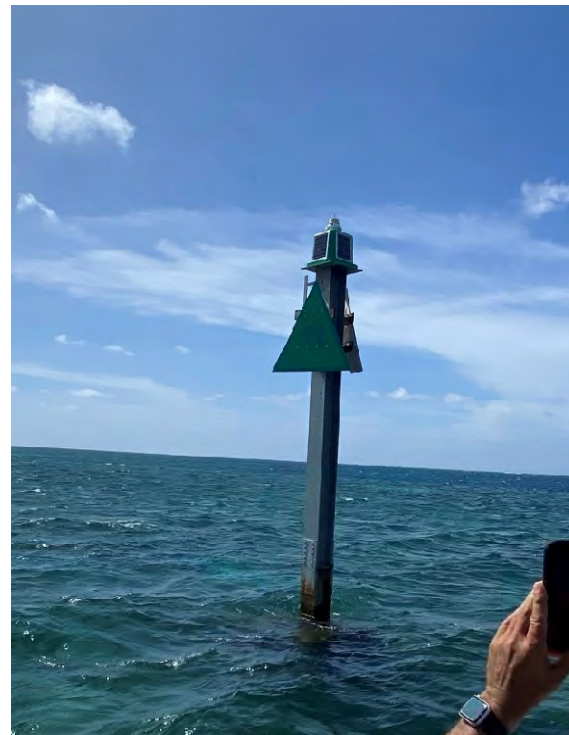
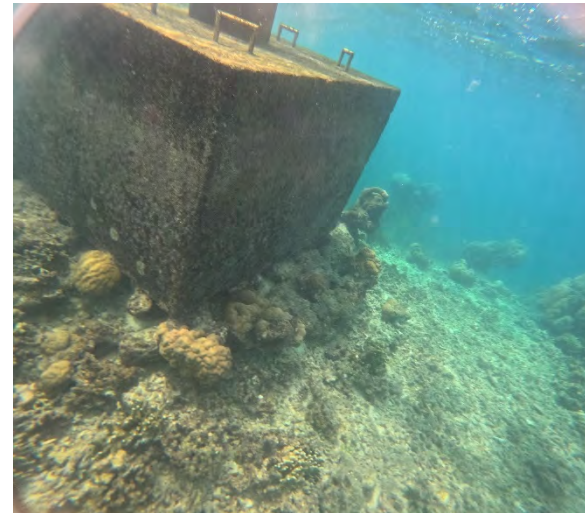
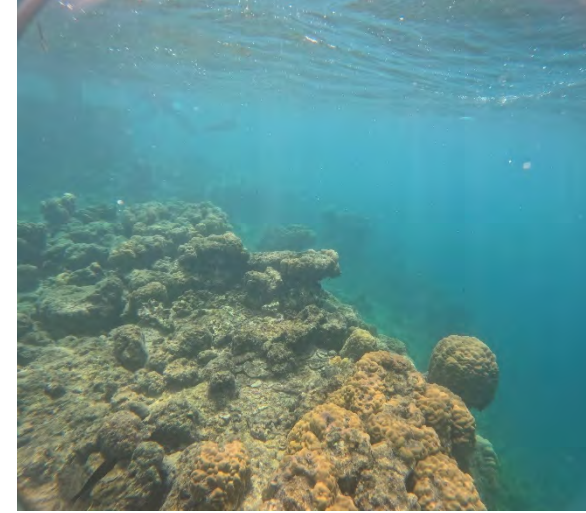
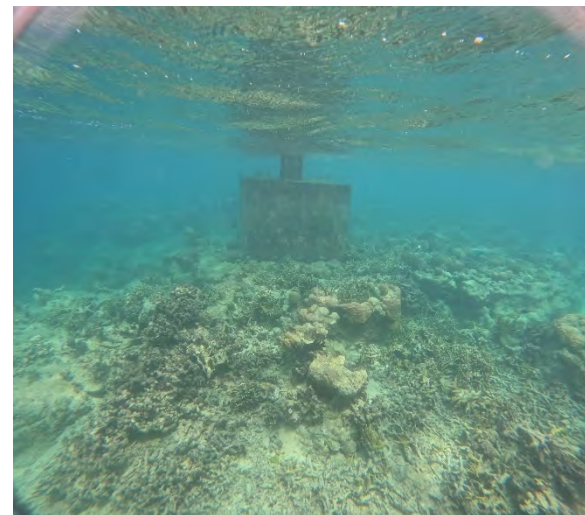
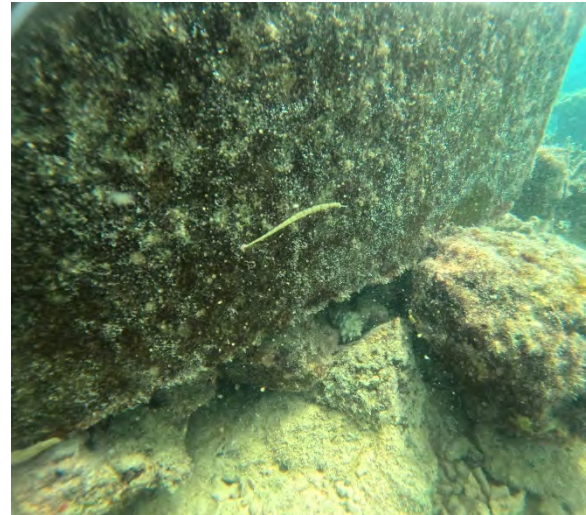
G11

Visible day boards front and back. This is a newer aid that was installed via a World Bank project within the past 5 years. Although there is corrosion protection installed on the pile, there is visible signs of surface rust at and above the splash zone. The foundation is placed on the coral, but no coral has attached to the foundation itself.

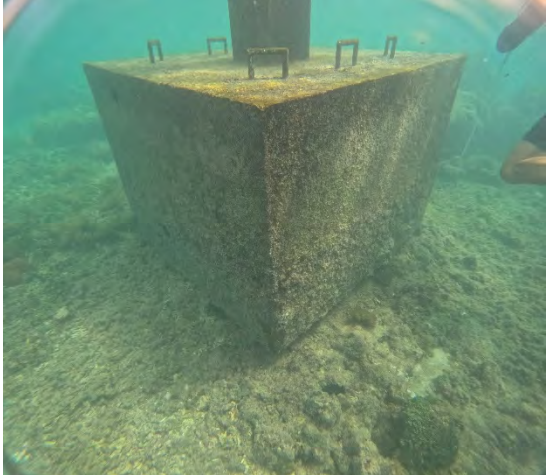
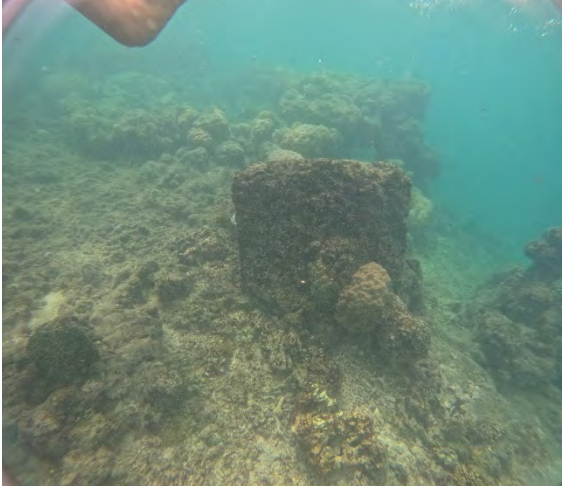
<p>G13</p>

<p>60" X 60" X 44"</p>	<p>6.0</p>	<p>Visible day boards front and back. This is a newer aid that was installed via a World Bank project within the past 5 years. Although there is corrosion protection installed on the pile, there is visible signs of surface rust at and above the splash zone. There are some corals around the foundation, but it is mostly rubble and sea grass in the immediate area around the foundation. There is evidence of old ATON's in the area. The driven pile that was left is just below the waterline and should be removed or cut off at the mudline to eliminate a navigational hazard.</p>
------------	---	--	--	------------------------	------------	--
