**Phase I Environmental Site  
Assessment  
Yap Seaport**

**ISLAND OF YAP FEDERATED STATES OF MICRONESIA**

**May 2024**

Prepared for NAVFAC Pacific by  
**AECOM Technical Services Inc**  
**1001 Bishop Street Suite 1600**  
**Honolulu HI 96813-3698**

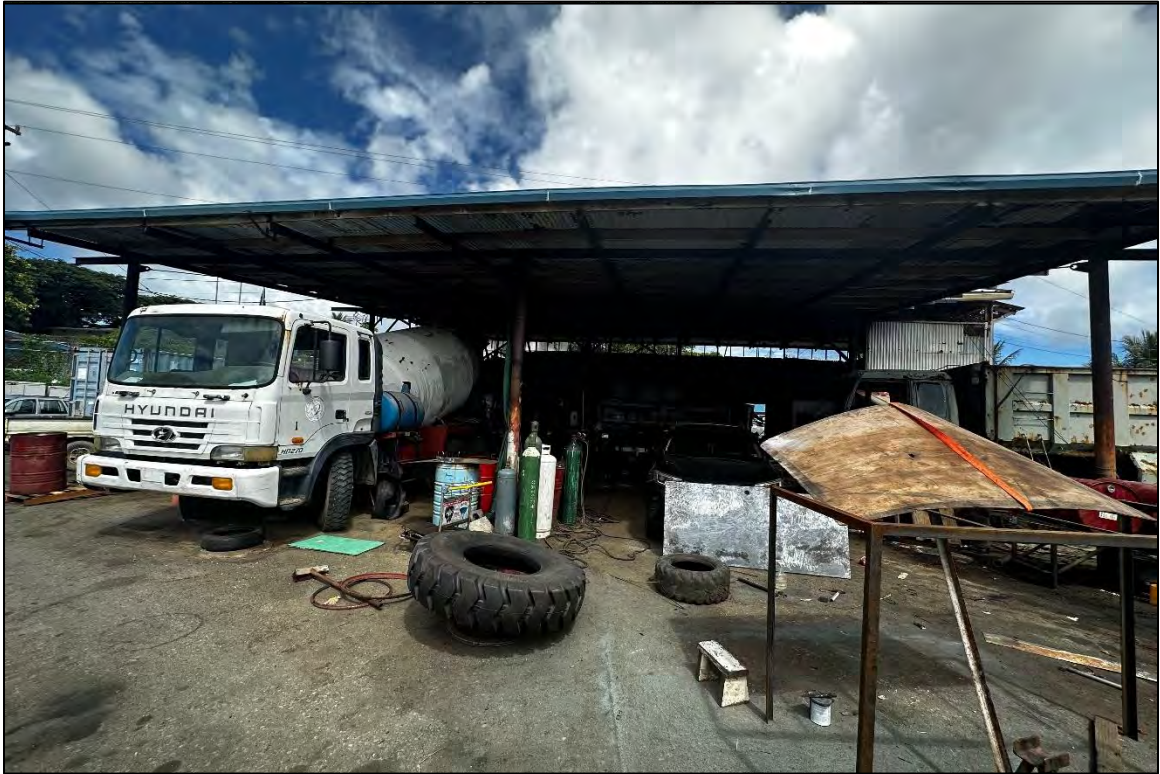
- Extensive oil staining at the Division of Sea Transportation maintenance shop, encompassing an area of approximately 200 square feet, is considered a REC, in AECOM's opinion. Petroleum hydrocarbons have likely leached to underlying soil and entered floor and trench drains.

- Twenty drums located within the Division of Sea Transportation maintenance shop (Appendix A, Photos 5–7). With the exception of six 55-gallon drums that are utilized for daily maintenance and repair activities, the drums were observed to be empty. None of the drums were labeled and all were uncovered and on concrete pavement. Extensive oil staining, estimated to be approximately 200 square feet in total area, was observed on the pavement throughout maintenance shop. Spilled fluids have likely infiltrated floor and trench drains at the shop, which discharge to the ocean (Appendix A, Photos 8 and 9).

Photo 5: Overview of the Division of Sea Transportation maintenance shop. Photo is looking west.

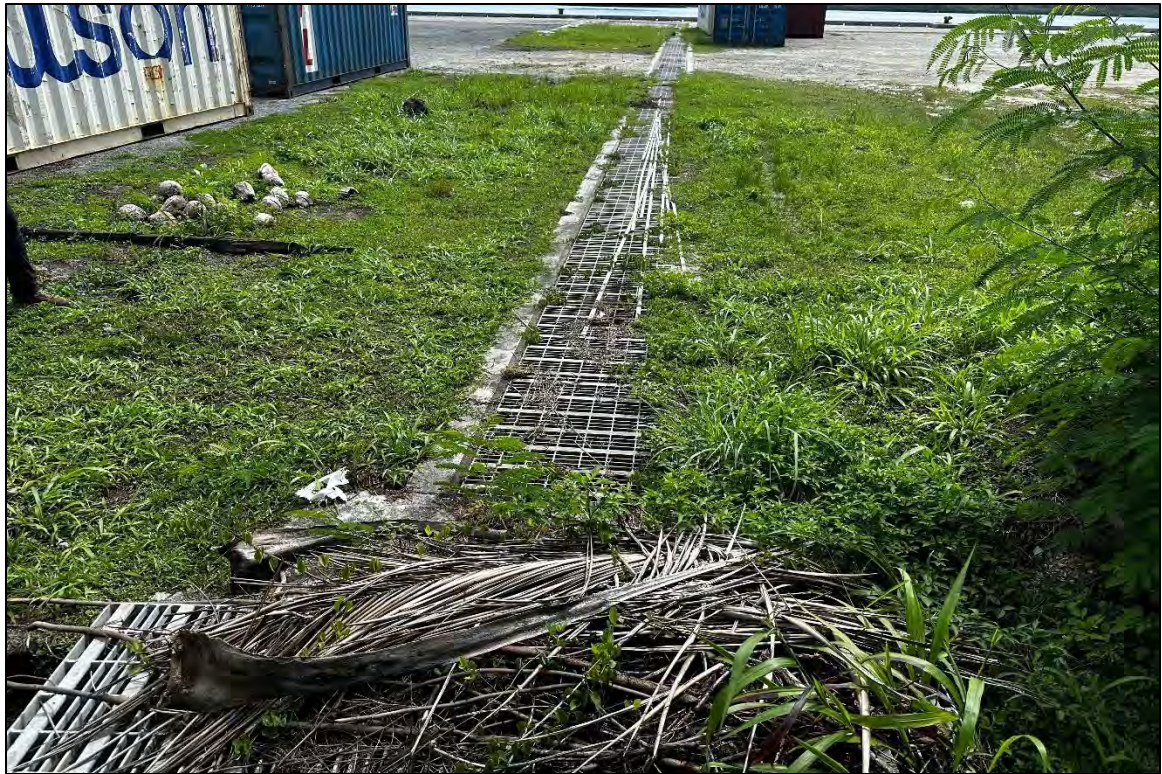
Photo 9: Drainage channel heading toward ocean. Photo is looking north.

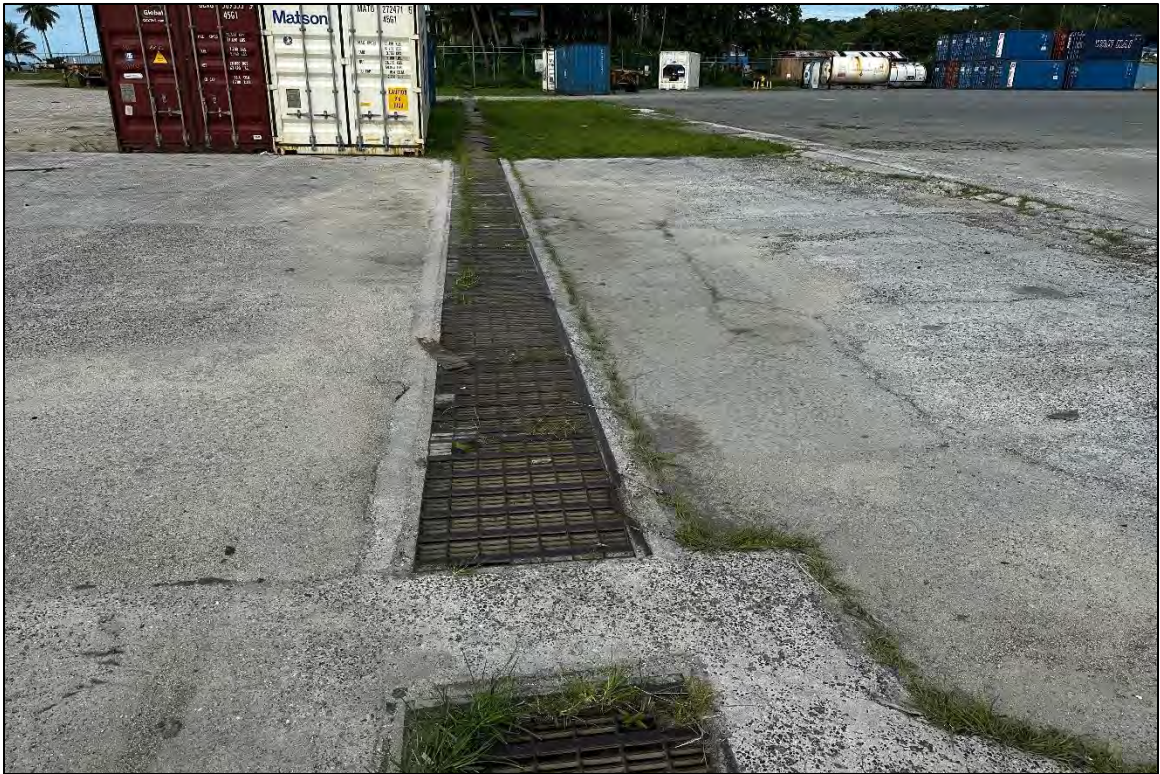
Photo 11: Storm drain channel which encircles the gated area within the port and leads toward the ocean. Photo is looking south.

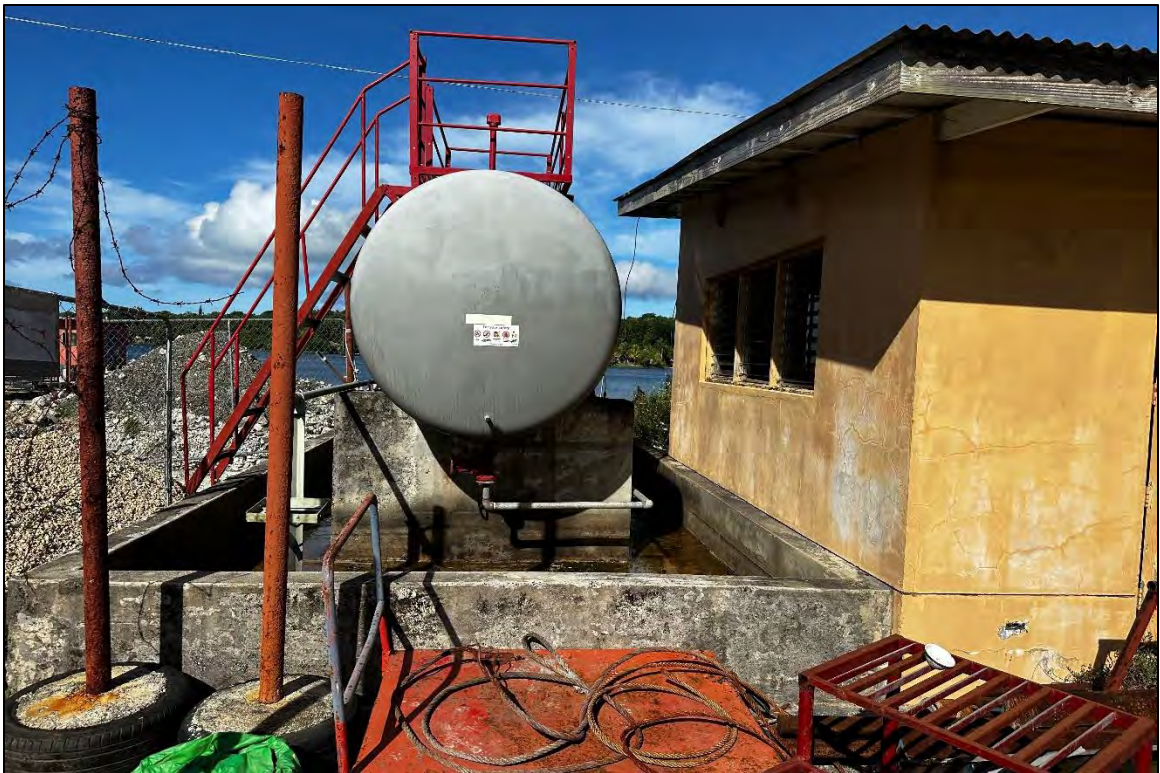
- A 10,000-liter diesel AST constructed of steel is present at the YFA facility (Appendix A, Photo 16). The AST is situated above a concrete containment basin. The installation date of the AST was unknown by YFA staff; however, the 1987 Yap Fishing Harbor Preparation Project drawings identify an “oil tank” would be installed (i.e., the AST was presumably installed after 1987). Mr. Yow and Ms. Falfen, the assistant general manager at YFA, indicated that other than a minor leak that was reported and repaired in 2022, no significant releases have been recorded from the AST. The 2022 leak was entirely contained within the concrete containment basin.

Photo 16: Overview of 10,000-liter diesel AST located at the YFA facility. Note: A concrete containment basin sits beneath the AST. Photo is looking south.

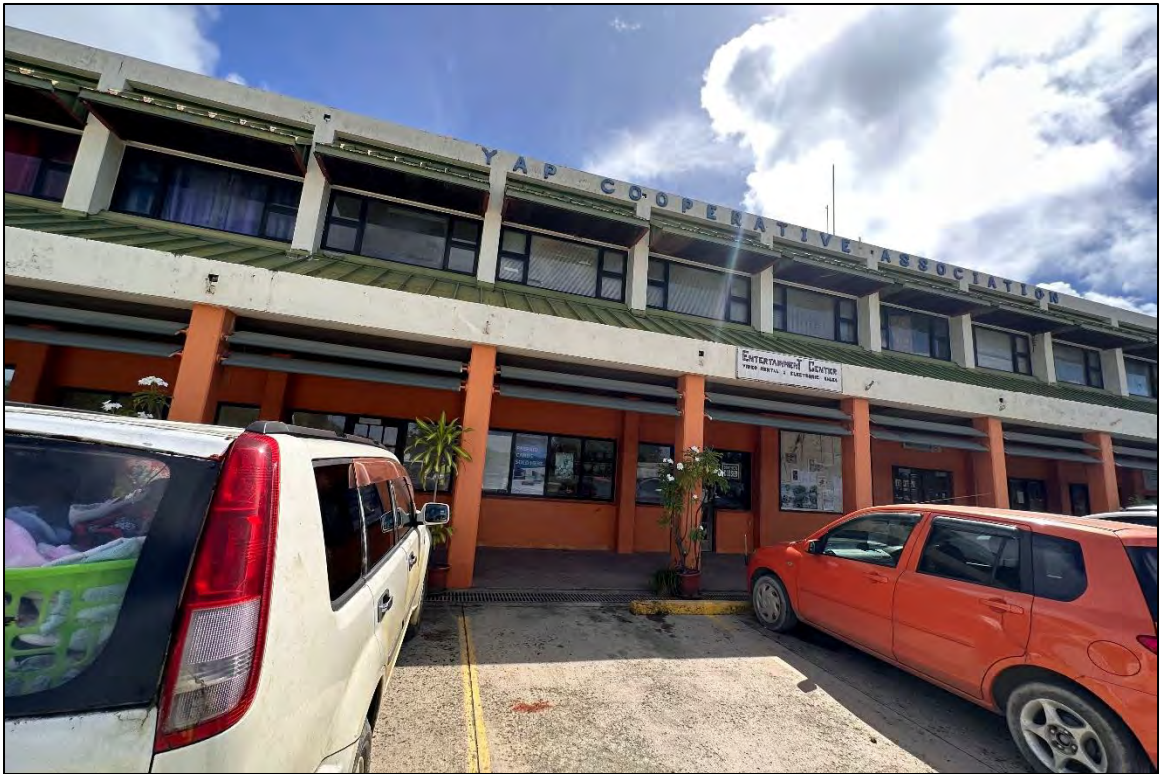
Photo 28: Overview of 320-gallon kerosene AST lacking secondary containment. Photo is looking east.

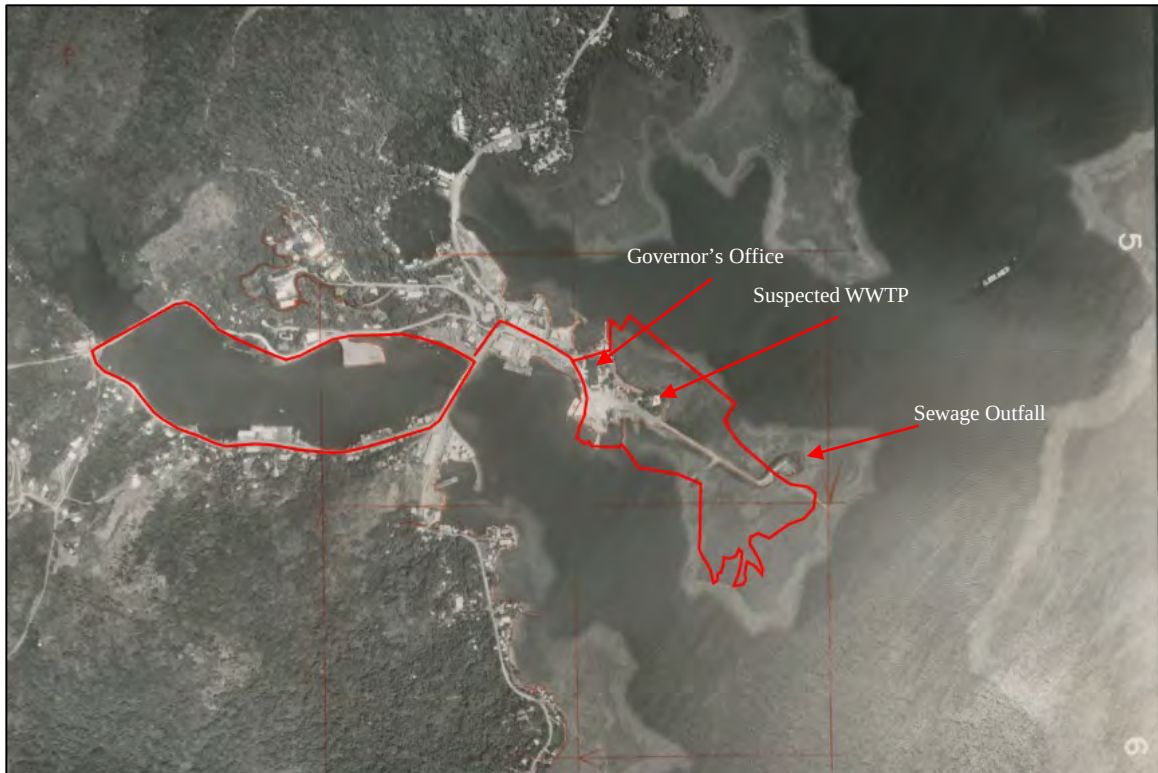
Historical aerial photographs indicate that the subject property, including the road encircling Chamorro Bay, was already partially developed by 1976. Visible structures include the Yap State Government and Administration Building, smaller structures in its vicinity, and the WWTP (Appendix B.1, Photo 1). The majority of the port area of the subject property is not yet in existence in the 1976 photo (i.e., the area is still ocean) and subsequently not illustrated in the 1983 topographic map. According to Mr. Yow, land reclamation and the construction of most of the port's buildings were completed in the 1980s. A review of the Yap Fishing Harbor Preparation Project at the Yap Fisheries Authority indicates that the FYA building was constructed after 1988.

Photo 1: 1976 – Subject property, Colonia. The majority of the subject property in the port area is undeveloped, with the exception of the governor's office and other features in the vicinity, including the suspected WWTP and its sewage outfall.

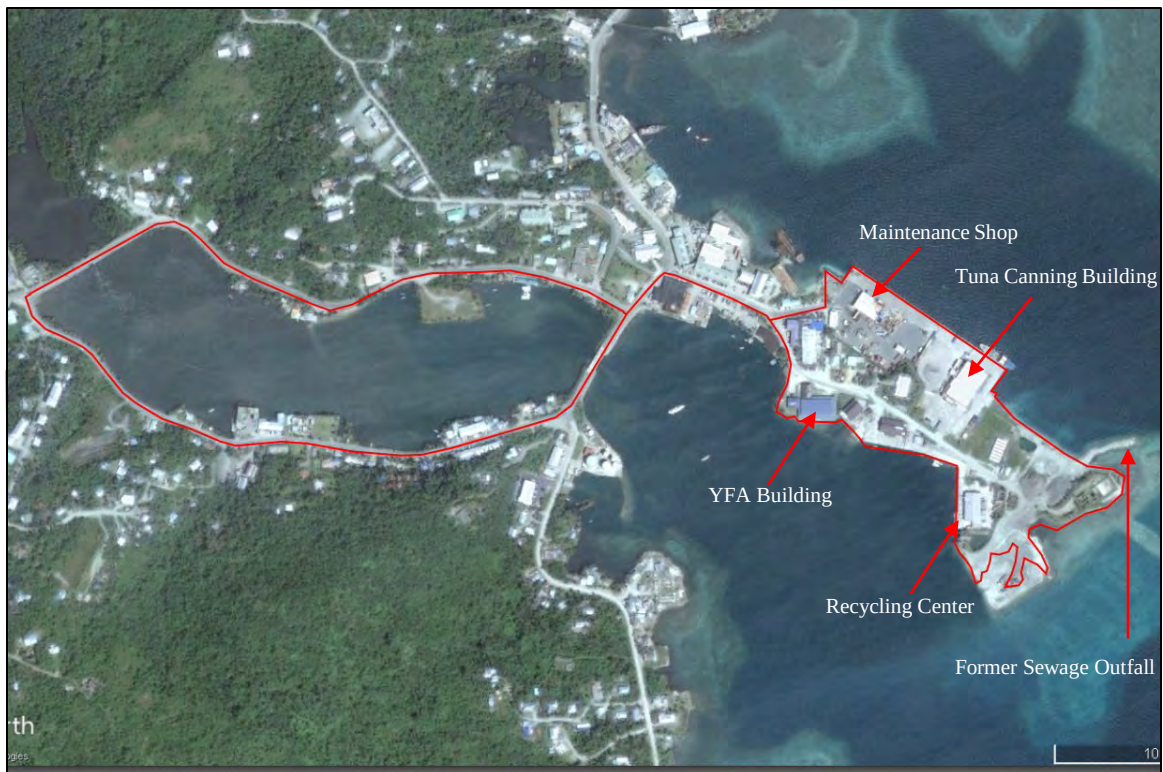
Photo 2: 2005 – Subject property, Colonia. The subject property appears fully developed. The wharf inside the gated area has been filled. The maintenance shop, YFA building, recycling center and tuna canning building are denoted by the red arrows. The majority of the former sewage outfall is now underwater.

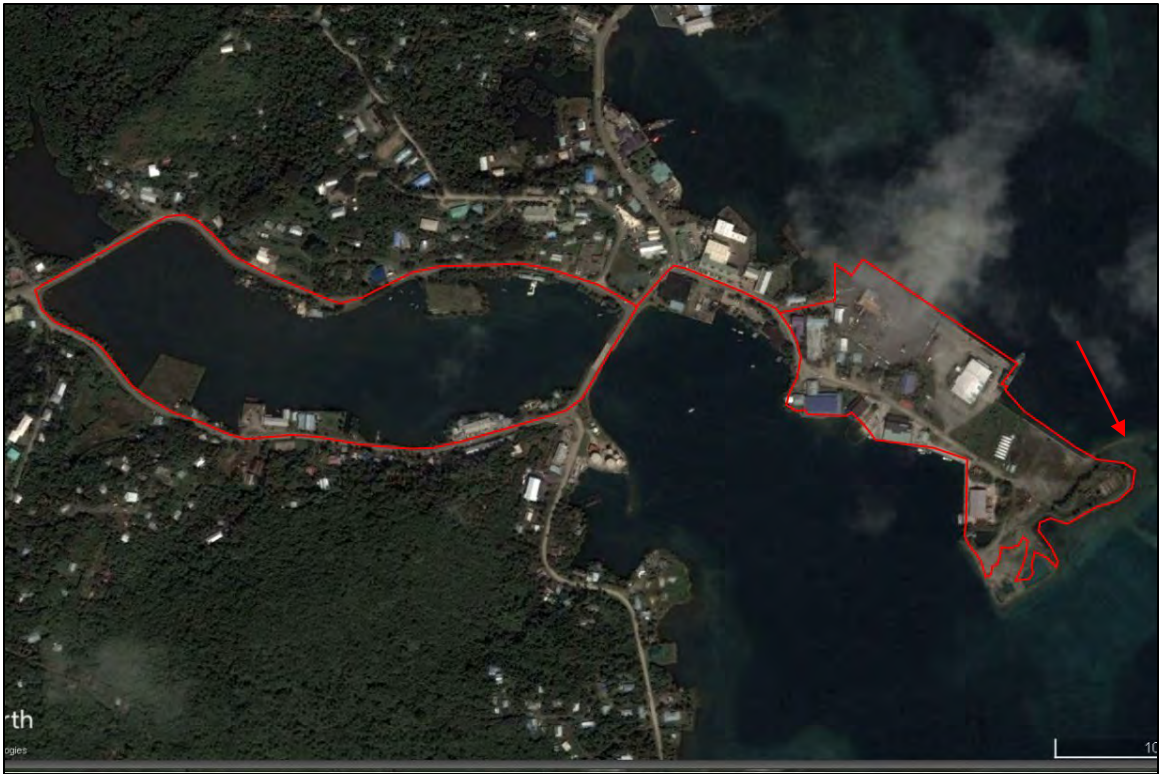
Photo 3: 2008 –Subject property, Colonia. The subject property looks generally the same from the last photo. Some portions of the easternmost point of the peninsula are now underwater. Red arrow points to the underwater strip of land associated with former sewage outfall

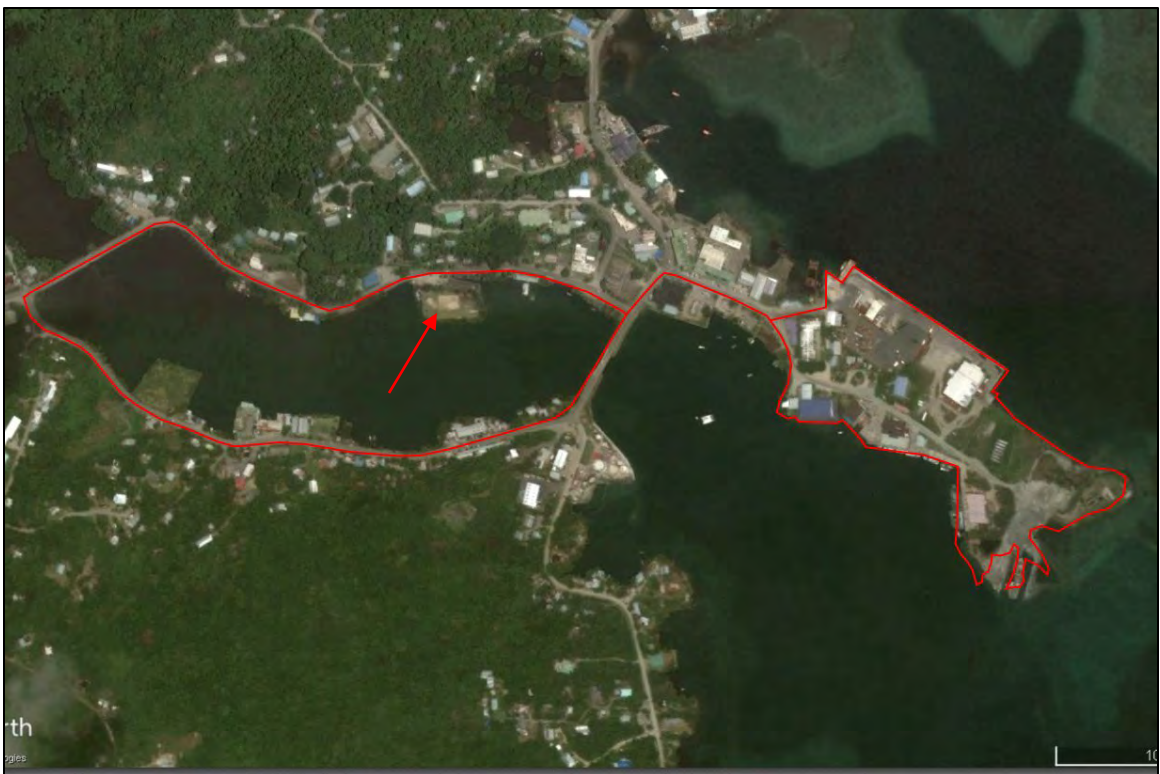
Photo 4: 2013 – Subject property, Colonia. The subject property looks generally the same from the last photo. There appears to be more shipping containers stored inside the gated area. There appears to be development in the adjacent area to the road denoted by the red arrow.

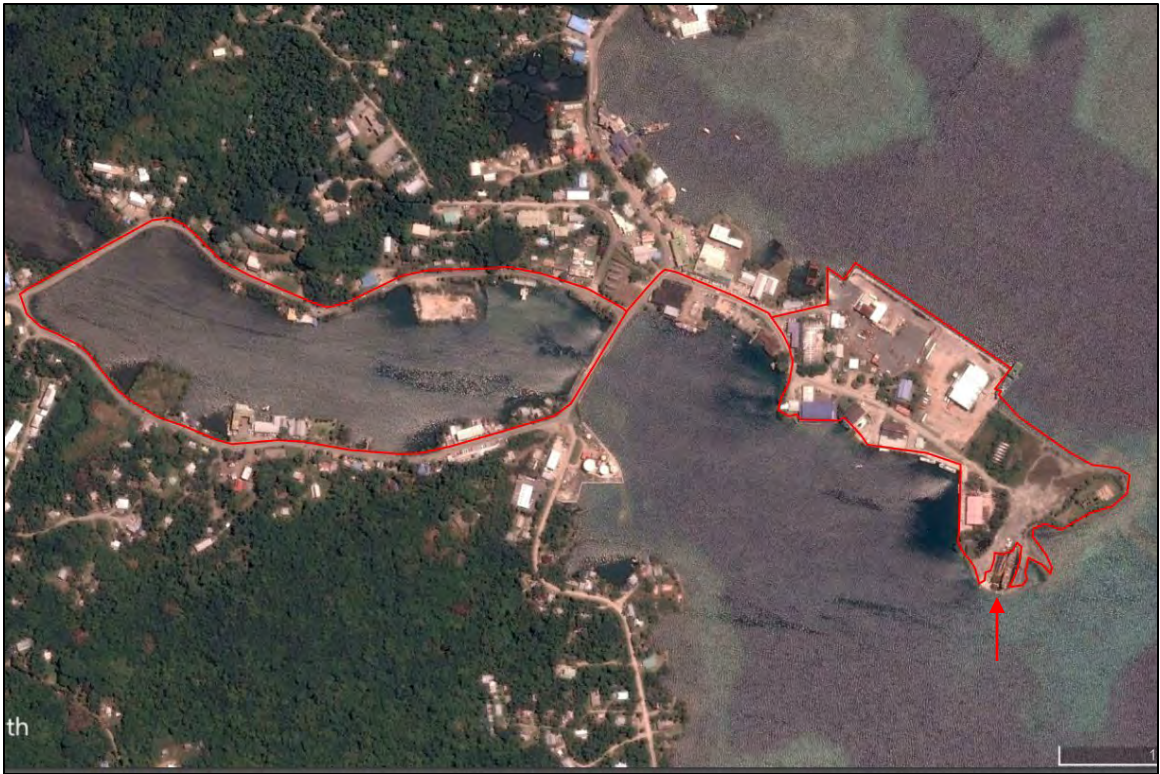
Photo 5: 2014 – Subject property, Colonia. The subject property looks generally the same from the last photo. The southeasternmost region of the subject property appears to be eroding. Red arrow points to region underwater.

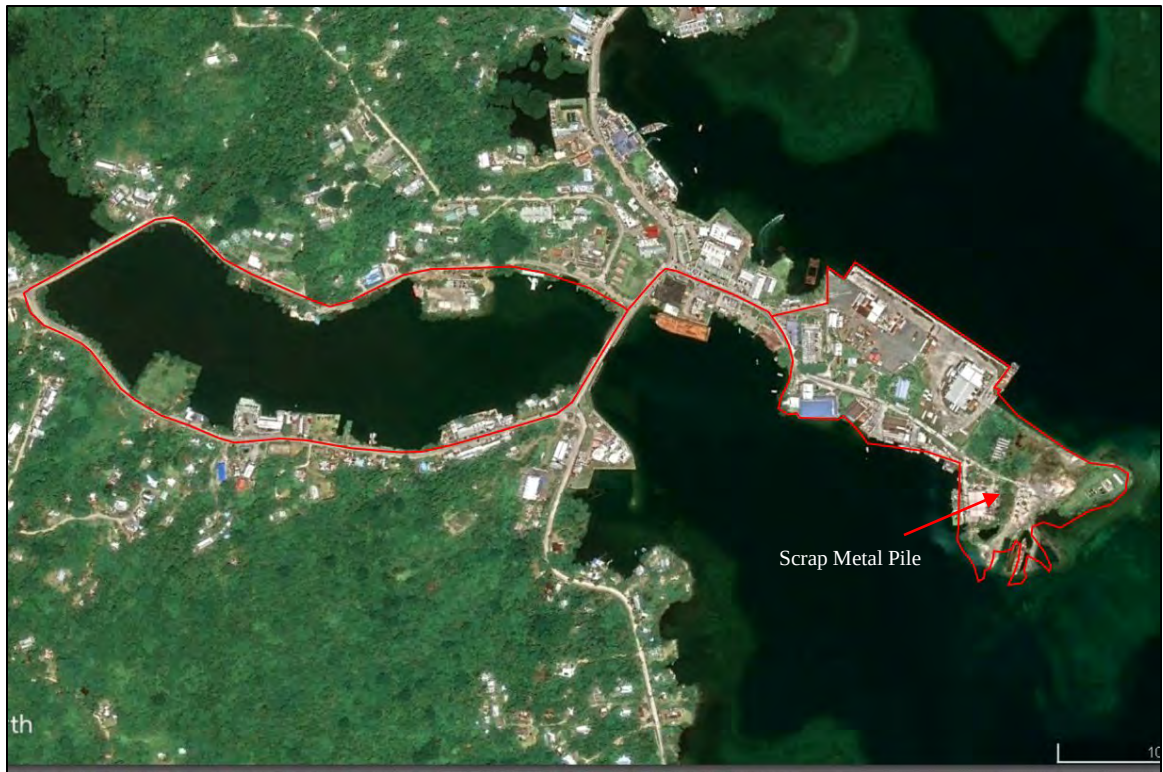
Photo 7: 2017 – Subject property, Colonia. The scrap metal pile adjacent to recycling center is now visible. Both piles are denoted by the red arrows.

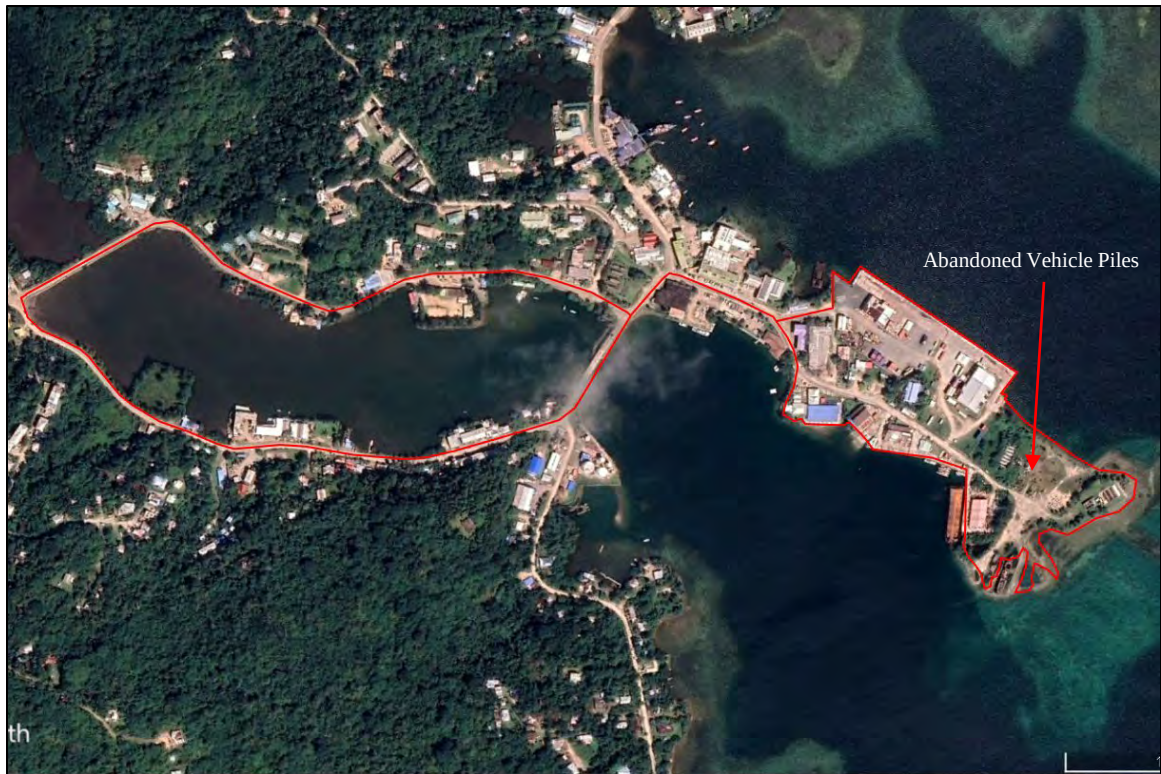
Photo 9: 2019 – Subject property, Colonia. The subject property looks generally the same from the last photo. The abandoned vehicle piles are beginning to accumulate (denoted by red arrow).

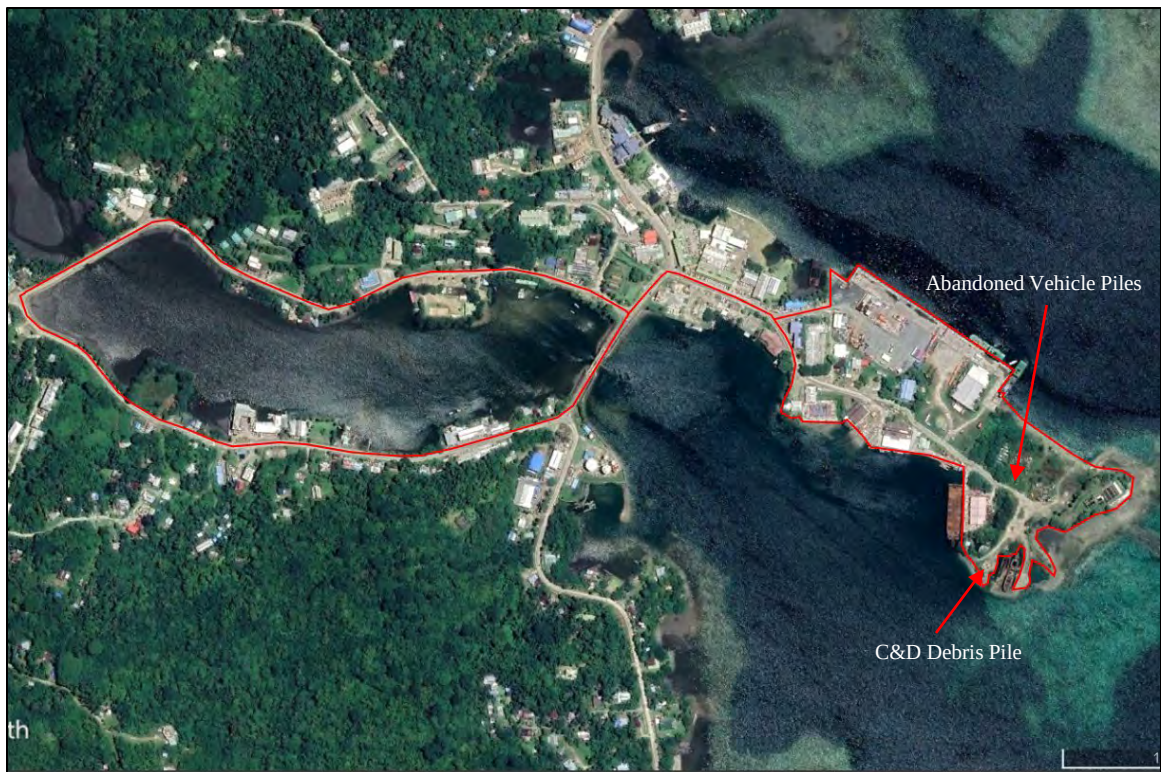
Photo 10: 2022 – Subject property, Colonia. The subject property looks generally the same from the last photo. More abandoned vehicles appear to be accumulated. Construction and demolition (C&D) debris pile is now visible (both areas denoted by red arrow).
